**NATIONAL TRANSPORTATION SAFETY BOARD
OFFICE OF AVIATION SAFETY
WASHINGTON, D.C. 20594**

**ADDENDUM NUMBER 2 TO THE SYSTEMS GROUP CHAIRMAN'S
FACTUAL REPORT OF INVESTIGATION – RUDDER SERVO CONTROLS
AND LINKAGE**

DCA02MA001

Operator: American Airlines
Aircraft: A300-600R
Location: Belle Harbor, New York
Date: November 12, 2001
Time: 09:16 EDT

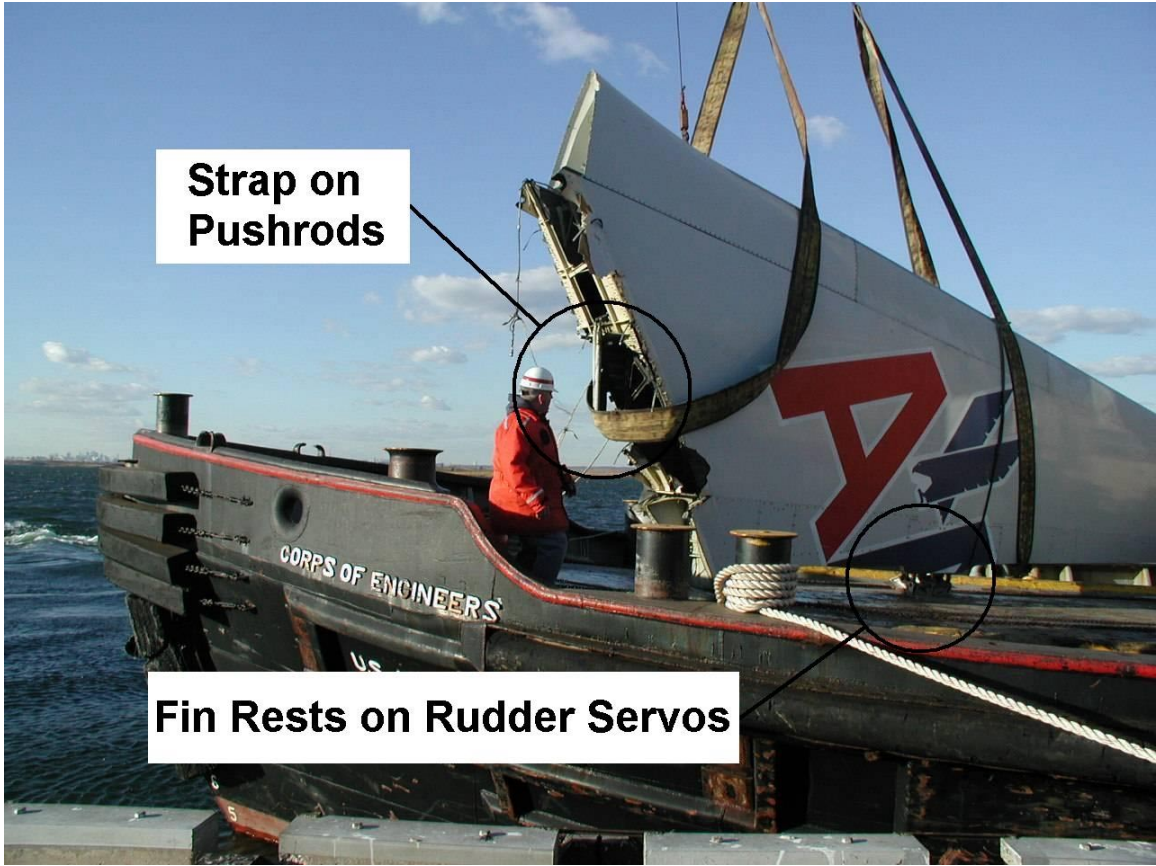
Figure 2.1B Recovery of Vertical Stabilizer from Jamaica Bay.

The observations and measurements shown in Table 2.3 were made with the lower crank rig pin installed. Dimensions are defined in Figure 2.3. It was observed that the fin was rested on the servos during the recovery process (Figure 2.1B). If sufficient force is applied to the rod end when hydraulics are not pressurized the piston can retract or extend.

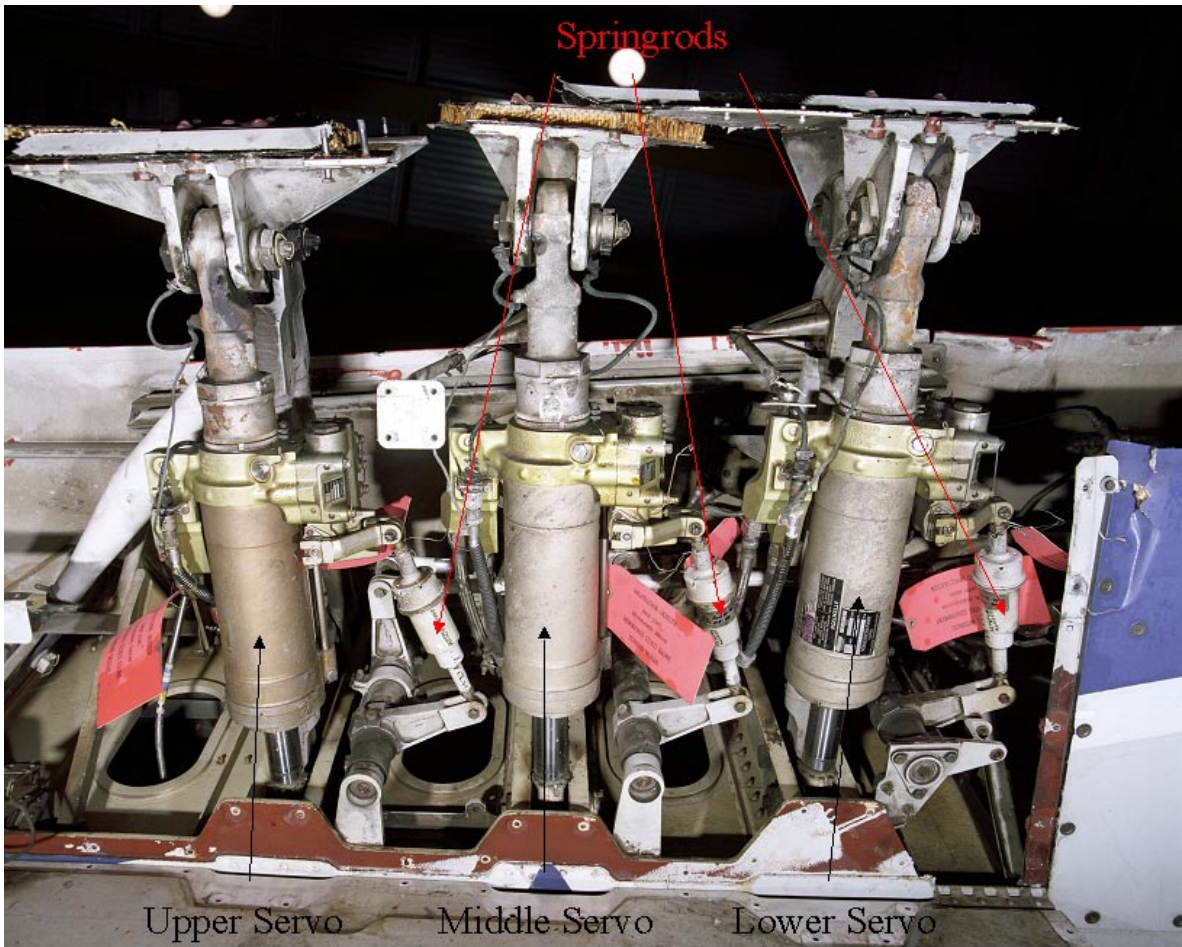
Figure 2.2A. Accident Airplane Rudder Servo Controls and Linkage

The springrods were found connected to the input bellcranks and to the rudder servos (Figure 2.2A). The upper servo input springrod was observed to be bent.

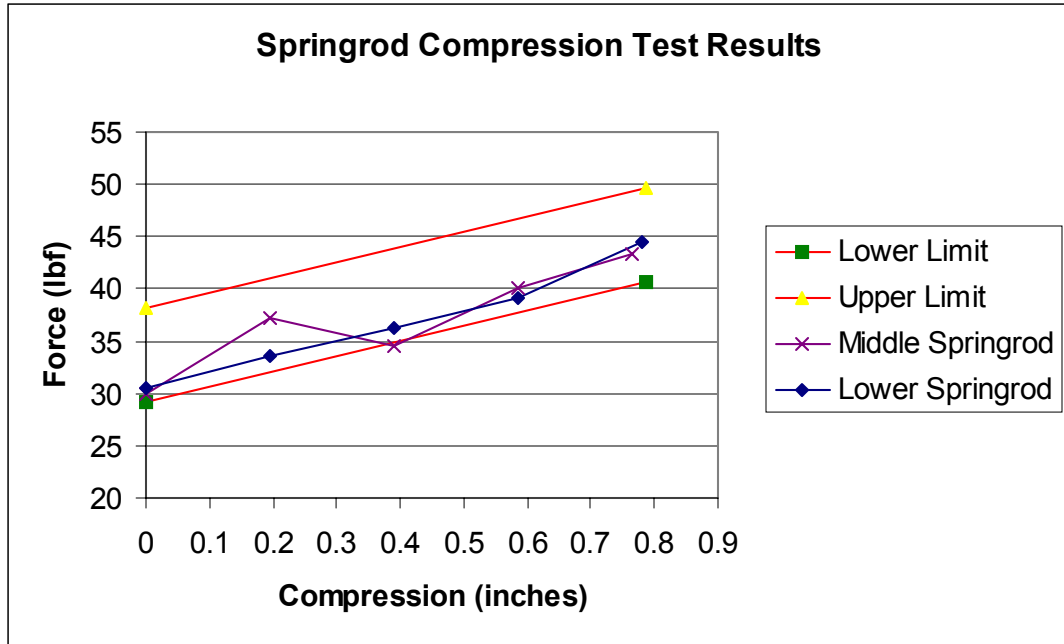
Figure 3.2B. Results of Extension Test.

Break out force between 50 and 55 lbf. The springrod went to full extension following breakout.

Break out force between 40 and 45 lbf. The springrod went to full extension following breakout.

A second test was performed on the lower springrod, and break out occurred between 35 and 40 lbf.

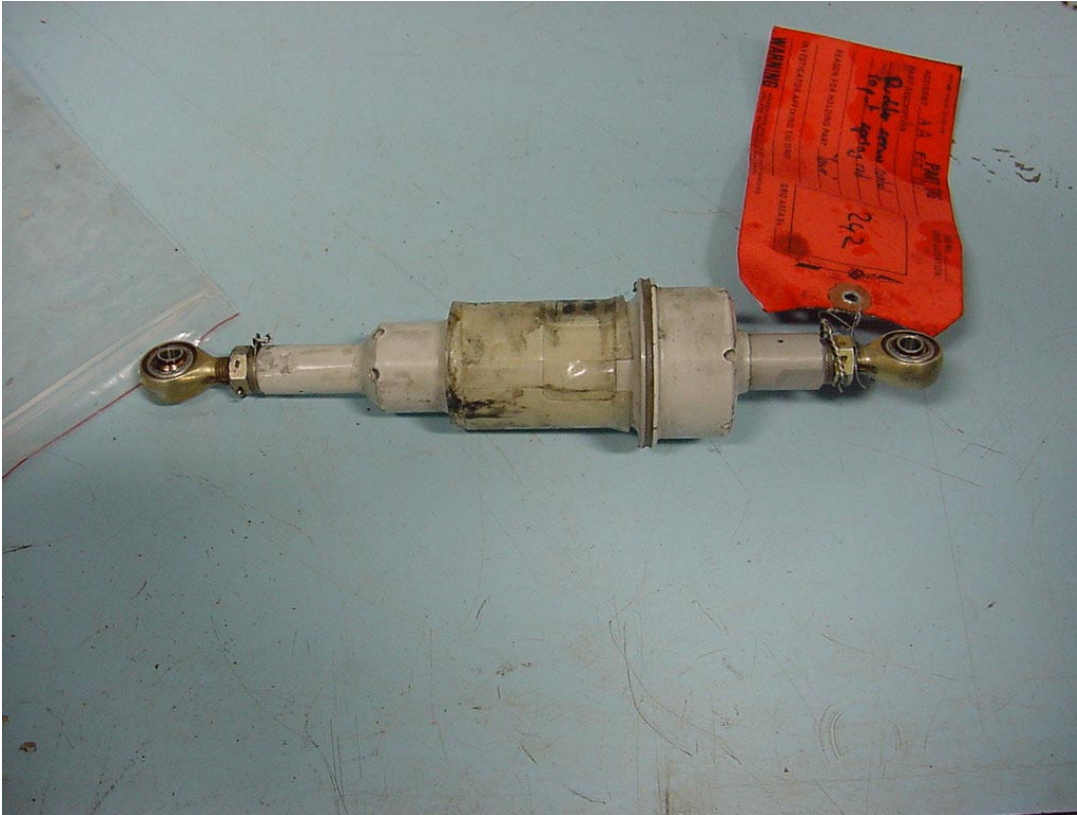
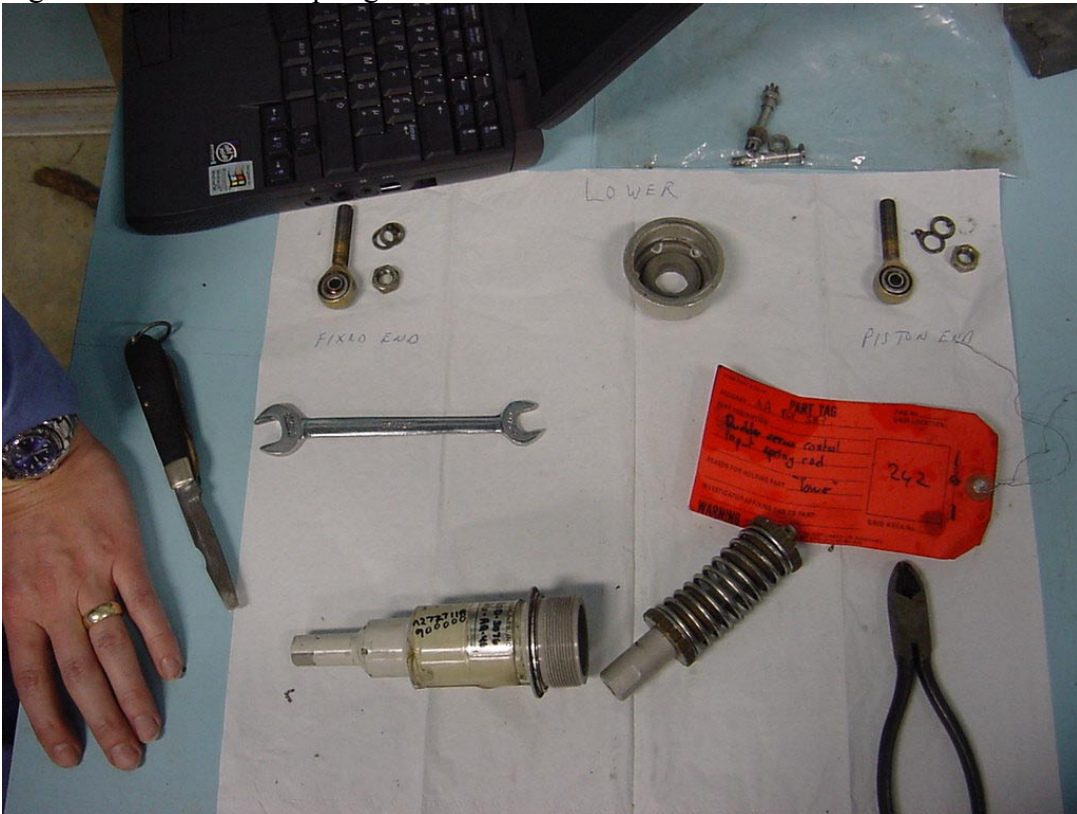
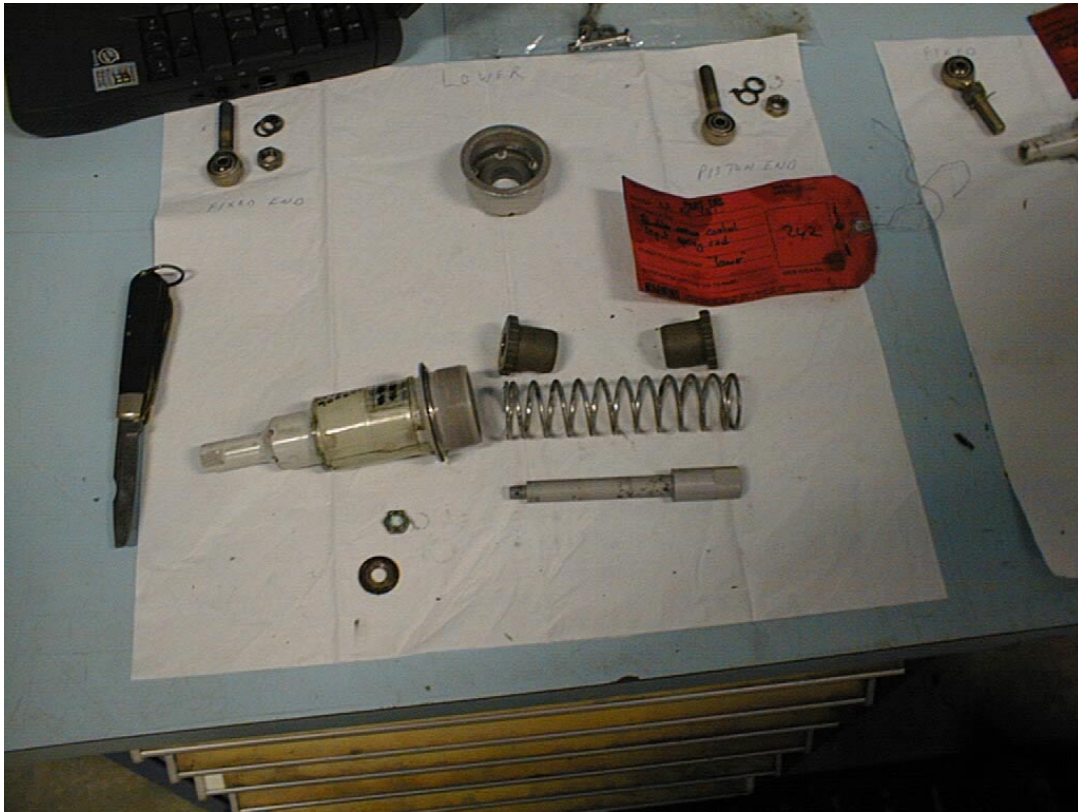
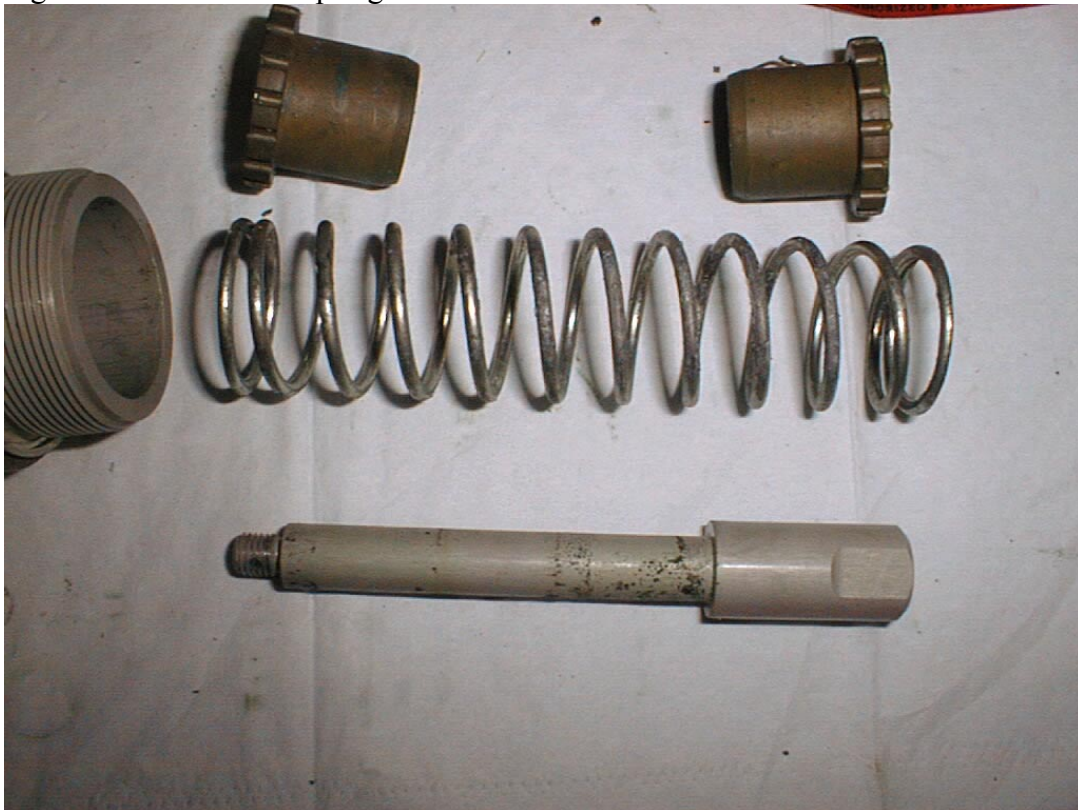
There was a slight discoloration in the interior of the housing, item 140. White deposits and discoloration were observed, mostly on one side of the spring circumference. Item 120 nut side is rusted. Item 90 washer was not installed. There was significant friction between the item 110 retainer and the item 60 piston, near the shouldered face of the piston, but it was not stuck. Some

friction was also noted when removing the item 110 retainer on the nut side. Numerous small spots of discoloration were observed on the piston operating surface. There were friction marks on the item 140 housing surface. On the retainer (piston shouldered face side) internal surface, there are significant blue spots located on 1/3 of the circumference.

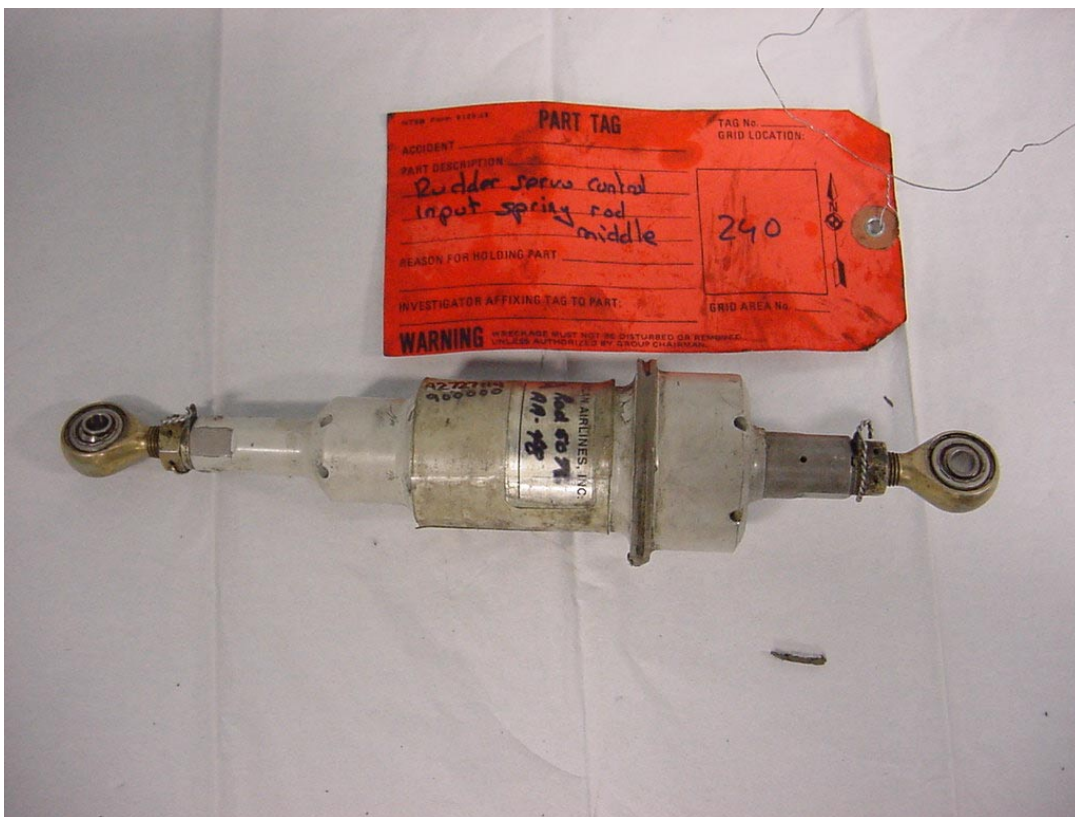
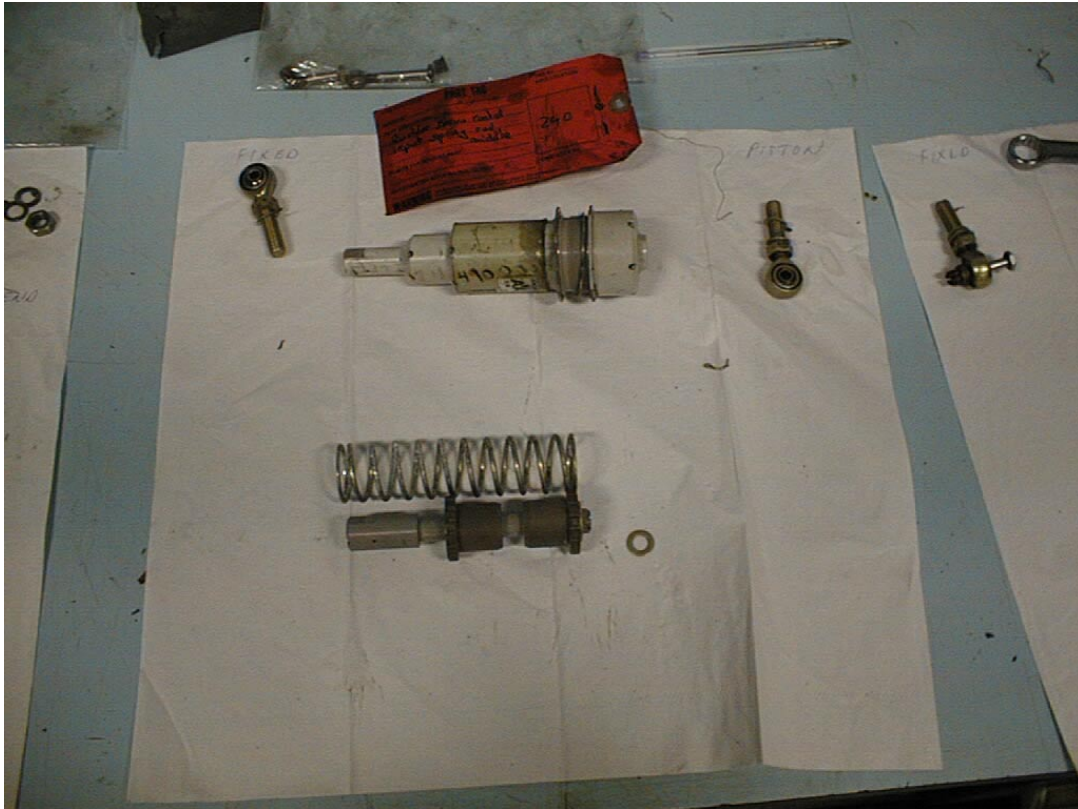
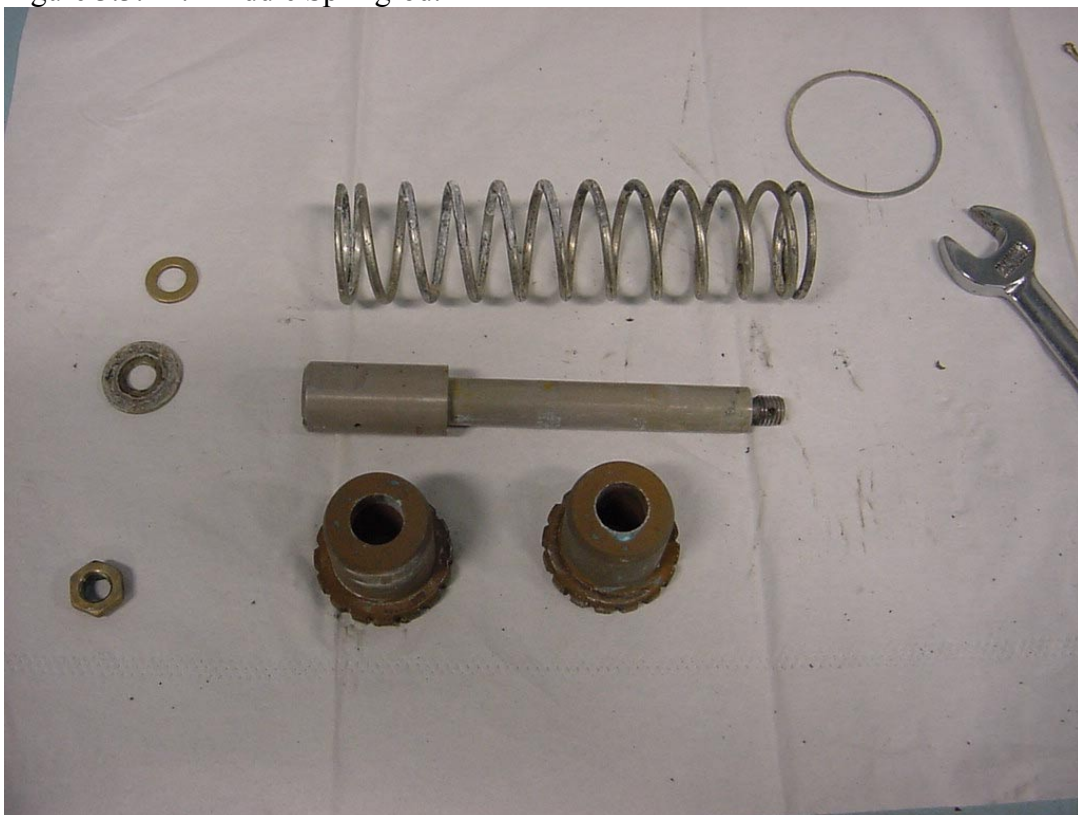
White deposits and discoloration were observed, mostly on one side of the spring diameter. White deposits were noted on the internal face of the housings and retainers. There were light traces of corrosion (blue marks on bronze) on the retainers. The retainers were free to move on the piston, but some spots of white deposit induce some friction

Item 120 CMM washer was missing on the piston end.

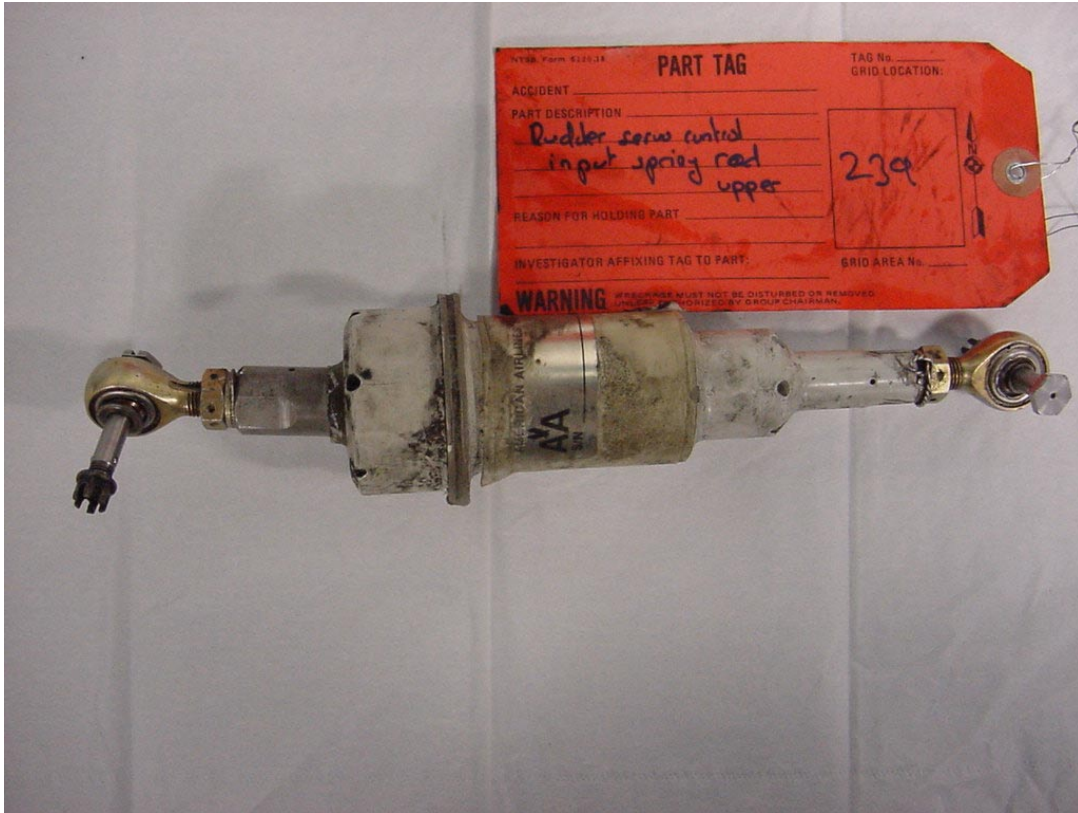
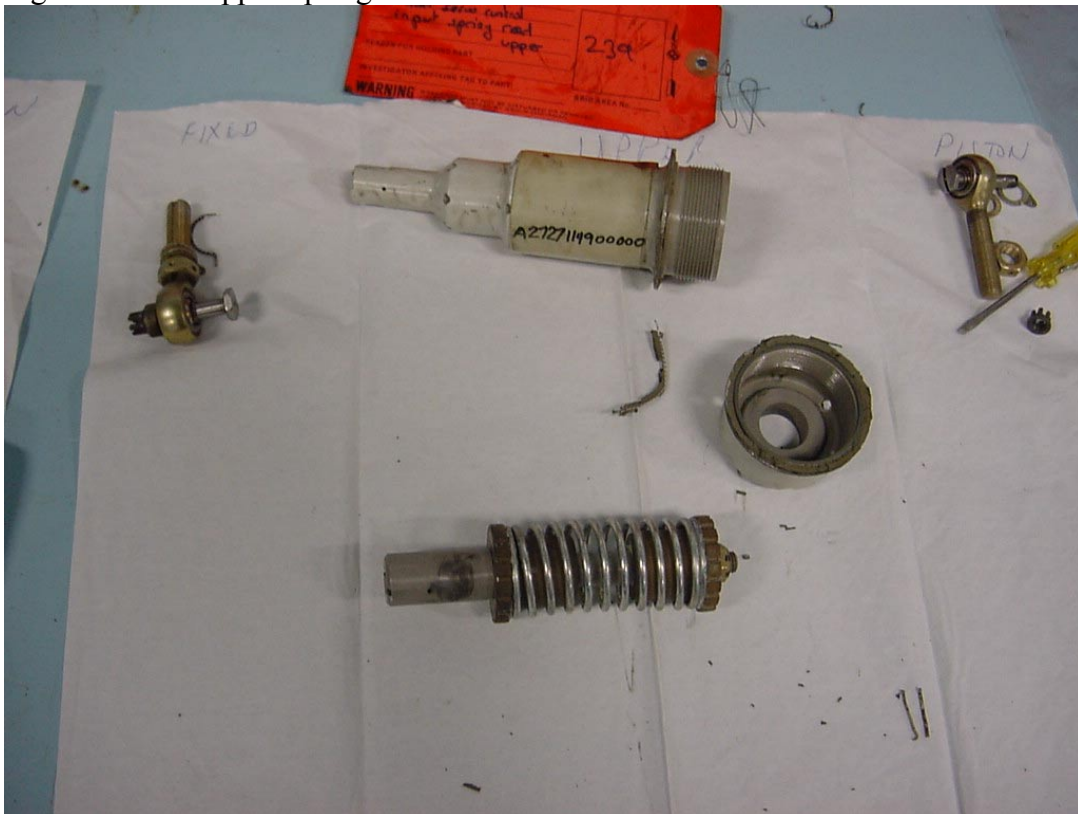
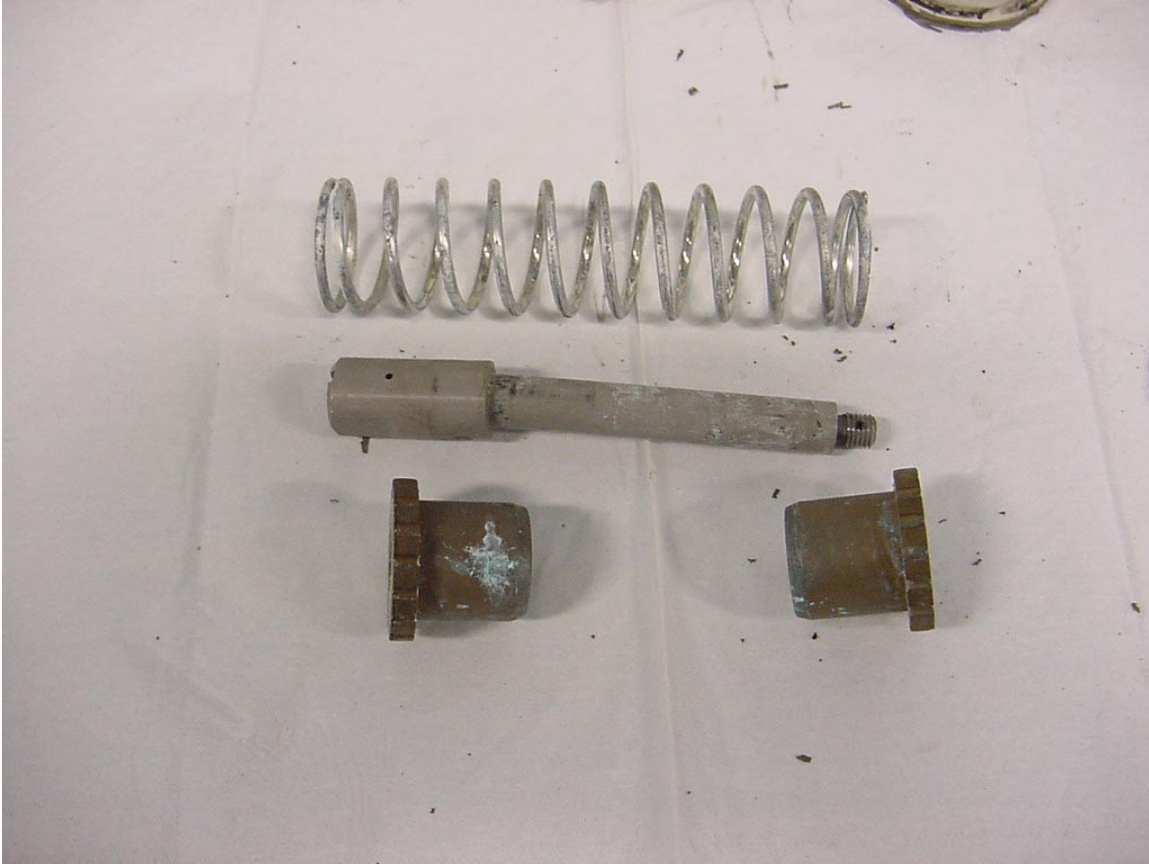
Housing item 40 had to be rotated together with the piston to allow disassembly, due to the bent piston. This housing has one dent at a draining hole.

The item 90 washer was missing. There was no item 120 on the shouldered face of the piston. There was corrosion on item 120 on the nut side. Light blue deposits were noted on the exterior of the retainer nut side. There were white deposits on $\frac{1}{2}$ of the diameter of the retainer internal surface.

White deposits and discoloration were present on $\frac{1}{3}$ rd of the spring circumference.

White deposits and numerous spots of discoloration were found on the operating surface of the piston, nut and retainer. There were light blue deposits on the exterior surface of the retainer piston shouldered face side. The shoulder side retainer was free to move with moderate friction. Several small spots of discoloration were noted under the retainer. Slight white deposits were observed on the interior face of this retainer.

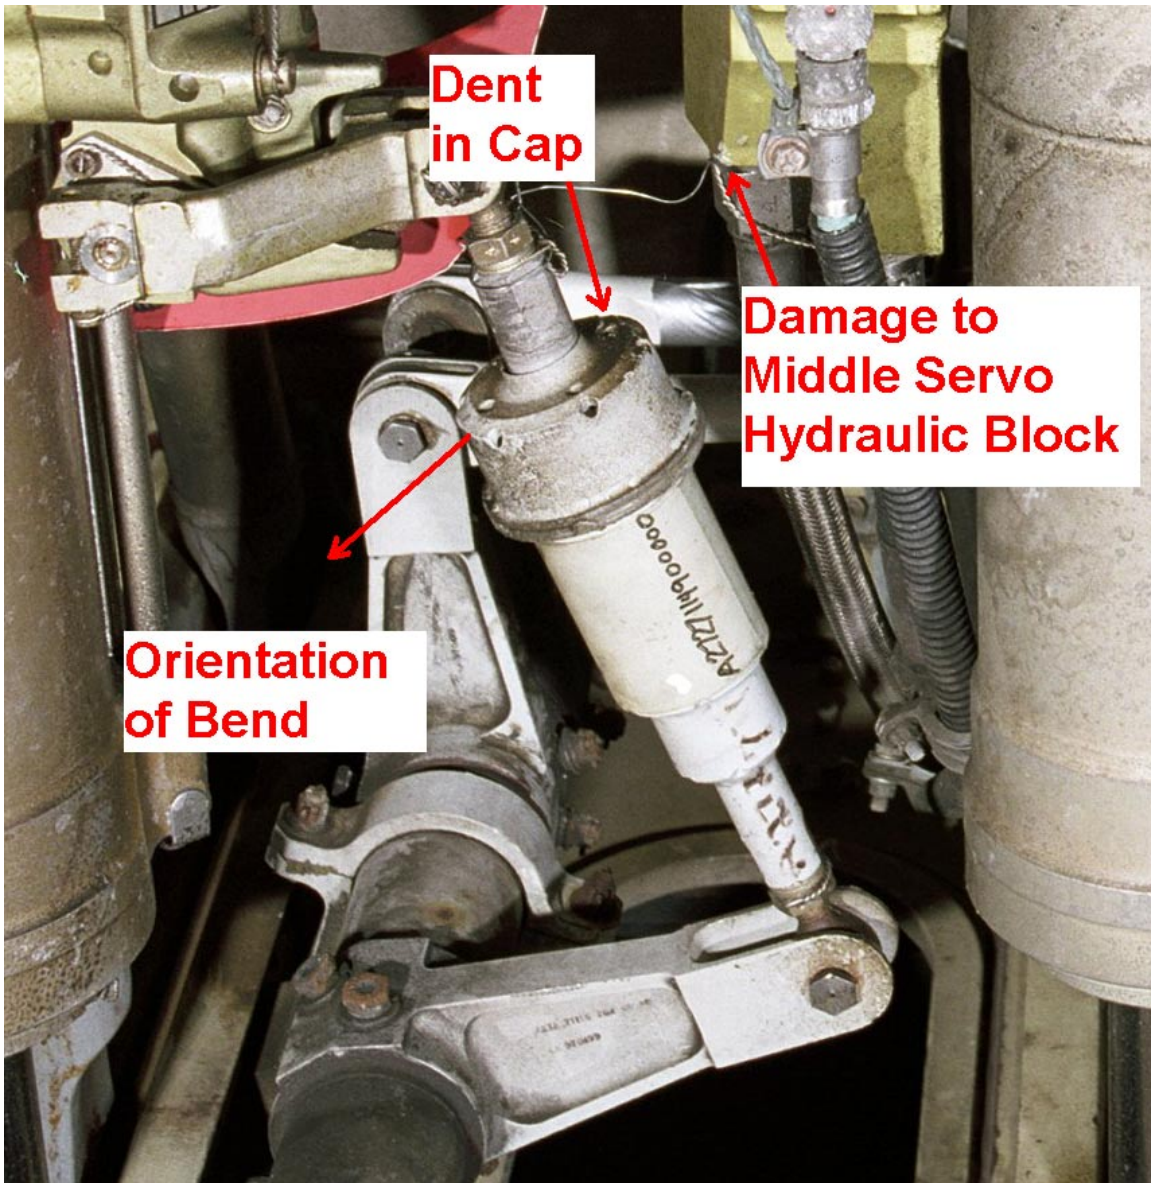
Figure 3.4A Upper Springrod as Installed Condition

The upper springrod was bent as shown in Figure 3.4A. A dent was observed in the springrod cap as well as damage to the corner of the middle rudder servo hydraulic block. After disassembly the springrod was submitted to the NTSB lab for further examination. The results were provided in the Materials Laboratory 15 - Factual Report 02-091, dated October 11, 2002.

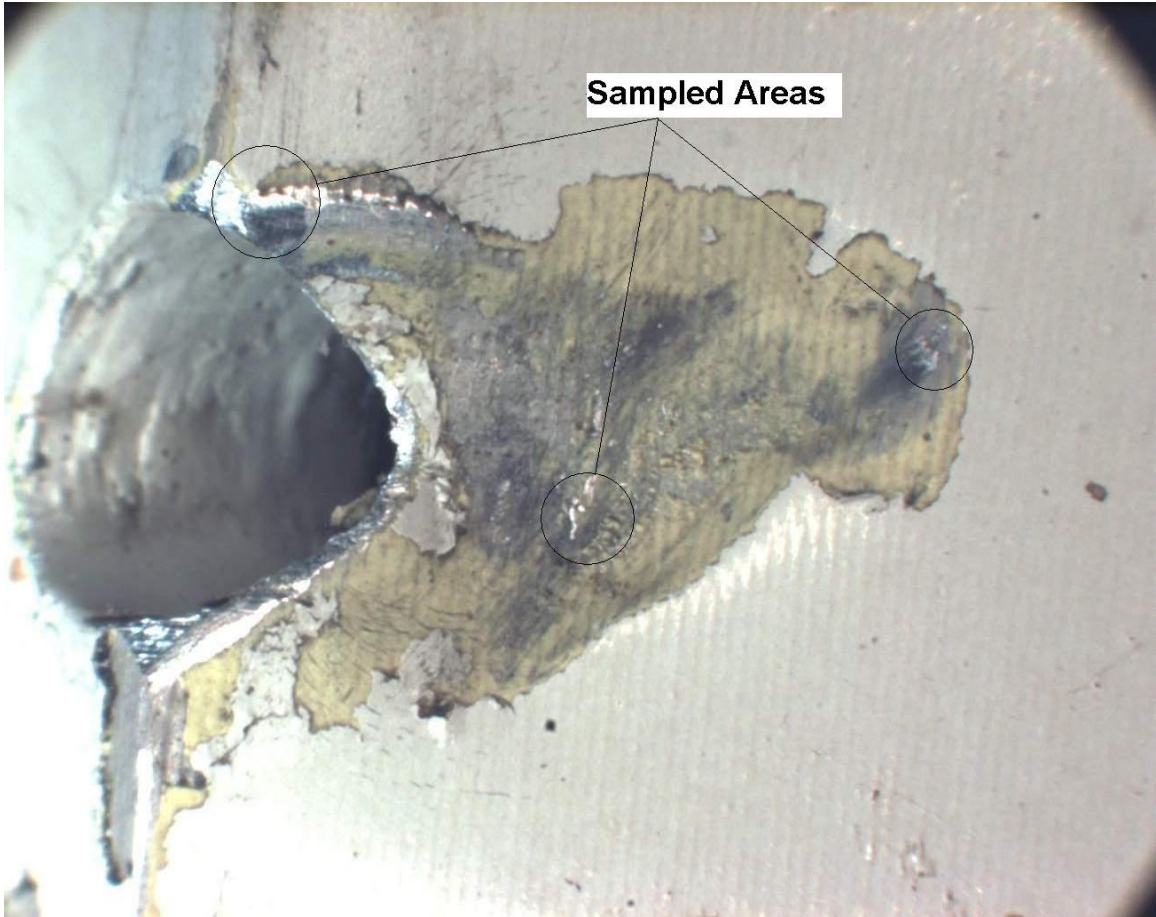
Figure 3.4B. Dent in Springrod Cap

The springrod cap, and rudder servo hydraulic block are manufactured from aluminum alloys (2024 and 2618 respectively). The American Society for Metals, Metals Handbook, Volume 9, page 366, indicates that alloy 2618 contains insoluble particles of FeNiAl_9 . Alloy 2024 is not known to have these constituents. The dent in the cap was inspected by scanning electron microscope (SEM) and energy dispersive spectroscopy (EDS). Figure 3.4B shows three areas of the dent which were sampled. Figure 3.4C is an enlargement of one of the areas. Many of the small bright spots in 3.4C were examined with EDS, and the results shown in Figure 3.3.4D were typical. Figure 3.4D showed the bright areas primarily contained Al, Fe, and Ni.
