NATIONAL TRANSPORTATION SAFETY BOARD
Office of Aviation Safety
Washington, D.C. 20594

SYSTEMS GROUP CHAIRMAN FACTUAL REPORT ADDENDUM
FOR DEPOSITS ON FUEL TANK ELECTRICAL COMPONENTS

A. ACCIDENT: DCA96MA070

Airplane : Boeing 747-131, N93119
Operated as Trans World Airlines (TWA) Flight 800

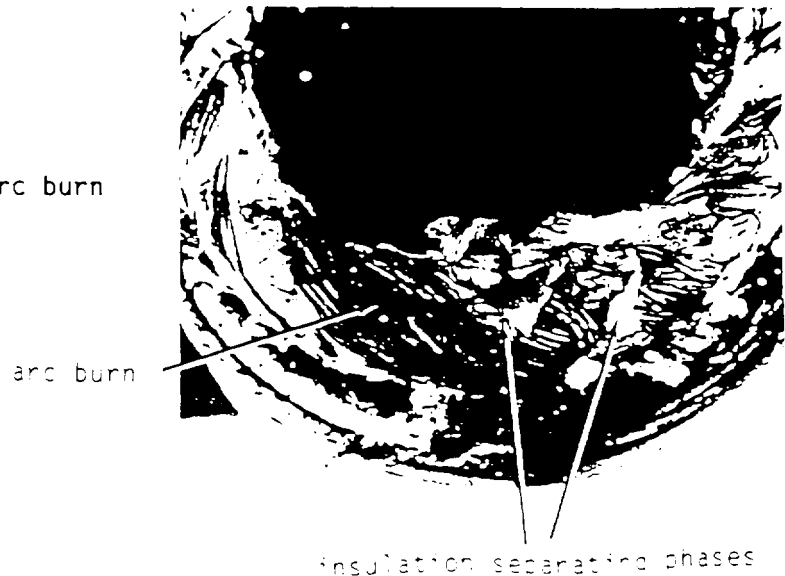
Sixteen of the 18 submitted stators exhibited extensive arc burned areas covered with a black sooty appearing deposit, (refer to Fig. 2). After removal of the insulation wrapping, the arc burned areas appeared as shown in Fig. 4 with numerous wires melted through and in some instances fused to adjacent wires. Eight of the eighteen stators had arc burned areas immediately beneath one of the thermal fuses (refer to Fig. 3). In all these latter cases, when the insulation and lead wires were removed a hole was found in the fuse case (see Fig. 10). In the remaining ten stators, five had arc burned areas on the end of the stator opposite the fuses while four had arc burned areas on the fuse end, but next to the core. One of these stators, No. 8 which exhibited only a minor arc burn on the stator end opposite the fuses (Fig. 5) passed the EQA electrical test inspection. The remaining stator (No. 18) exhibited no severe arc burns but had a fuse which lost electrical continuity with no evidence of arcing or burning. Examination of this fuse revealed extensive corrosion pitting had penetrated the fuse case (Fig. 6) exposing the thermal pellet material to fuel (fuel has been shown capable of dissolving the pellet material, reference (c)).

Fig. 4 Photograph showing a typical arc burn after removal of insulation layers (Mag. 1.6X).

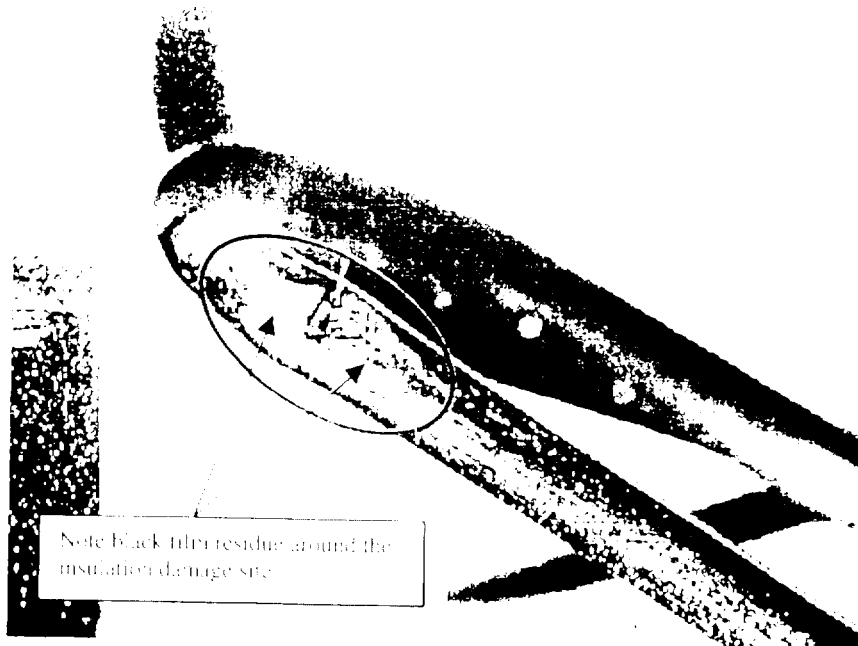
Note black film residue around the insulation damage site

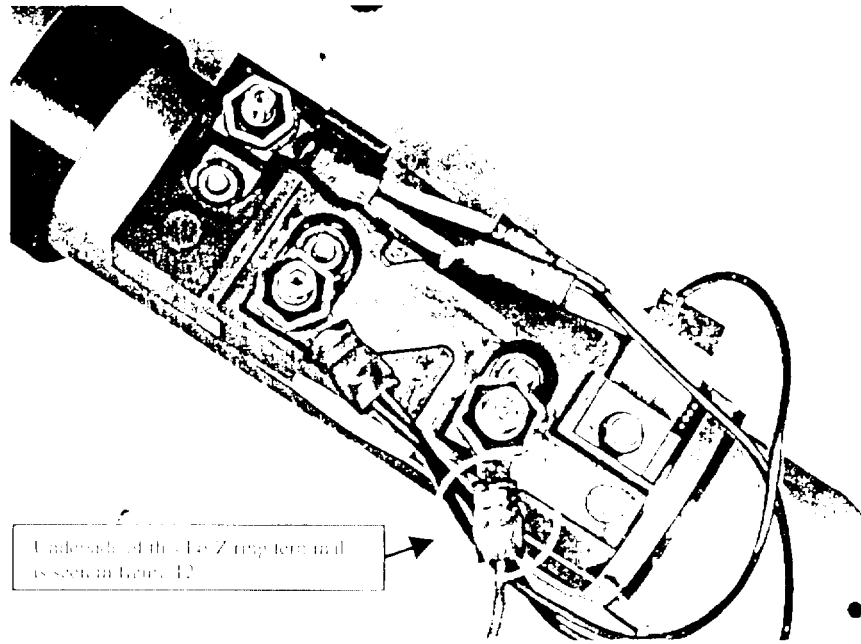
Figure 11. Example of film residues found on 747-156, number N1341W (probe serial number A-118).

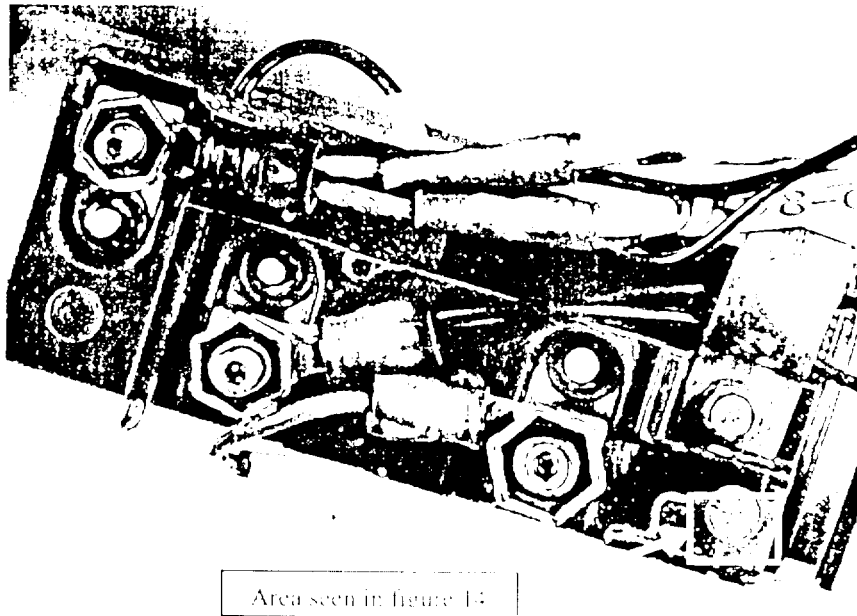
Figure 13. Example of terminal block exhibiting film residues. Red 16 Z wire has been rotated 180 degrees out of place to expose residue stain beneath (747-156, number N134FW, probe serial number A-173).

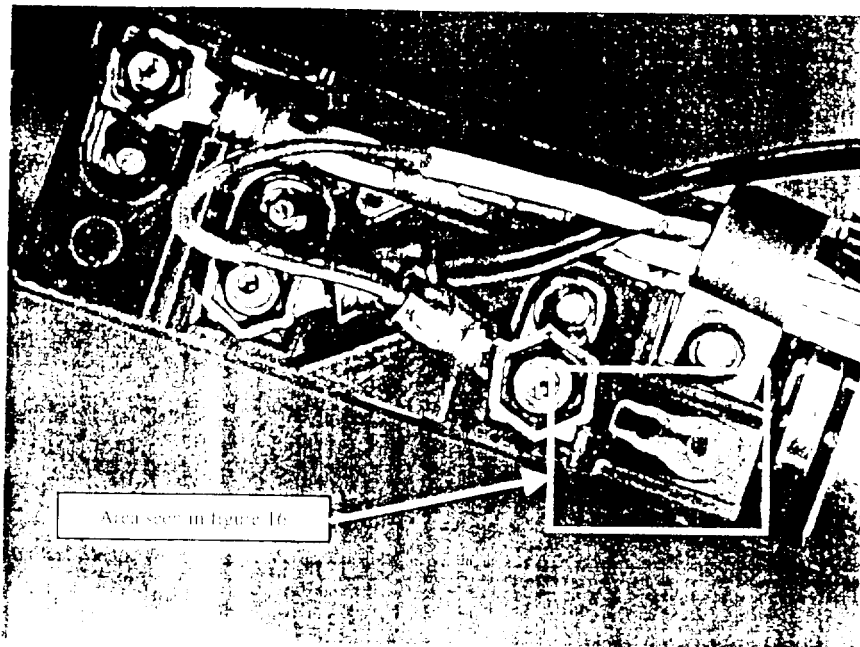
Figure 15. Example of terminal block exhibiting film residues. Red Lo-Z wire has been rotated 180 degrees out of place to expose residue stain beneath (747-156, number N134TW, probe serial number A 65).

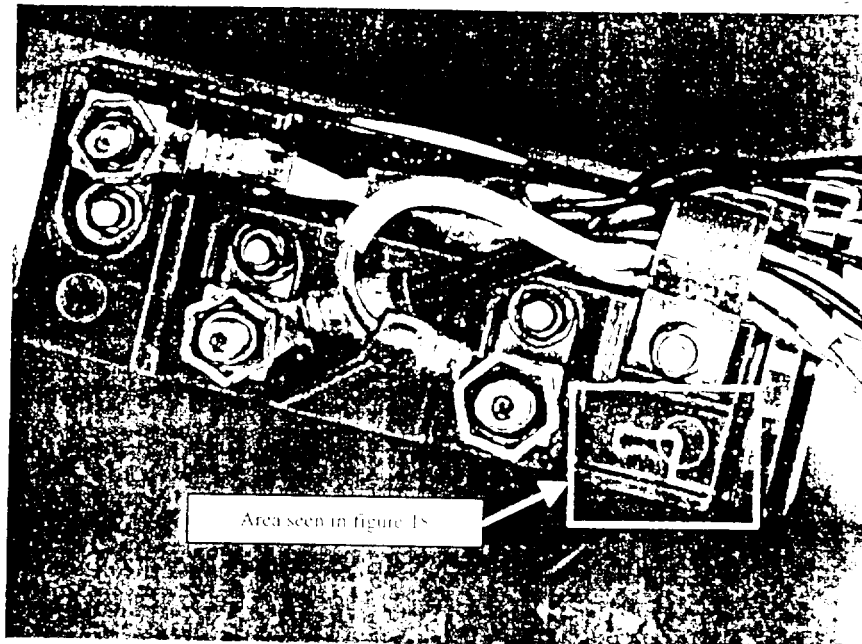
Figure 17. Example of terminal block exhibiting film residues. Red I/O Z wire has been rotated 180 degrees out of place to expose residue stain beneath (747-156, number N134TW, probe serial number A 70).

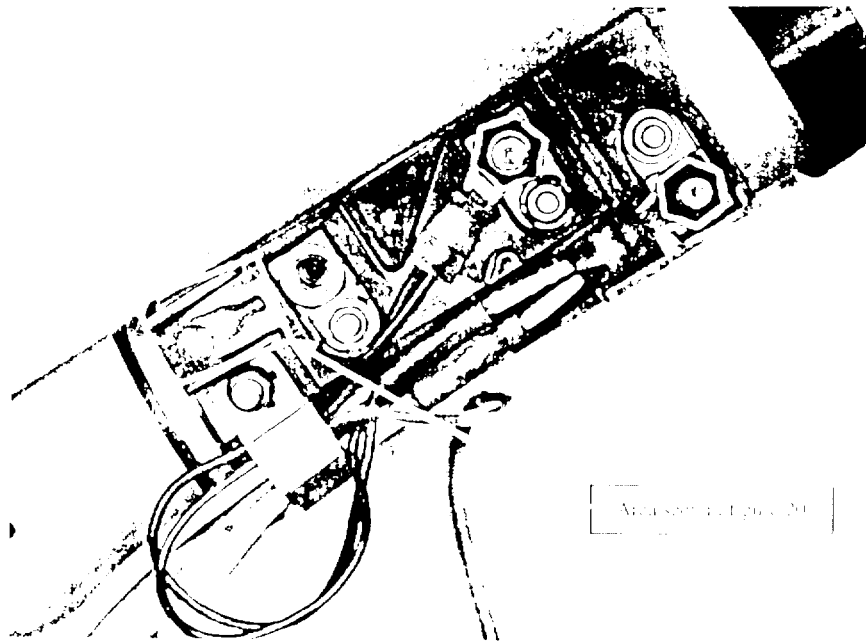
Figure 19. Example of terminal block exhibiting film residues. Red 16 Z wire and screw terminal have been removed to expose residue stain beneath (747-156, number N1341W, probe serial number A-85).

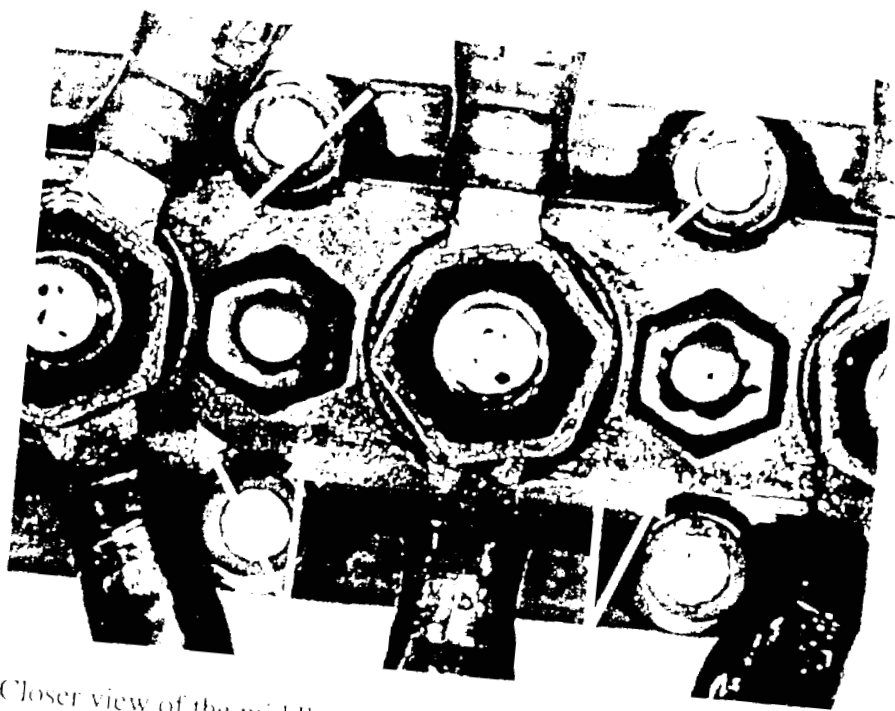
Figure 30. Closer view of the middle terminals (2 and 3) on the terminal strip seen in figure 28. Note heavy residue stains.

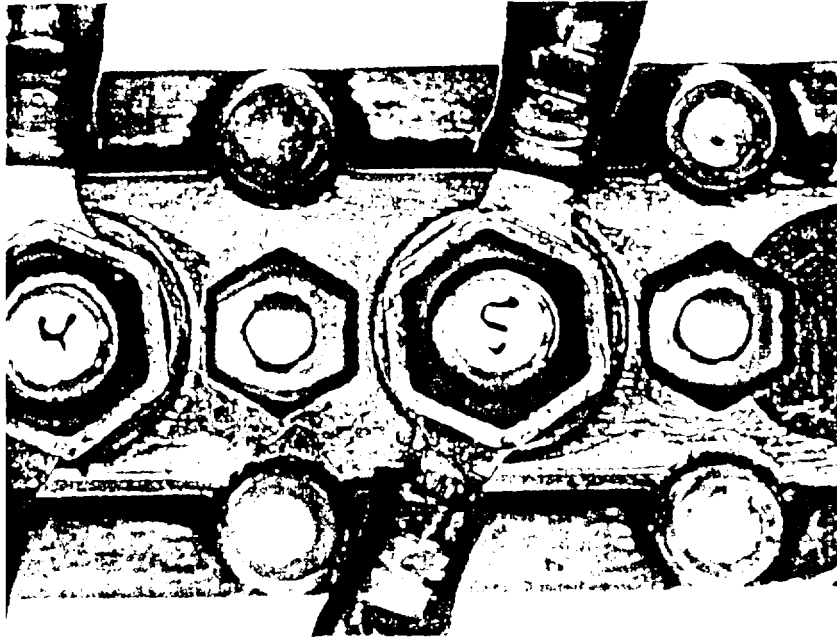
Figure 31. Closer view of end terminals 4 and 5 on the terminal strip seen in figure 28. Note heavy residue stains.

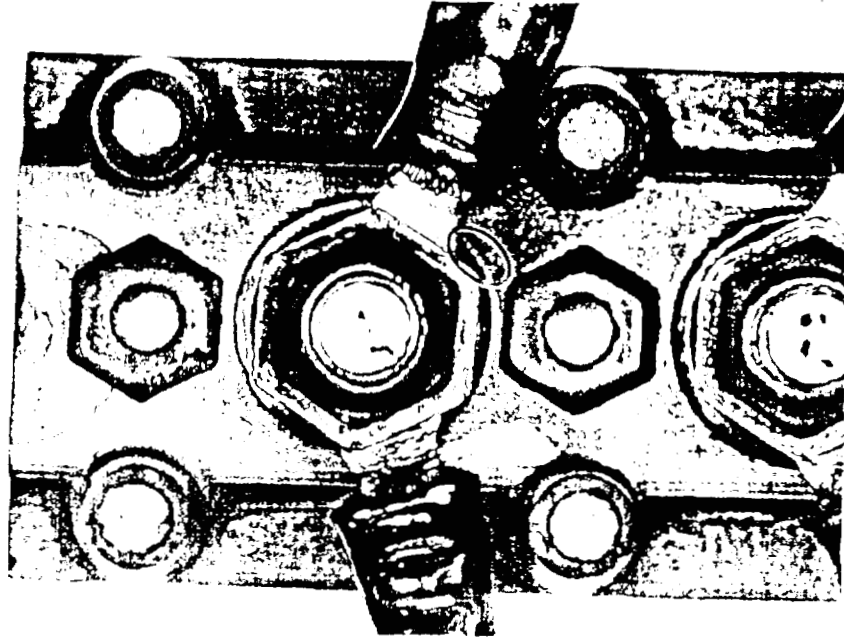
Figure 37. Closer view of the top end of terminal strip (as mounted in CWI) seen in figure 28. Note dark residue stain starting at top most terminal (terminal 1) and "running" down. EDS surface analysis was performed in circled area. The resulting spectral plot is seen in figure 38.

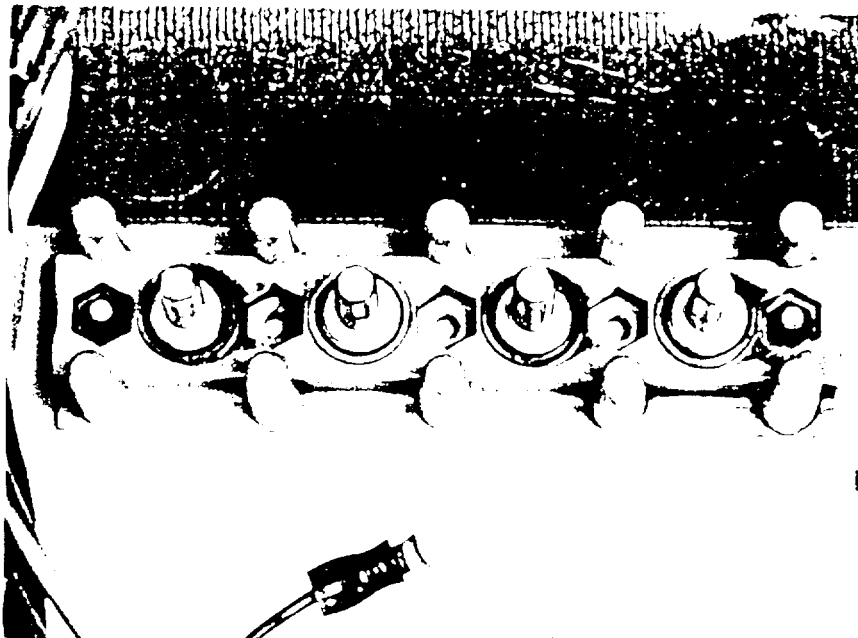
Figure 2C. Closer view of terminal strip seen in figure 1C. Note residue stains on the surface around and beneath threaded terminal posts.

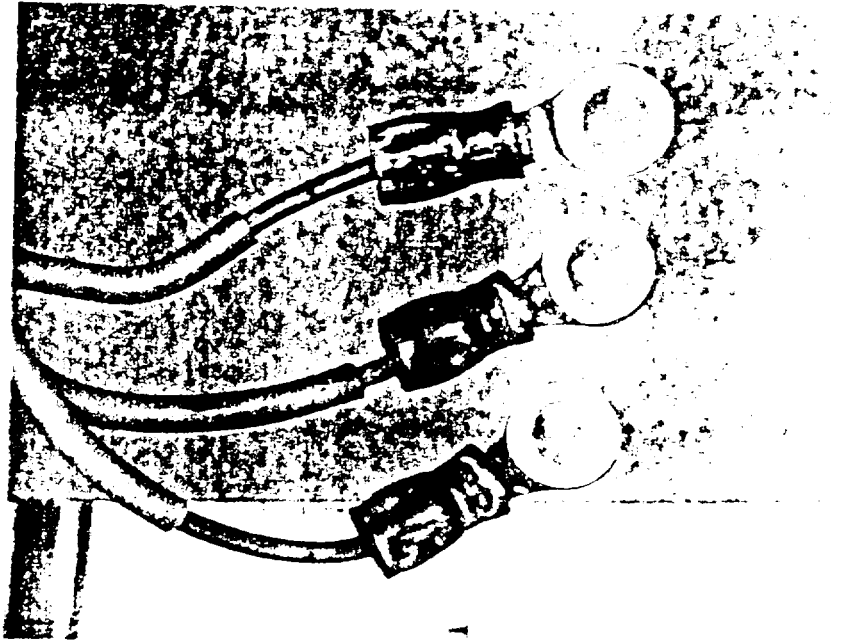
Figure 3C. Closer view of crimp-on wire terminals seen in figure 1C. Note presence of dark residue stains on terminal and wire insulation

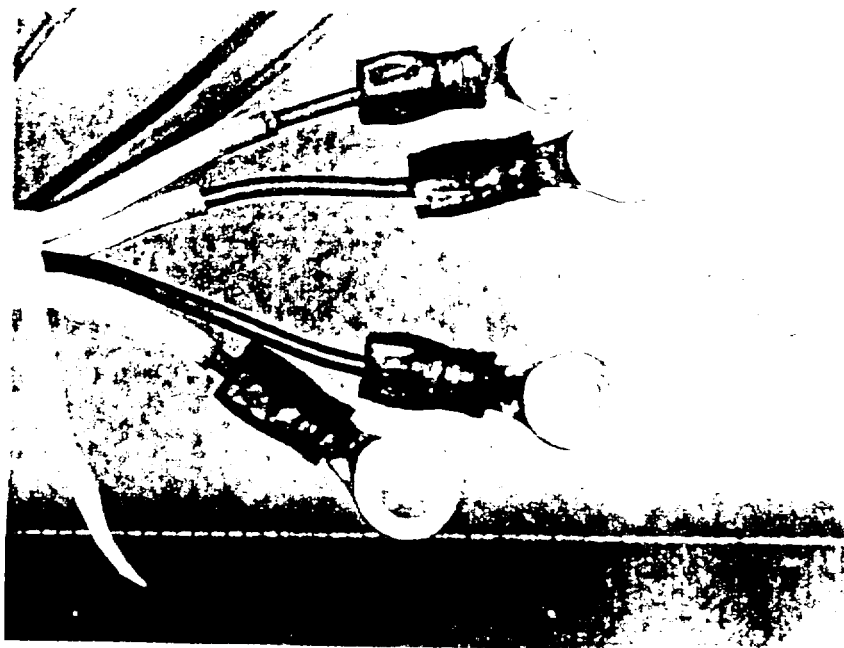
Figure 4C. Closer view of crimp-on wire terminals seen in figure 1C. Note presence of dark residue stains on terminal and wire insulation. (Wires were tied together to facilitate taking this photograph)

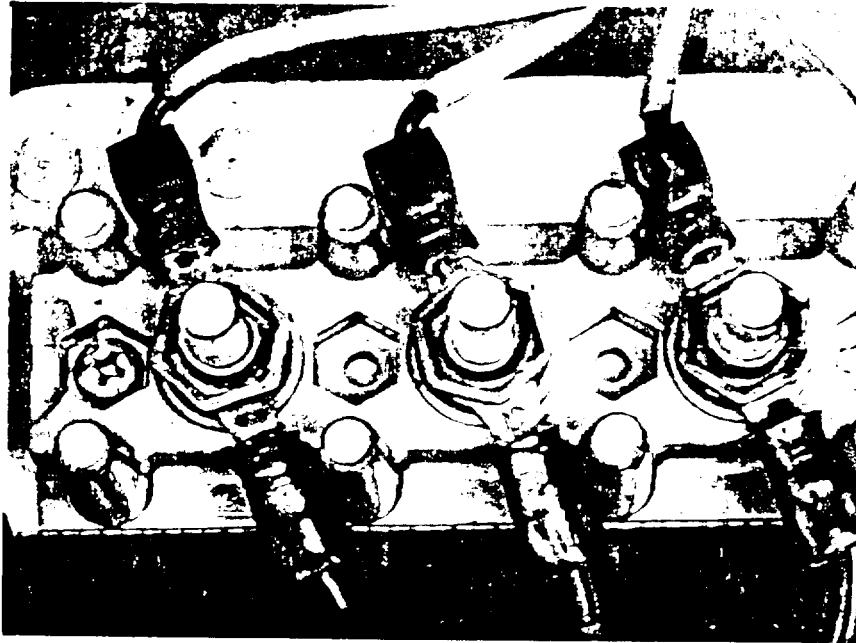
Figure 7C. Closer view of terminal strip seen in figure 5C. Note the stained appearance of the two wire terminals to the left of the picture. This is the top end of the terminal strip as mounted in the aircraft. Terminal strips with heavily stained wire terminals typically exhibit stains on the surface of the terminal block beneath the wire terminals running down across the surface of the terminal block. The absence of such staining suggests this terminal block was in service a shorter time than the stained crimp-on wire terminals.

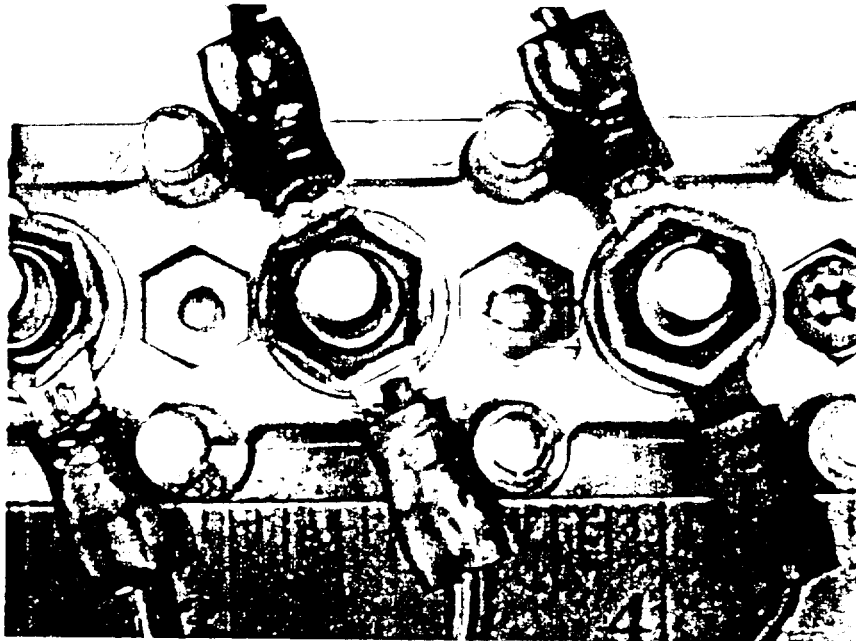
Figure 8C A closer view of the terminal block shown in figure 5C. Note the very heavily stained wire terminal (far right). A heavily stained wire terminal is typically associated with residue deposits on the surface of the terminal strip.

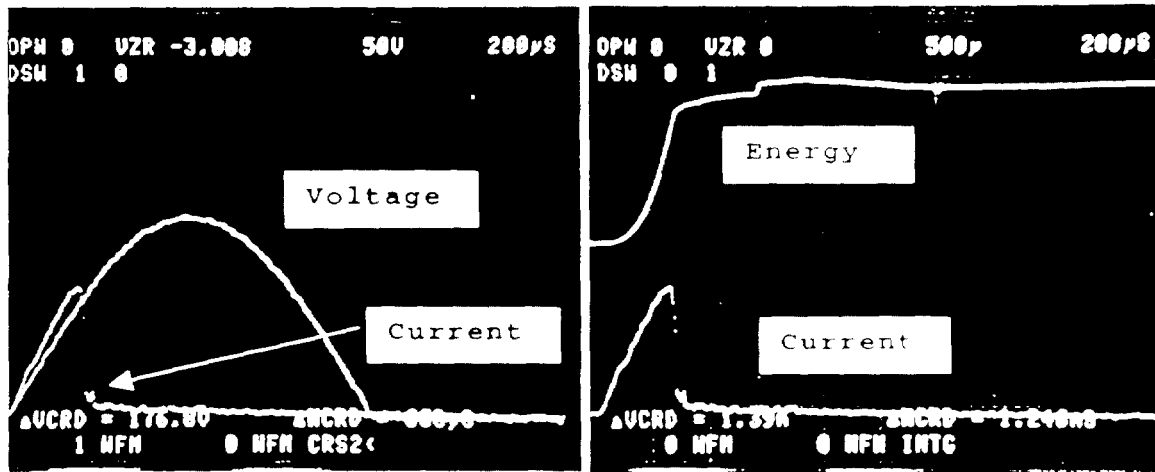
Figure 11. Voltage breakdown on terminal block under Low-Z insulated terminal lug from fuel probe 93117 F40 S/N Z-116. Peak breakdown values (red arrows) were 90V and 11mA (left) and calculated energy was 0.14 mJ (right, conversion factor = 0.1X).
