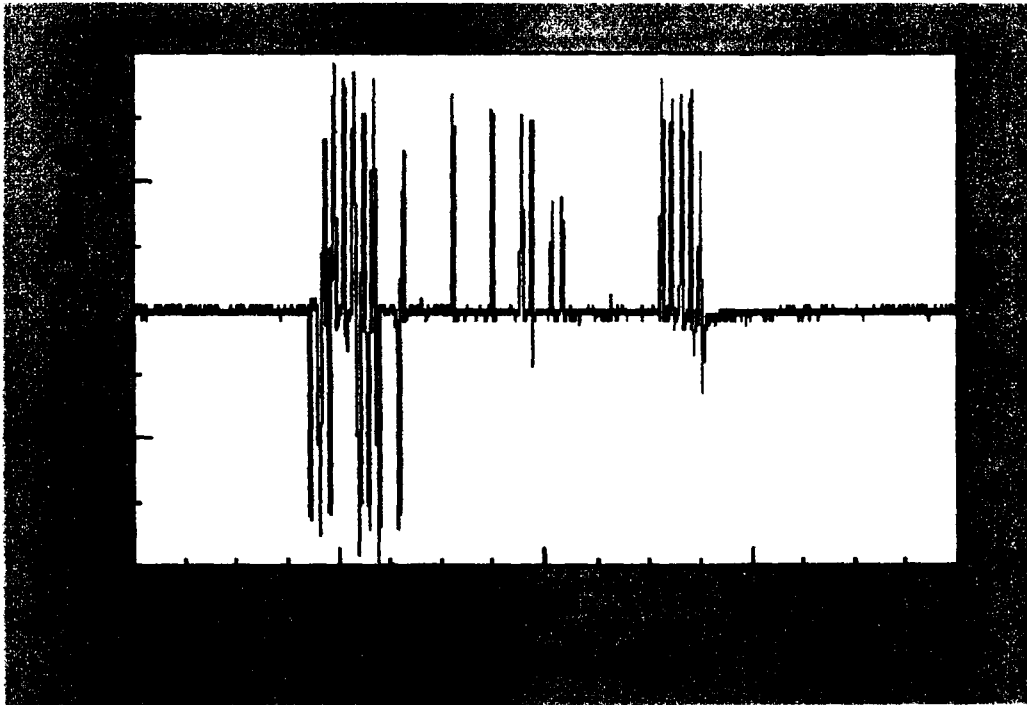
Figure 22. Test 1: Oscillogram showing intermittent current during a flashing event.
