NATIONAL TRANSPORTATION SAFETY BOARD

GROUP CHAIRMAN'S FACTUAL ADDENDUM CONCERNING RE-EXAMINATION OF FUEL PROBES

DCA-96-MA-070

Location : East Moriches, New York
Date : July 17, 1996
Time : 2031 Eastern Daylight Time
Airplane : Boeing 747-131, N93119
Operated as Trans World Airlines (TWA) Flight 800

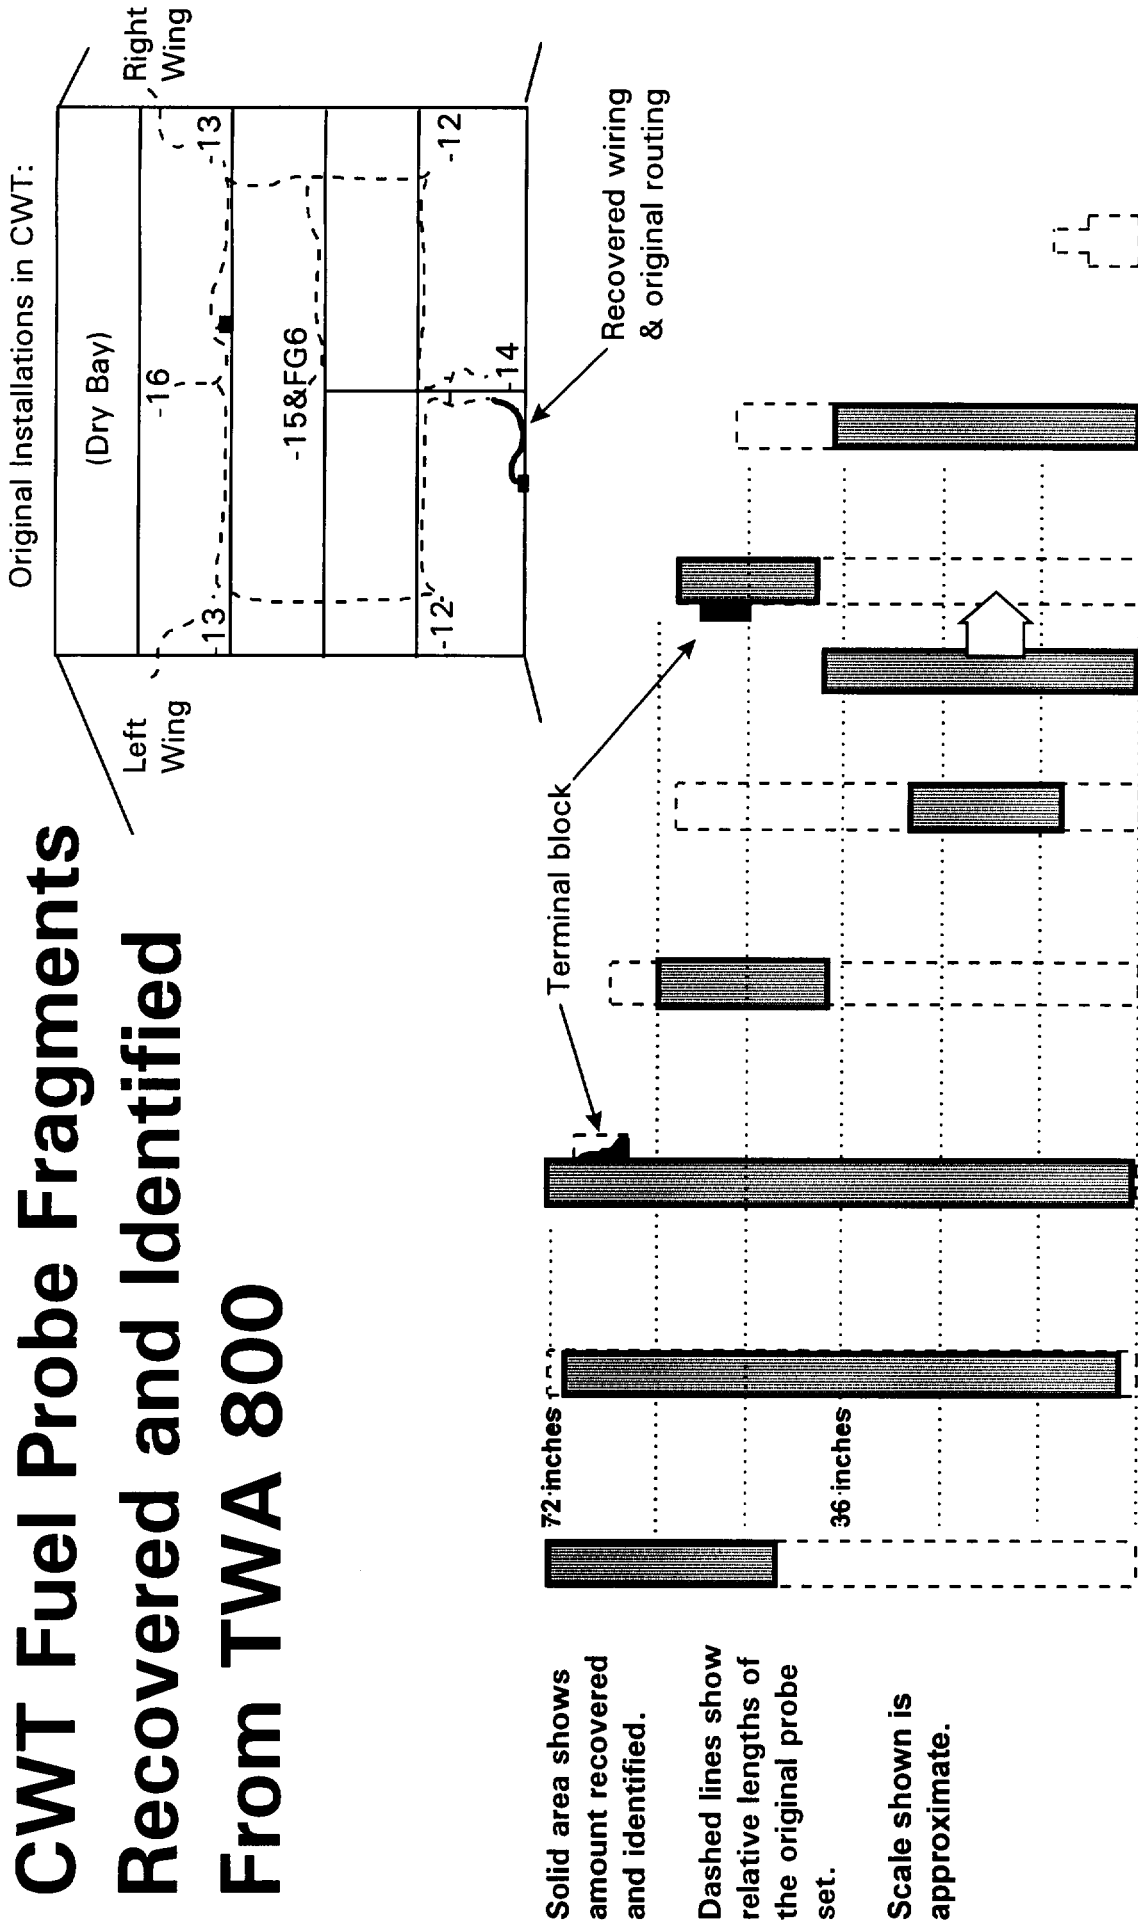
CWT Fuel Probe Fragments Recovered and Identified From TWA 800

Solid area shows amount recovered and identified.

Dashed lines show relative lengths of the original probe set.

CWT & tank 4R contain resolidified aluminum & blackened features.
