NATIONAL TRANSPORTATION SAFETY BOARD

METALLURGIST'S FACTUAL REPORT

Report No.96-160

Place : East Moriches, New York
Date : July 17, 1996
Vehicle : Boeing 747-100, N93119
Operator : Trans World Airlines (TWA flight 800)
NTSB No. : DCA96-M-A070
Investigator : Robert Swaim (AS-40)

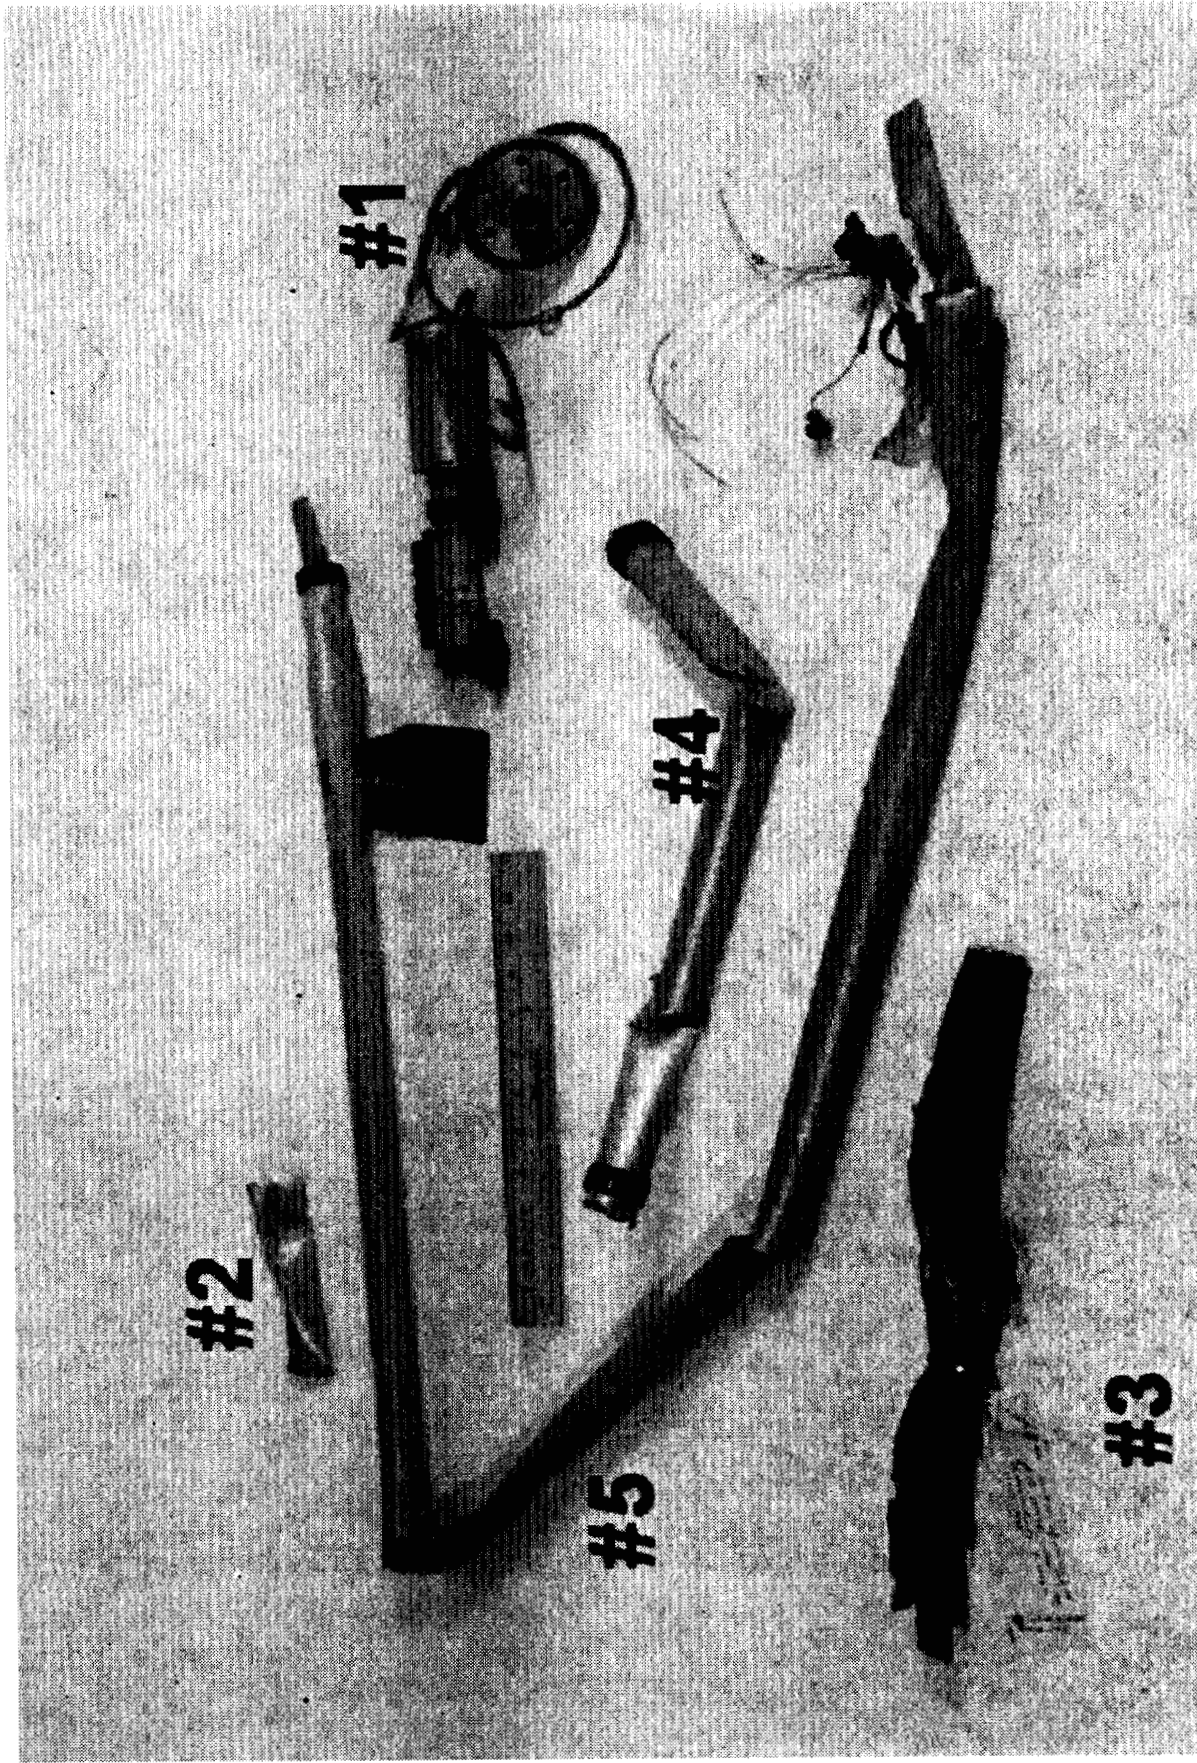
Five fuel quantity indicator components were received and examined on October 16 and 17, 1996. Participating parties to the investigation included, Boeing Commercial Airplane Co., Tecstar Inc., Honeywell, and TWA. The items were arbitrarily assigned identification numbers, #1 through #5 and are shown with labels in figure 1.

Figure 1 An overall view of the as-received fuel quantity indicator components with assigned identification numbers.
