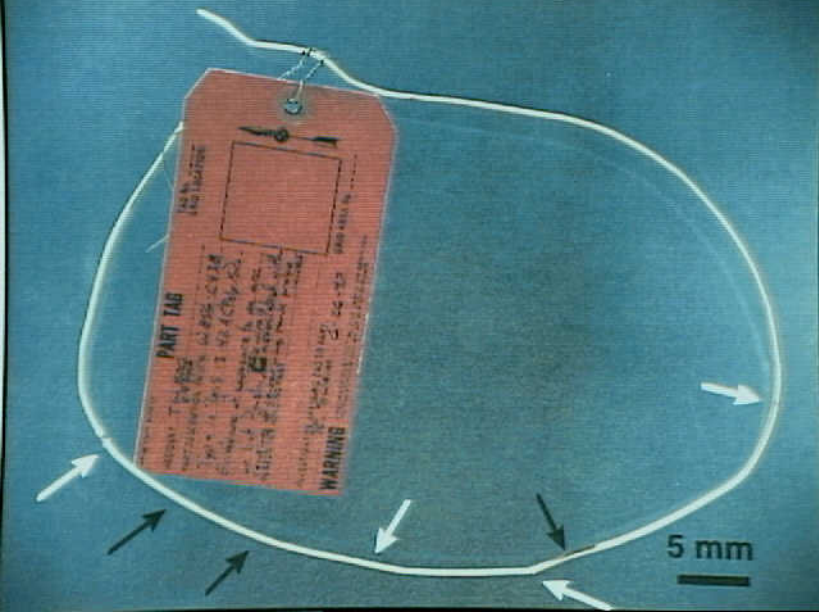
Systems 9 - Exhibit No. 9B - Photo 1. Figure 1d. Wire sample submitted for analysis. The insulation exhibited blacked areas (black arrows) and mechanical damage (white arrows).
