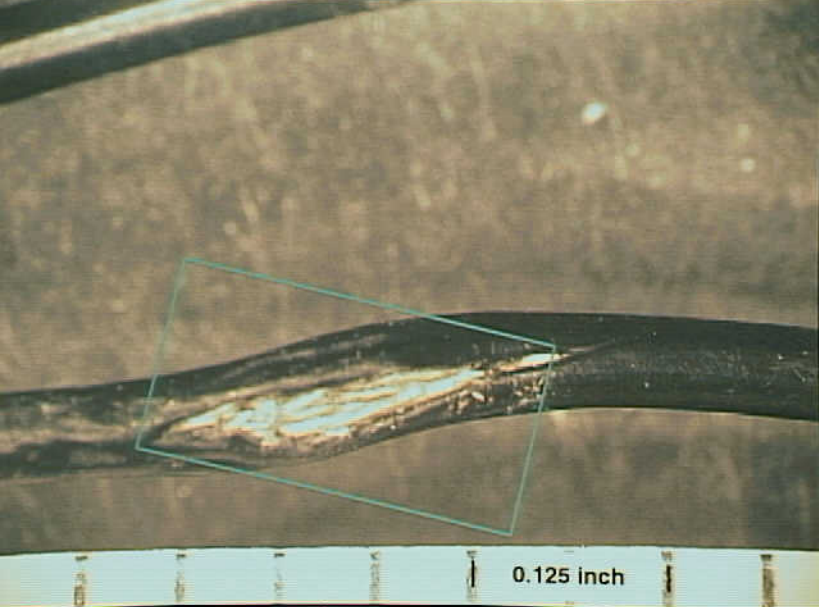
Systems 9 - Exhibit No. 9B - Photo 12. Figure 12g. Hi-Z shield pigtail lead wire from N93110, sample #29. Damage occurred at edge of nylon strain relief clamp.
