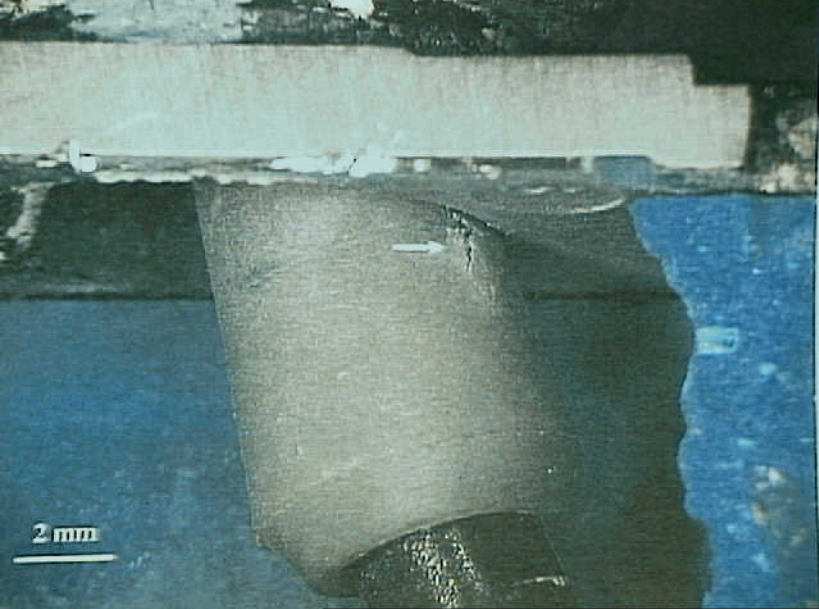
Systems 9 - Exhibit No. 9B - Photo 16. Figure 16a. Scavenge pump switch plunger guide exhibiting surface cracks from the mold runner (arrow).
