Systems 9 - Exhibit No. 9B - Photo 18. Figure 18g. Representative damage to a fuel probe, wiring and terminal block from N93119.

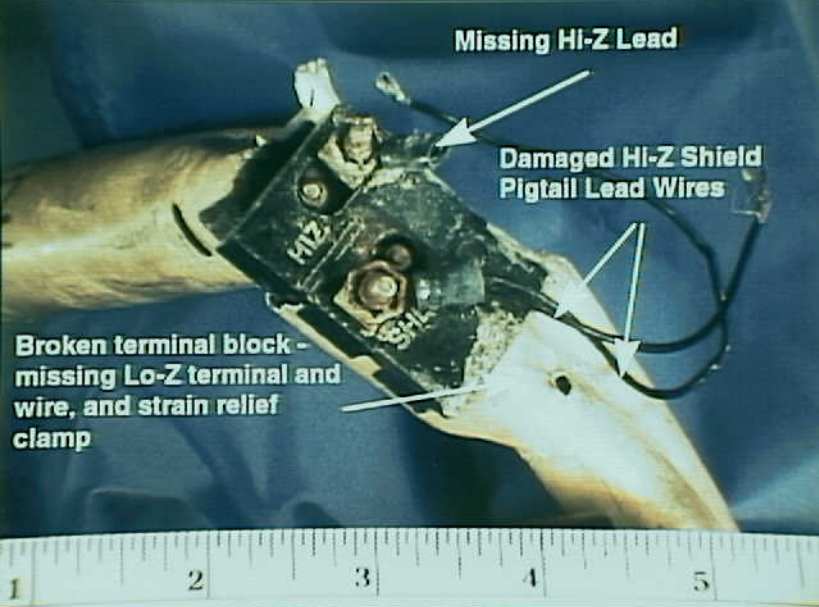
Missing HI-Z Lead

**Damaged HI-Z Shield
Pigtail Lead Wires**

**Broken terminal block -
missing Lo-Z terminal and
wire, and strain relief
clamp**
