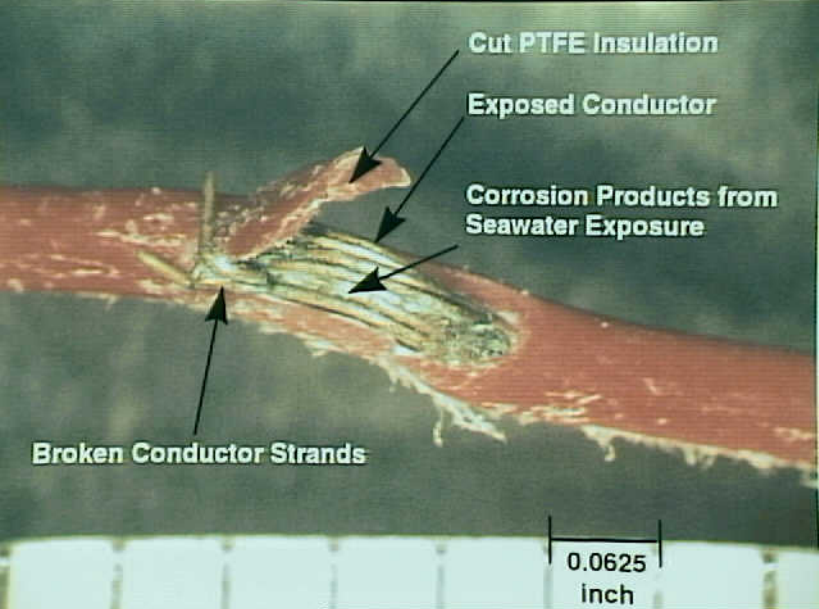
Systems 9 - Exhibit No. 9B - Photo 19. Figure 19g. Representative damage to a fuel probe wiring from
