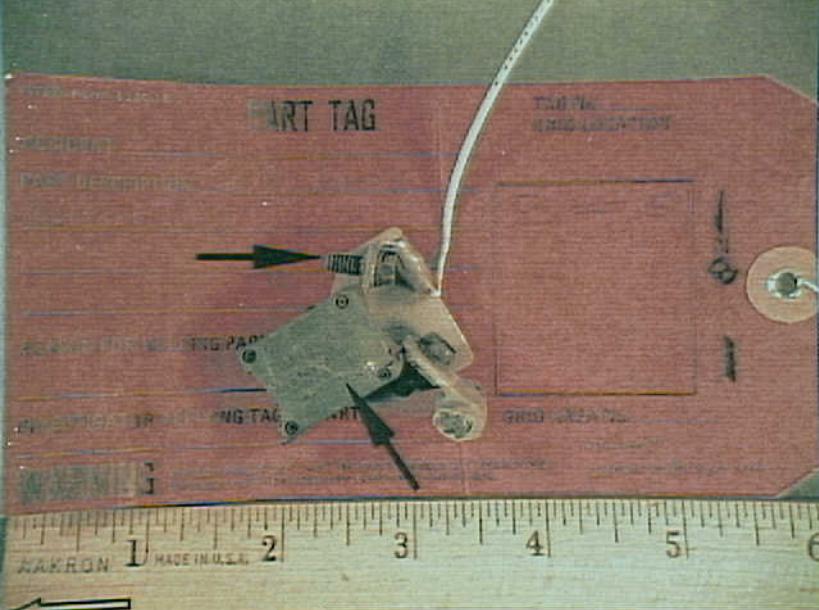
Systems 9 - Exhibit No. 9B - Photo 2. Figure 2c. As received condition of the SPR circuit breaker. The upper arrow highlights the corroded terminal hardware. The lower arrow highlights the cracked housing.
