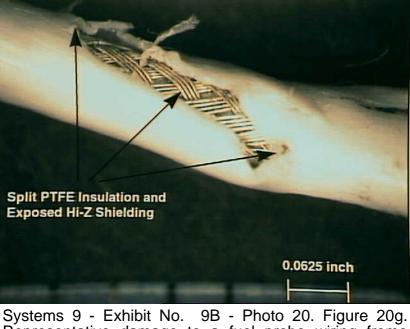
Systems 9 - Exhibit No. 9B - Photo 20. Figure 20g. Representative damage to a fuel probe wiring fromo N93119.
