Systems 9 - Exhibit No. 9B - Photo 30. Figure 30g. SEM image--broken shielding wire strand fracture surface.

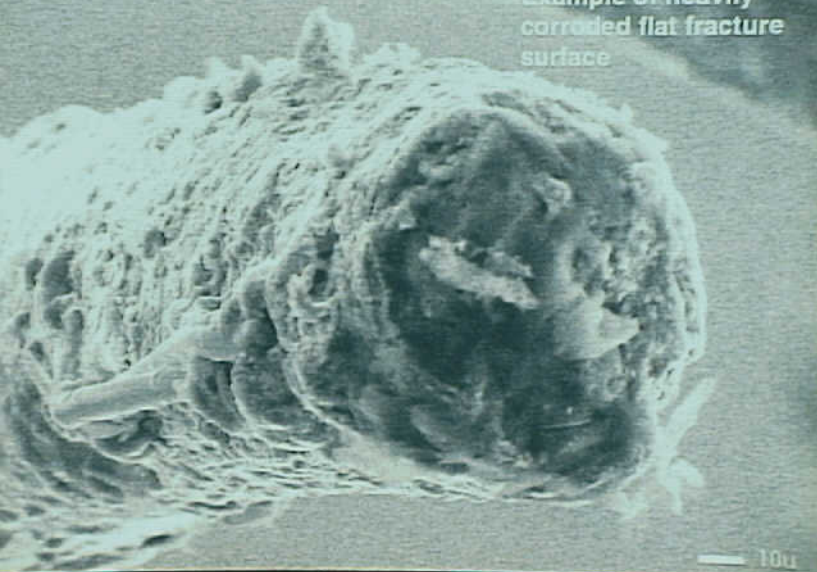
Example of heavily
corroded flat fracture
surface
