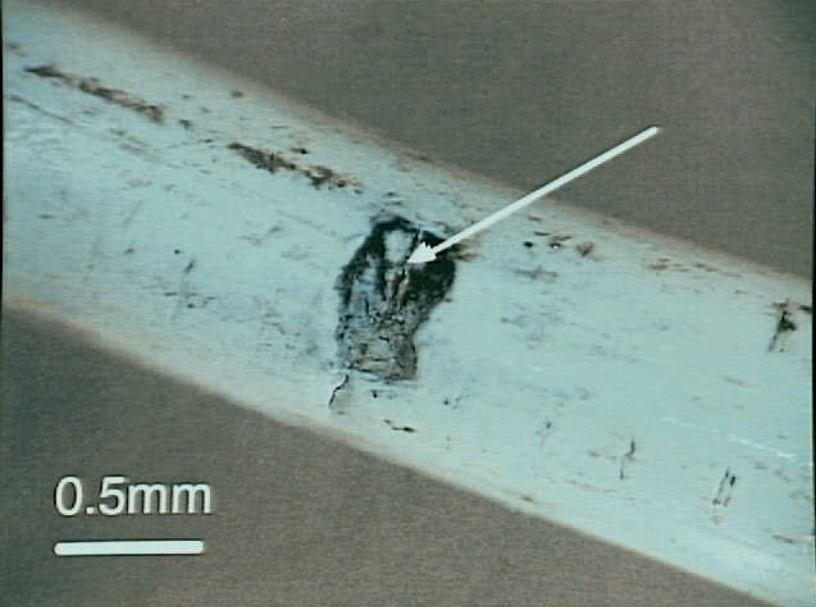
Systems 9 - Exhibit No. 9B - Photo 4. Figure 4f. Crack found to propagate from a hot stamp mark. Optical inspection revealed the conductor was exposed.
