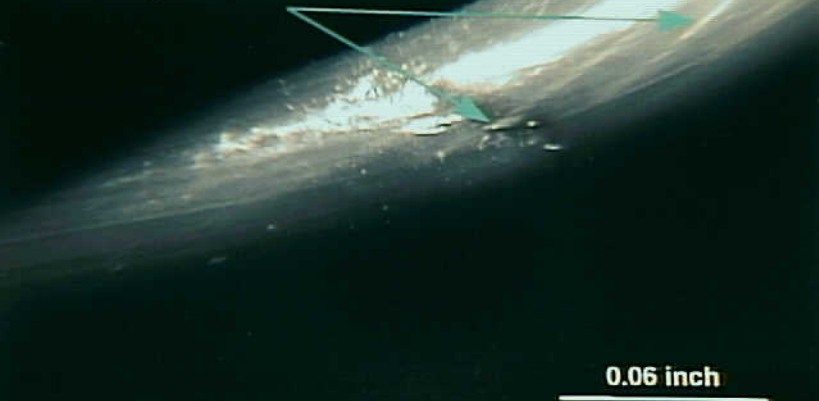
Conductor strands visible where PTFE insulation was compressed within "P" strain relief clamp shown in Figure 45

Systems 9 - Exhibit No. 9B - Photo 46. Figure 46g. Compression damaged Hi-Z pigtail lead wire from compensator (model no. FG6C2, serial no. Y-147) from
