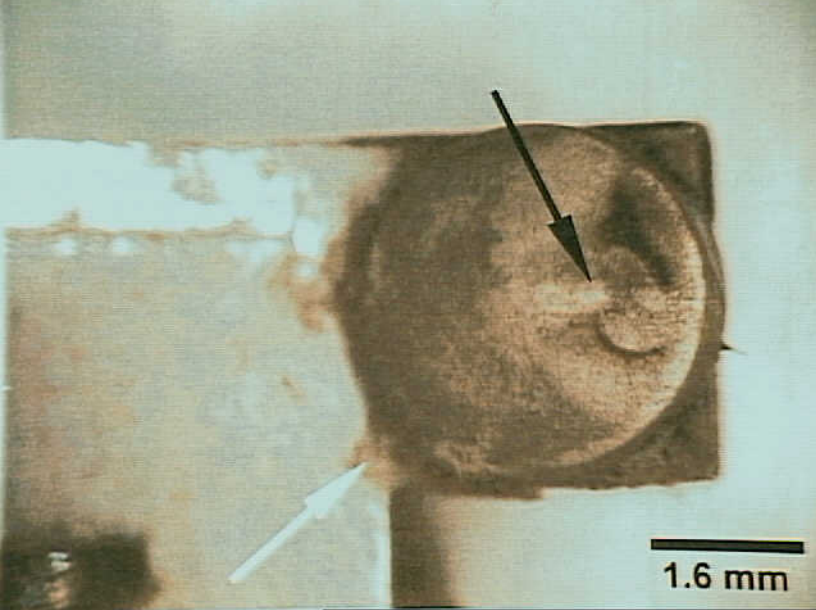
Systems 9 - Exhibit No. 9B - Photo 5. Figure 5c. The moving line contact of the SPR circuit breaker has a tarnished appearance. Black arrow highlights mechanical wear from the making and breaking of the contacts. White arrow indicates the fibrous residue
