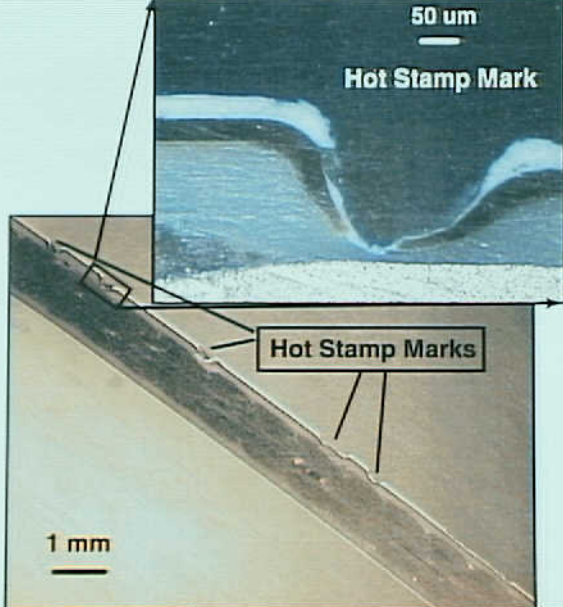
Systems 9 - Exhibit No. 9B - Photo 8. Figure 8f. Lateral cross section of a different wire than from figure 7. Again note depth variability of the mark from right to left. Note all three insulation layers were again penetrated.
