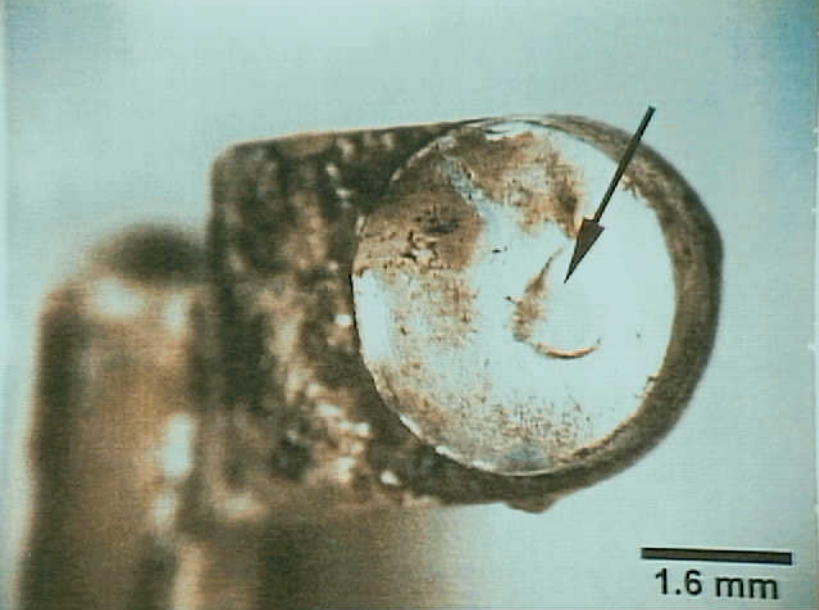
Systems 9 - Exhibit No. 9B - Photo 9. Figure 9c. The stationary line contact of the SPR circuit breaker has a tarnished appearance. Arrow highlights the mechanical wear from the making and breaking of the contacts.
