Analysis of A Submitted Wire

Examine submitted wire for evidence of electrical arc damage.

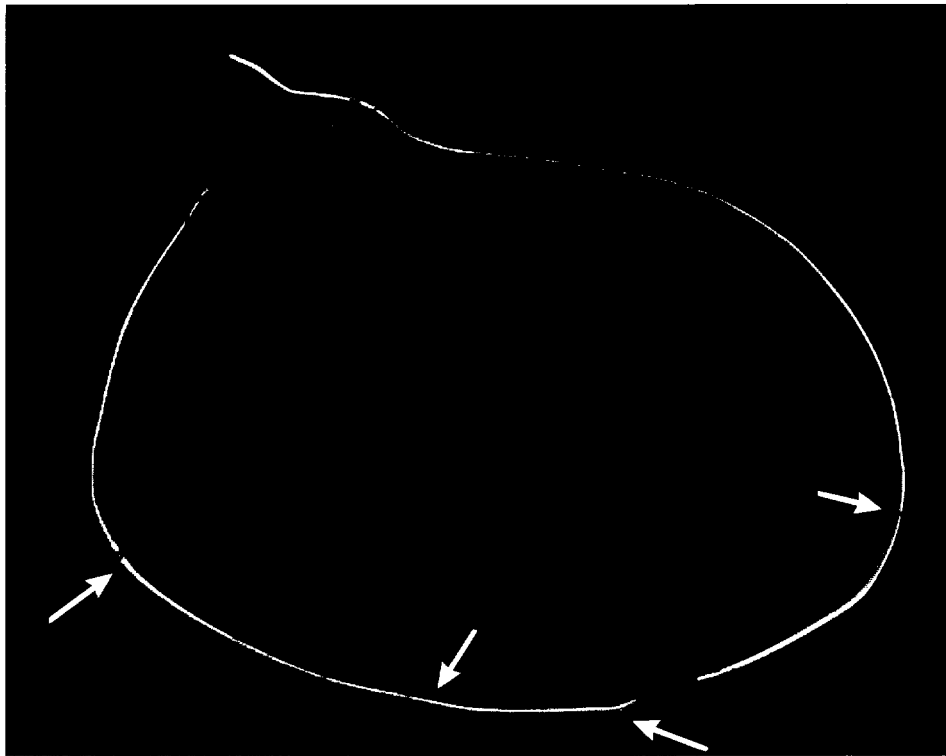
Figure 1. Wire sample submitted for analysis. The insulation exhibited blackened areas (black arrows) and mechanical damage (white arrows).

The wire was removed from TWA 800 wreckage on 26 June 1997 and was reported to be a BMS 1342A (Poly-X) type wire that was associated with the routing of center wing tank probe wires. There were three blackened areas (black arrows, Figure 1) and at least four mechanically damaged areas (white arrows, Figure 1) on the wire insulation. The blackened areas were typically associated with thermal damage. Multiple orientation images of the largest blackened area are shown in Figure 2.

There was no evidence of carbonization of the insulation or melting of exposed conductors which are typically associated with arc damage.

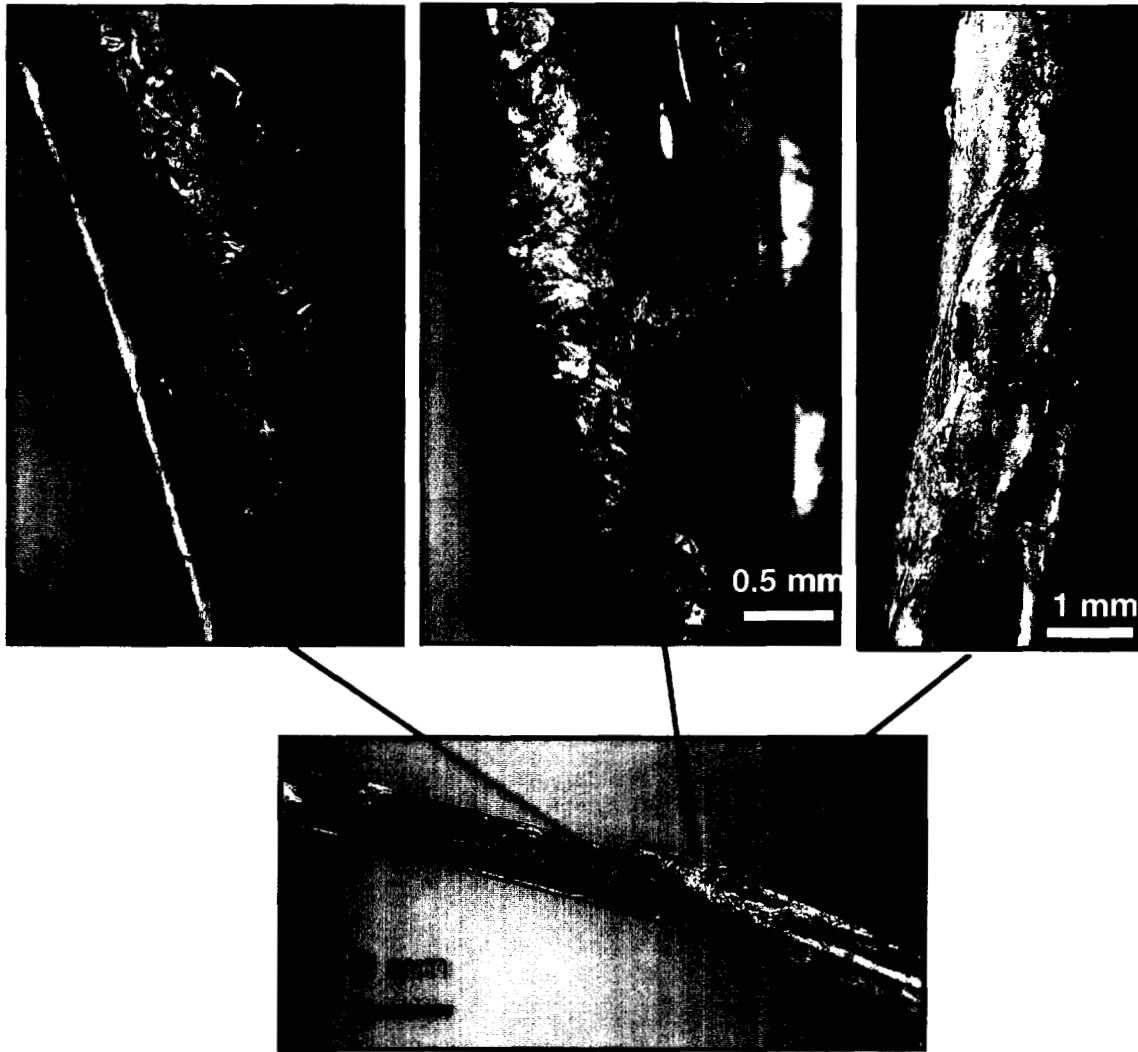
Figure 2. Multiple images of the largest blackened and thermally damaged area on the submitted wire.

Note the black residue on the insulation surface and mechanical damage to the multi-layered insulation. The amber tape was not carbonized and only exhibited mechanical damage. The black residue was easily removed mechanically from the insulation surface. Another blackened and raised area is shown in Figure 3.

The black residue could be removed mechanically.

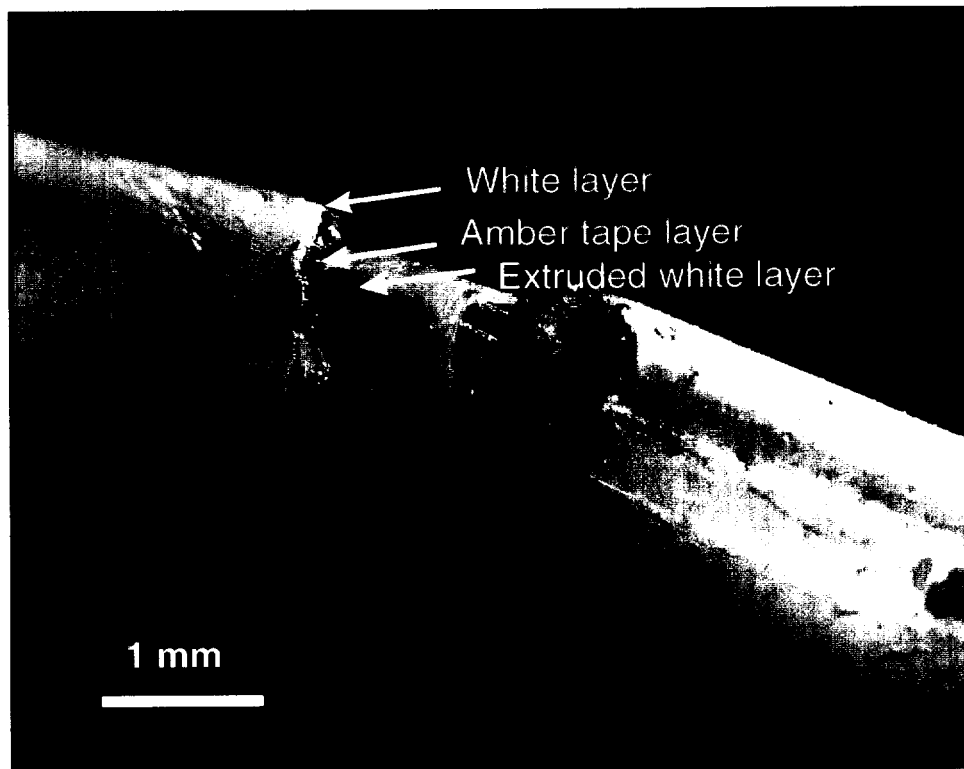
Figure 4. Typical mechanically damaged insulation area. Note the damage reveals the multiple layered insulation construction.

The insulation was flexible and bending of the insulation outside damaged areas did not produce cracks.

Mechanical damage was isolated and there was no evidence of insulation embrittlement.
