APPENDIX A

APPENDIX ASummary of the N17105 Equipment Study

APPENDIX B

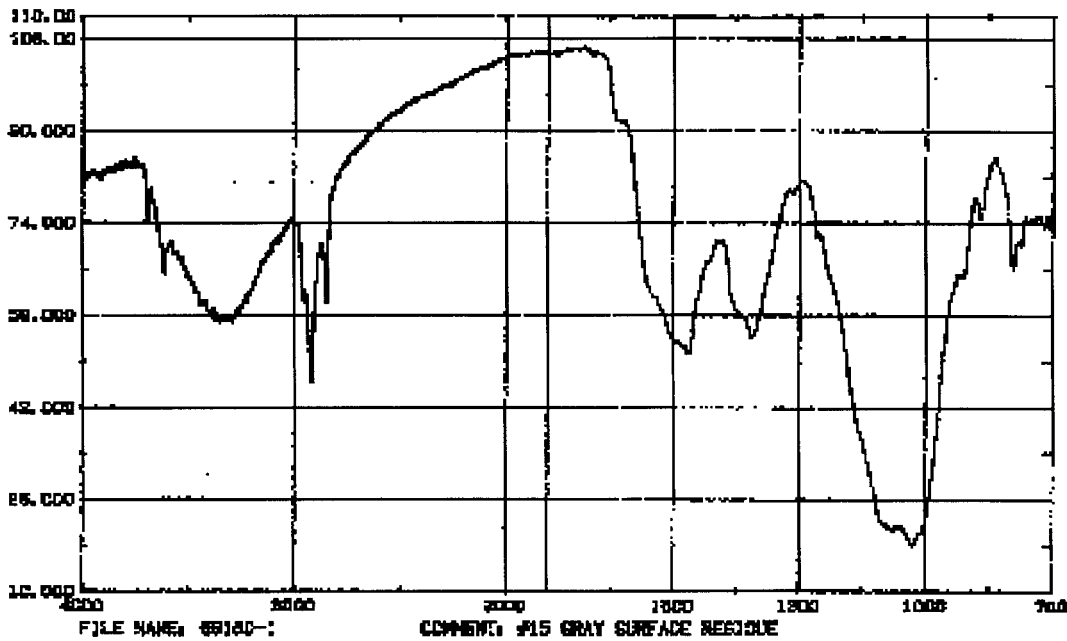
Spectrum 1. FTIR spectrum for part of the black-colored residue. The spectrum was typical of a mixture of organic and inorganic components which includes carbonates, silicates, and aliphatic hydrocarbons, cellulose materials and carboxylic acid salts.

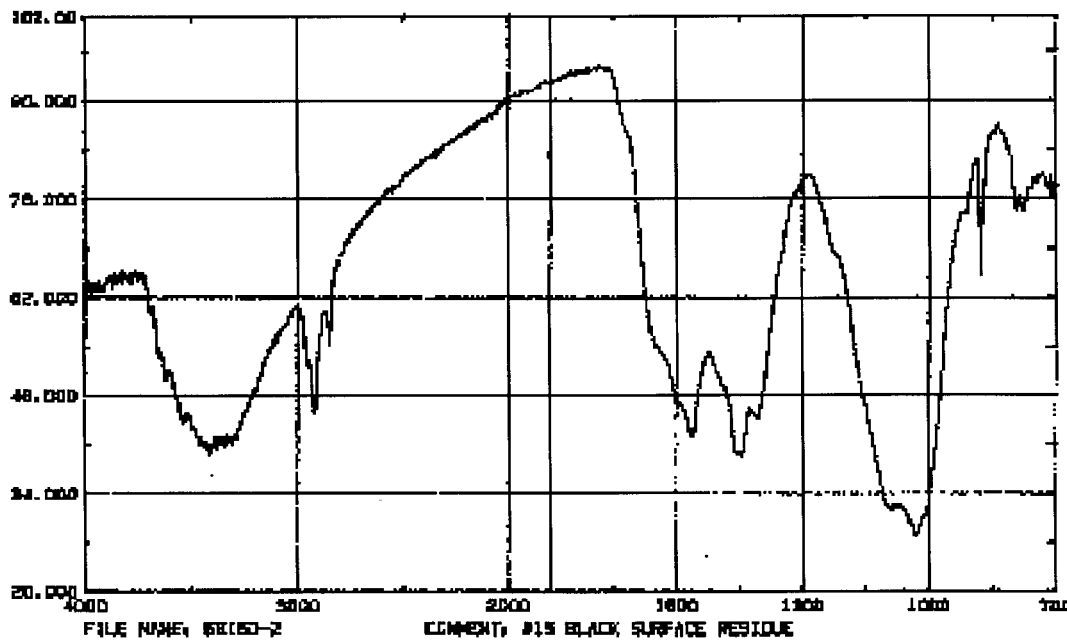
Spectrum 2. FTIR spectrum for another portion of the black-colored residue. The spectrum was typical of a mixture of organic and inorganic components which includes carbonates, silicates, and aliphatic hydrocarbons, cellulose materials and carboxylic acid salts.

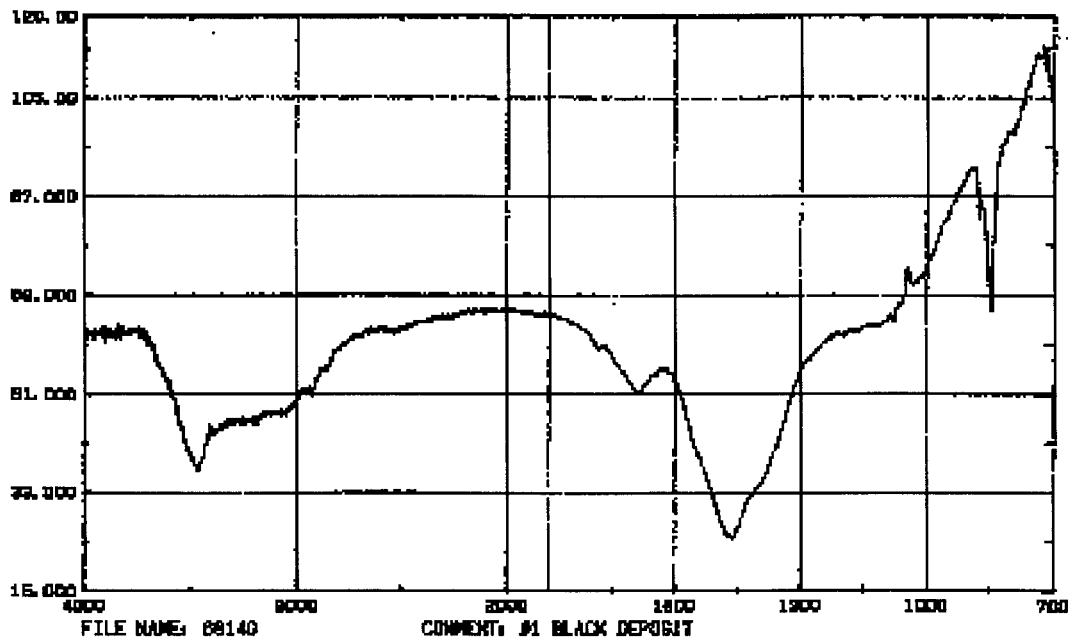
Spectrum 1. Micro FTIR spectrum obtained for scrapings from the black discoloration area. The spectrum most closely matched references for inorganic carbonate compounds with possible presence of some inorganic silicate materials. There was no evidence of any organic materials observed.

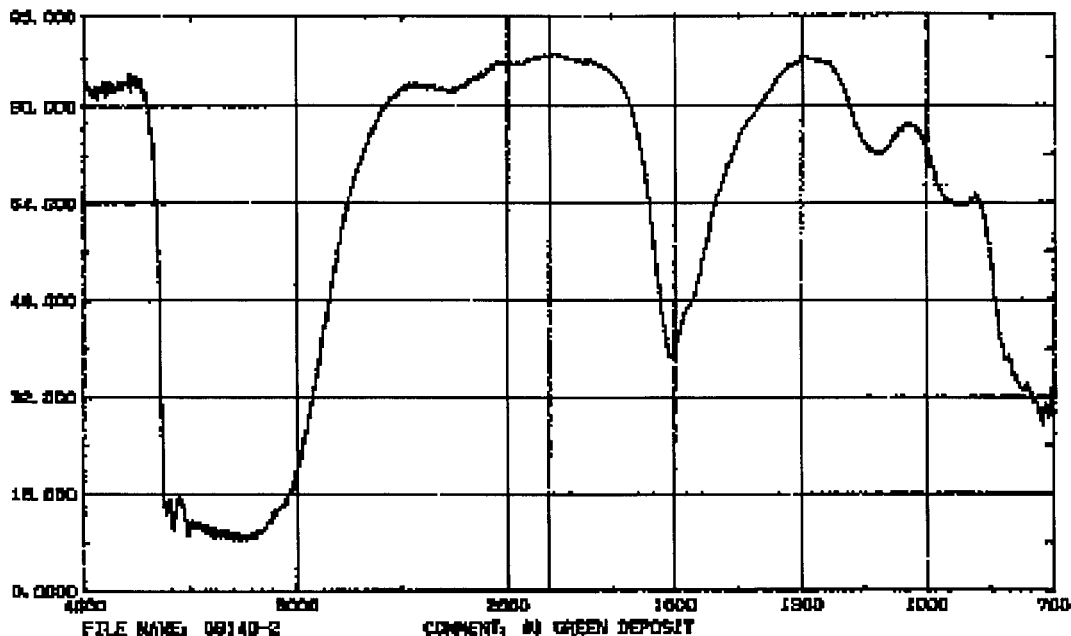
Spectrum 2. Micro FTIR spectrum obtained for the green material found in the area of black discoloration. The spectrum suggests the presence of hydrated inorganic oxides or hydroxides. There was no evidence of any organic materials observed.

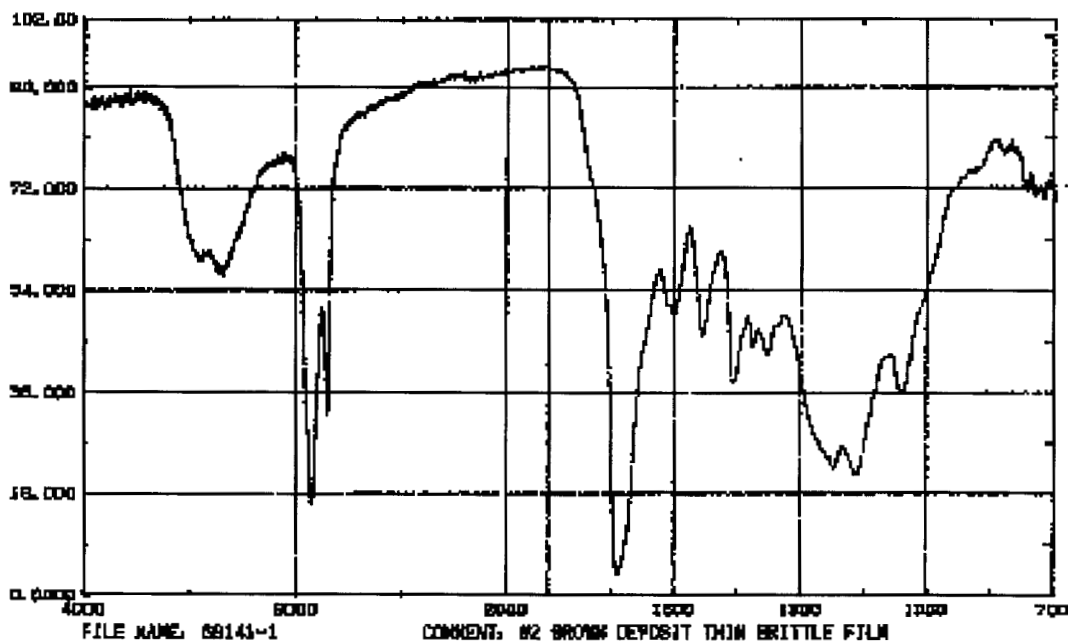
Spectrum 3. Micro FTIR spectrum obtained for the brown deposit (thin brittle film) near the bare end of the tube. The spectrum obtained was similar to some reference spectra for polyurethane materials.

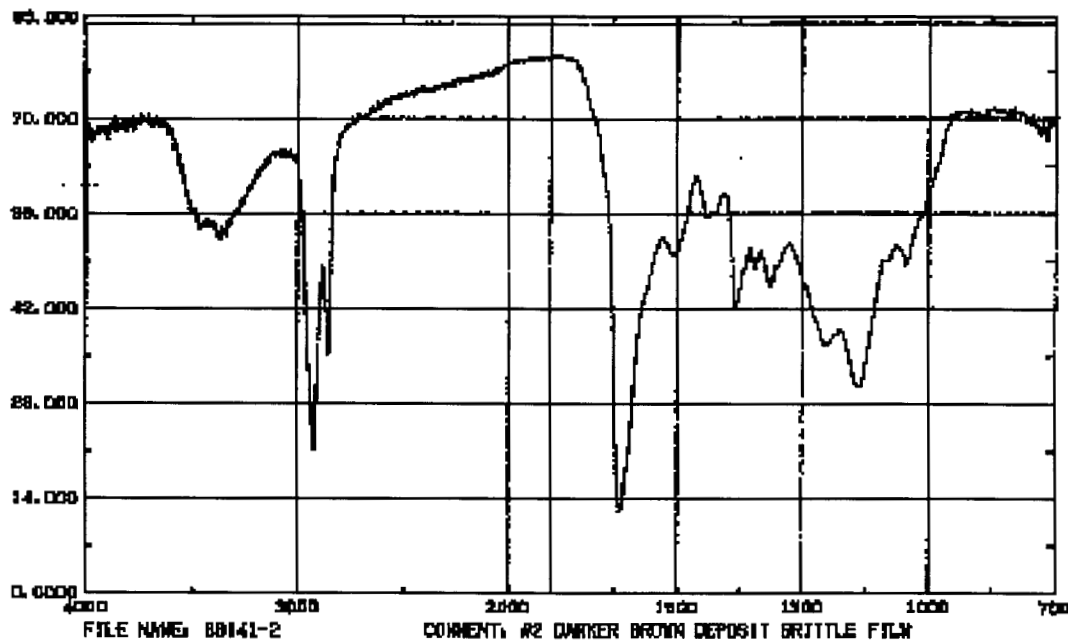
Spectrum 4. Micro FTIR spectrum obtained for the brown deposit (thin brittle film) near the bare end of the tube. The spectrum obtained was similar to some reference spectra for polyurethane materials.

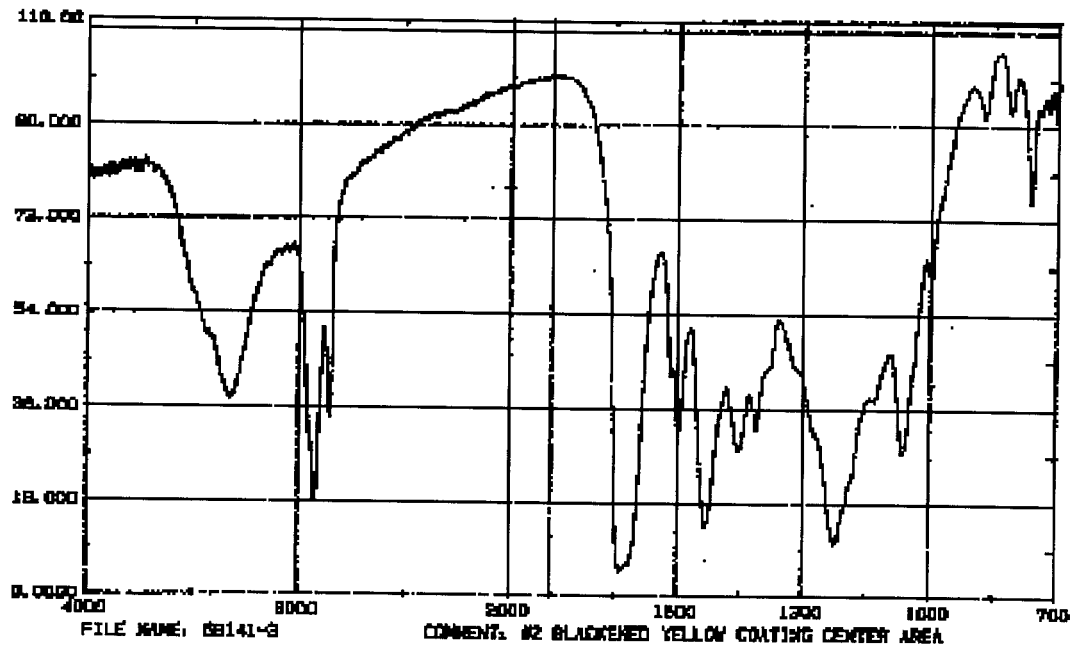
Spectrum 5. FTIR spectrum for a blackened yellow coating on the center area of the tube. The spectrum most closely matched references for polyurethane materials.

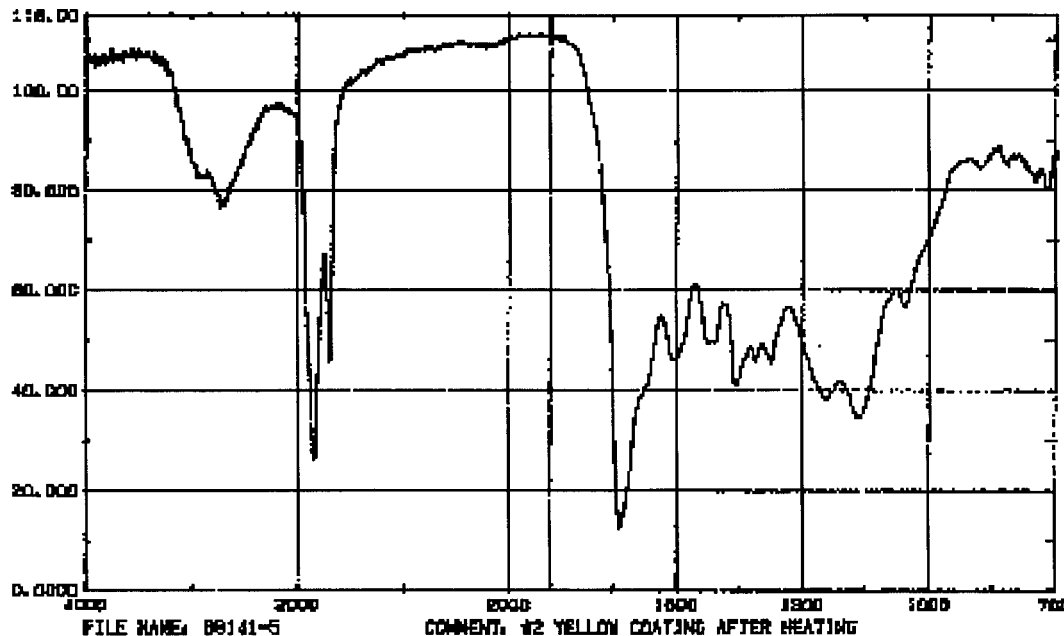
Spectrum 7. FTIR spectrum of a portion of the clean yellow coating following heating. The spectrum obtained matched very closely with those obtained for the brown deposit. Data suggest the brown deposit was composed of thermally degraded urethane coating.

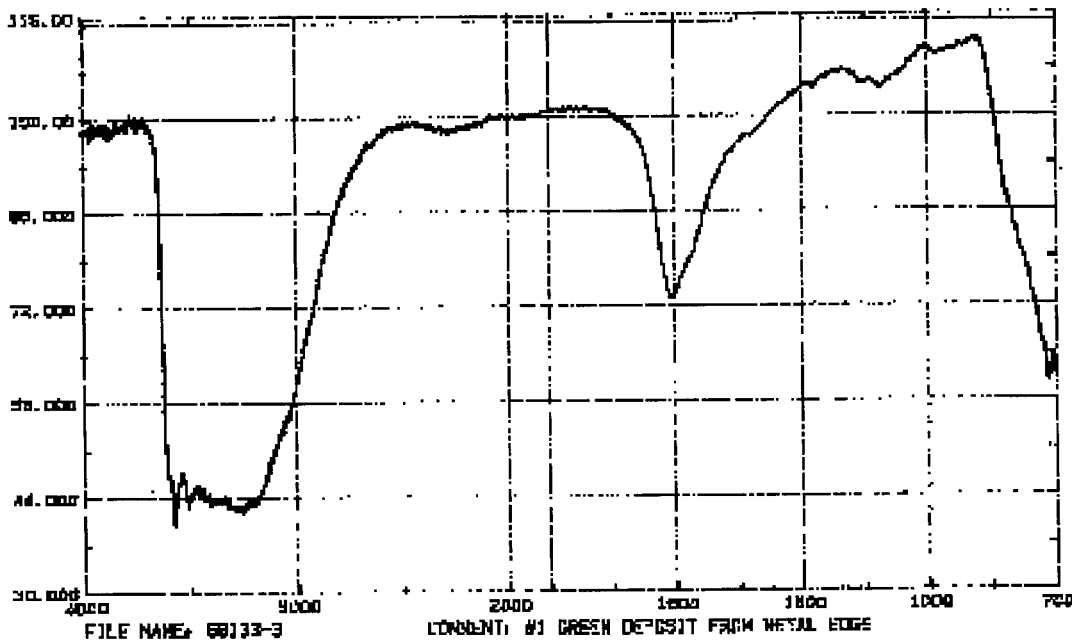
Spectrum 3. FTIR spectrum for the green crystalline solid observed near one edge of the metal plate. The spectrum obtained suggested it was composed of a hydrated inorganic oxide or hydroxide.

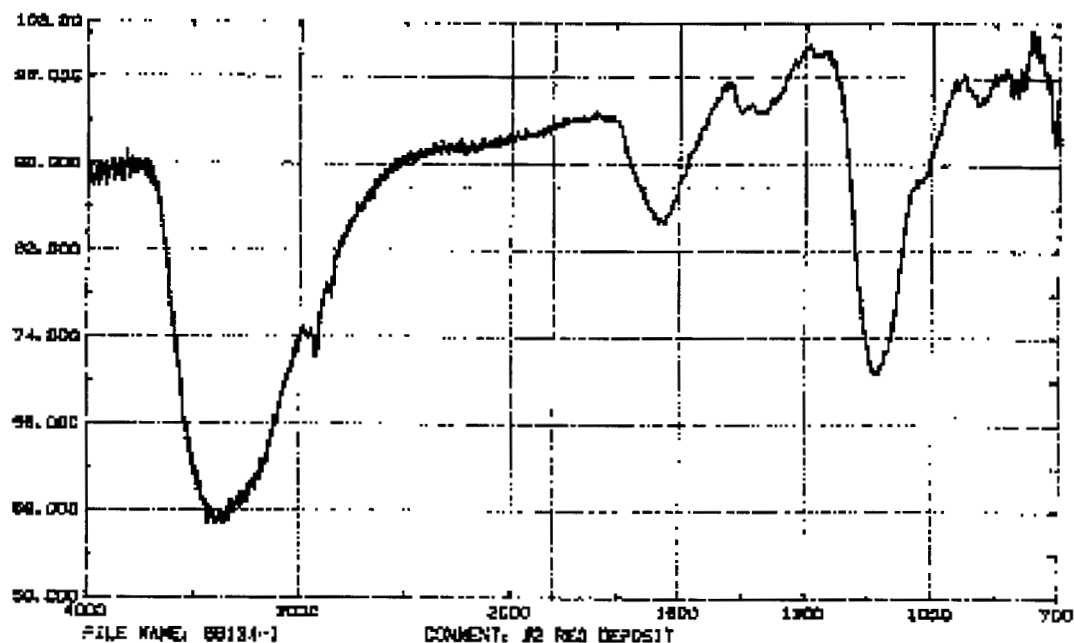
Spectrum 4. FTIR spectrum for the red deposit found on one area of the metallic plate. The spectrum obtained suggested the presence of hydrated inorganic oxide or hydroxide compounds. The absorption observed at 1137 cm^{-1} could be due to the presence of either inorganic silicate or sulfate compounds. Weak absorptions in the 2940 cm^{-1} region suggested the presence of small amounts of organic material.

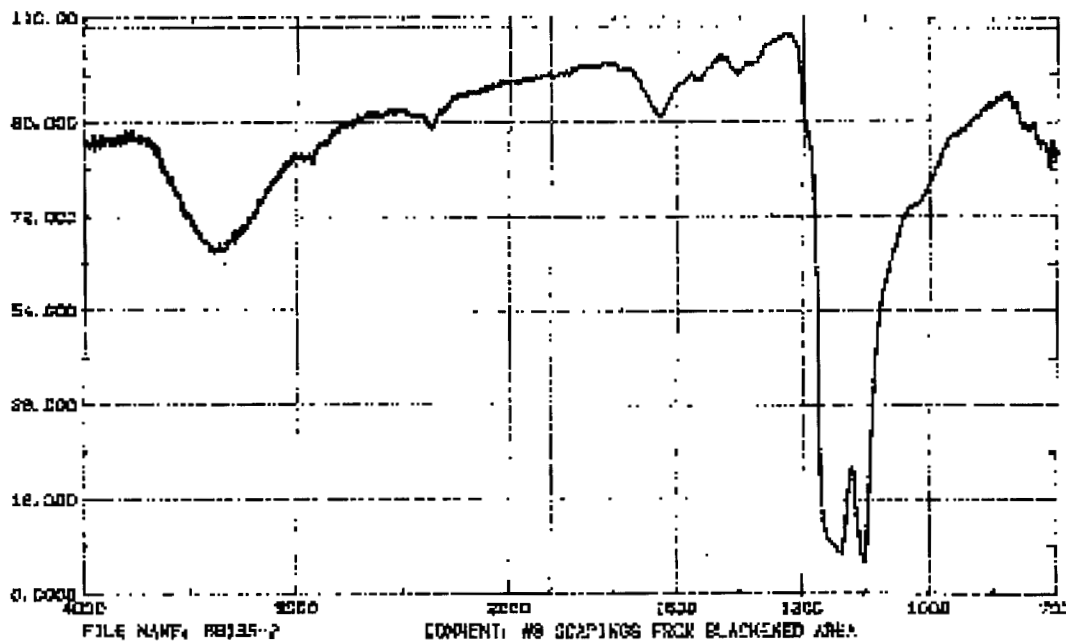
Spectrum 8. FTIR spectrum for the black deposit found on the white colored plastic material. The spectrum exhibited weak absorptions which suggested the possible presence of a hydrated inorganic compound.
