DOCKET NO. **SA- 516**

EXHIBIT NO. **9C**

**NATIONAL TRANSPORTATION SAFETY BOARD
WASHINGTON, D.C**

**ATTACHMENTS TO THE
SYSTEMS GROUP CHAIRMAN'S FACTUAL
REPORT OF INVESTIGATION**

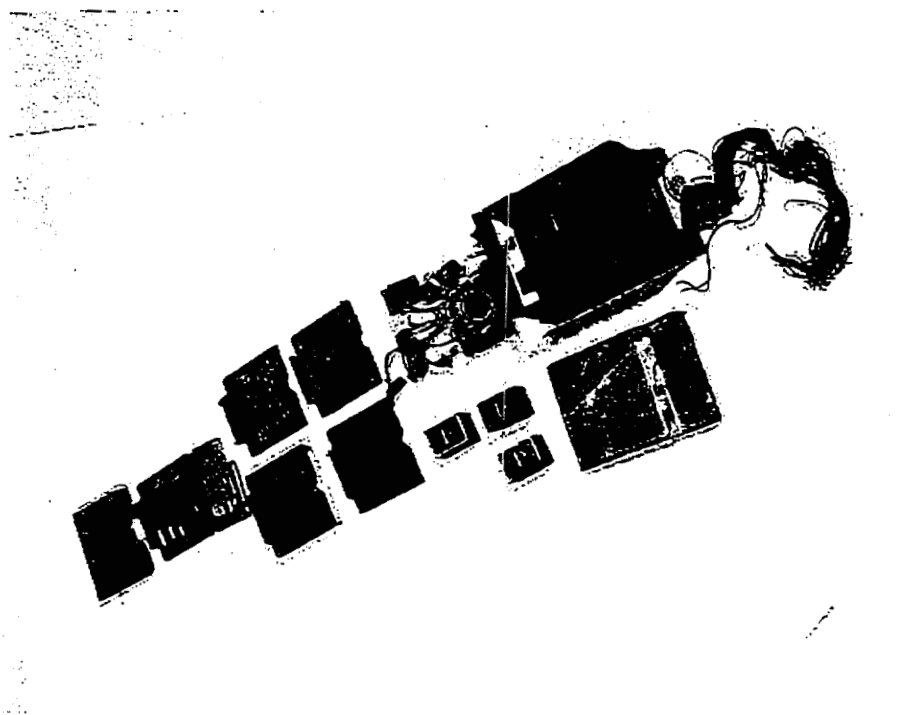
Figure 9. Printed wiring boards removed from an aircraft accident. Note the extensive heat damage to the hardware.

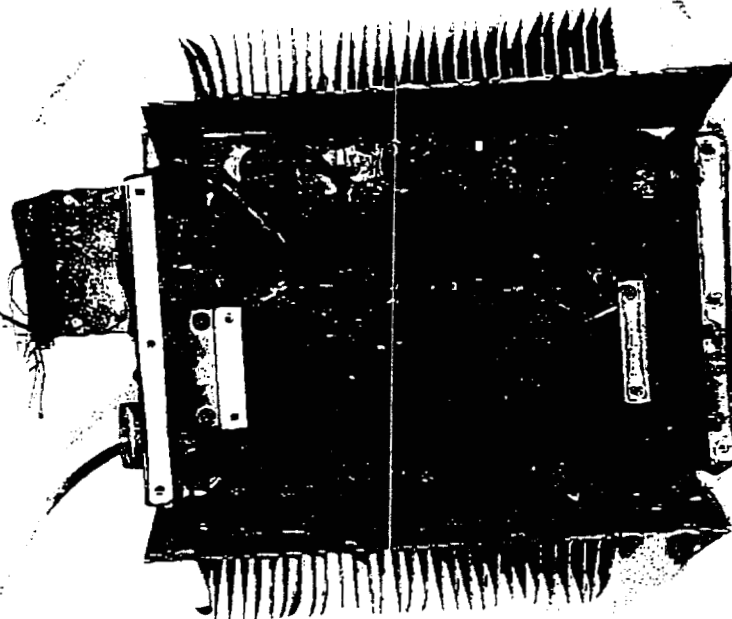
Figure 10. Close-up showing the physical and thermal damage exhibited by electronic hardware involved in an accident.

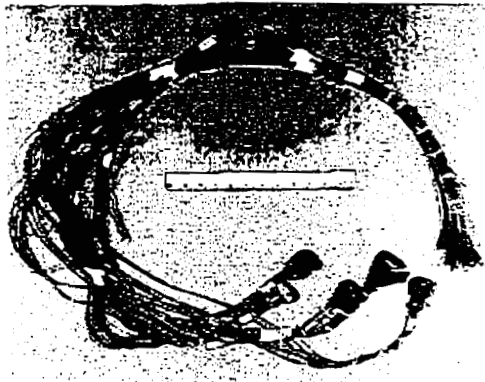
Figure 3. Example of a dry arc propagation failure in MIL-W-81381.

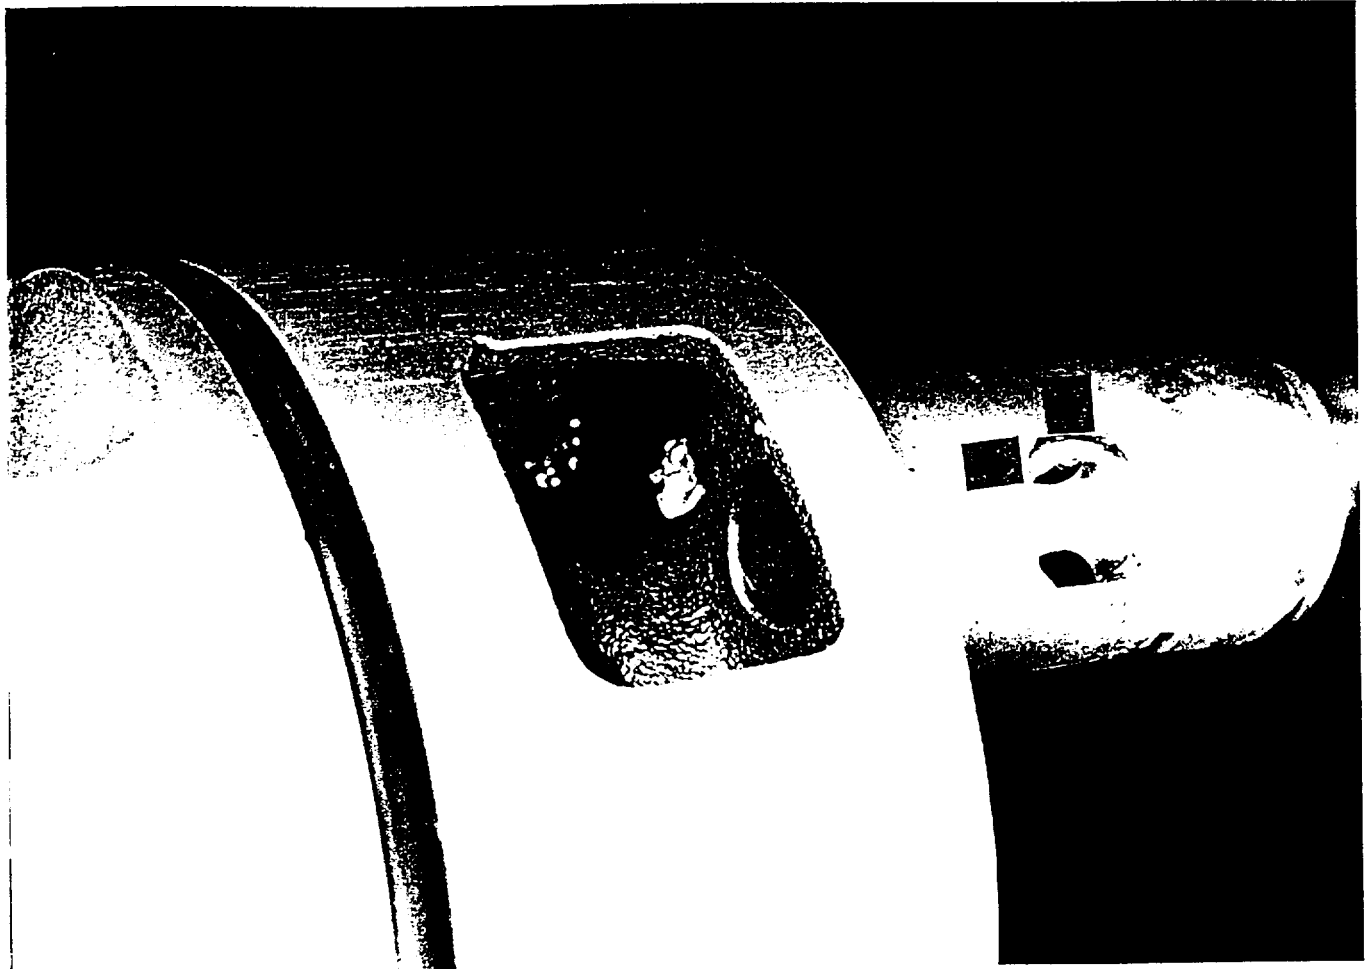
EQUIPMENT QUALITY ANALYSIS
EQA NUMBER: 1659T
PIOTO NUMBER: 9

Reference paragraph 5.3.4 & 5.3.5, A piece of non magnetic metal approximately 0.194" by 0.092" was found in the pump discharge chamber of the pump housing [P/N RR24675-1]. Red arrow indicates a piece of rubber type material approximately 0.297" by 2.16" by 0.048" thick, was also found jammed in the pressure relief valve [P/N RD24684].

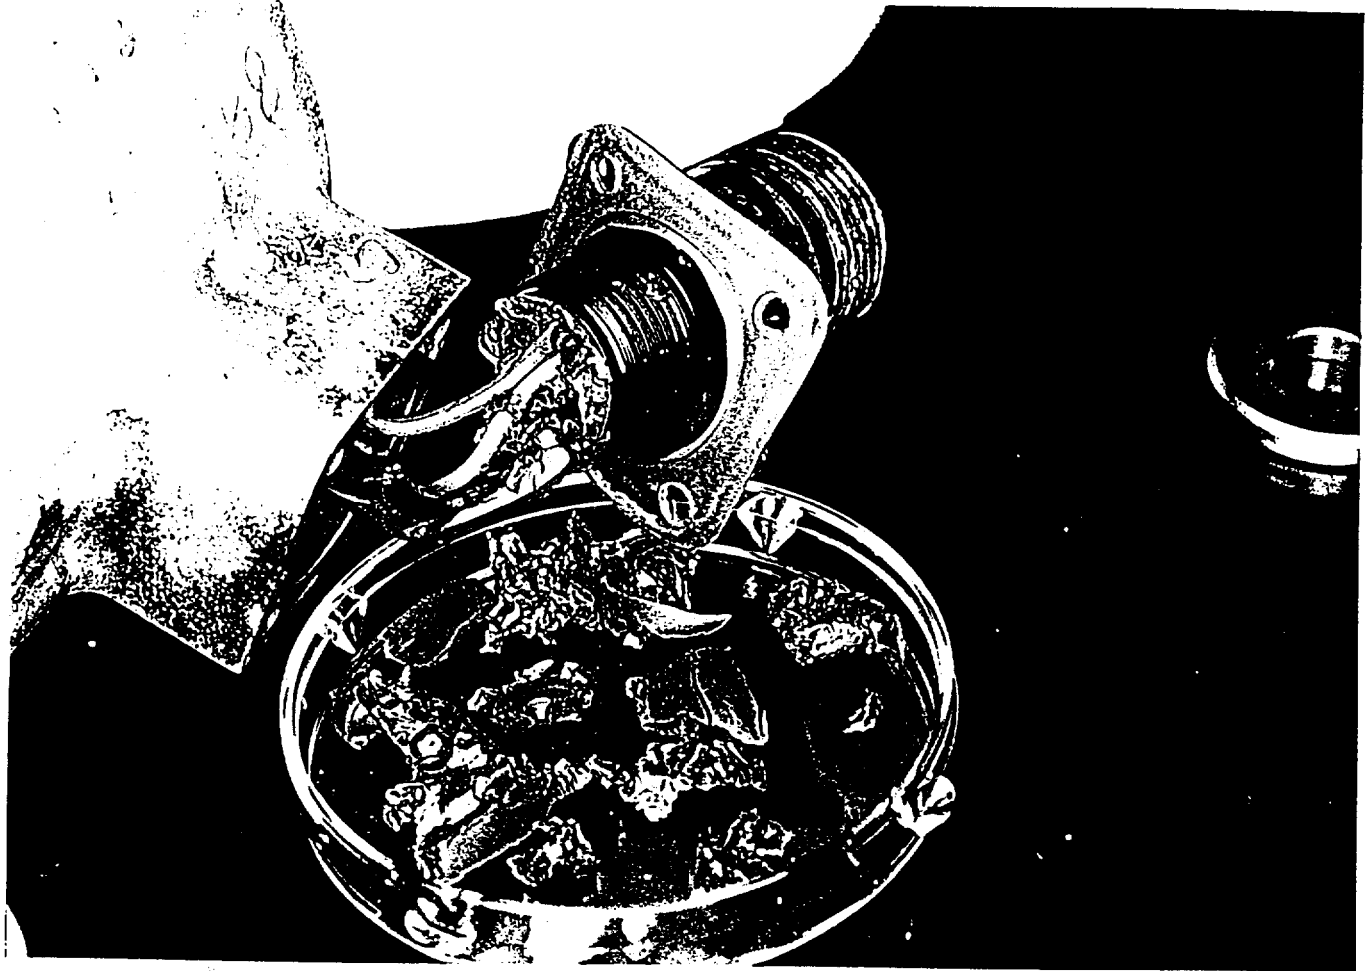
EQUIPMENT QUALITY ANALYSIS
EQA NUMBER: 1659T
PIOTO NUMBER: 26

Reference paragraph 5.8.2, The protective sleeving and connector grommet had deteriorated due to contamination and exposure to fuel.

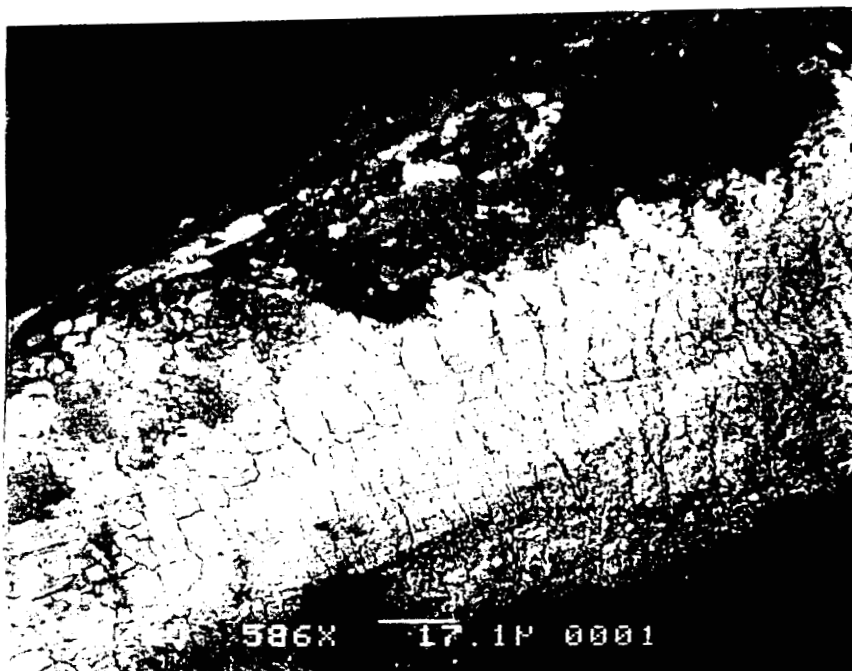
Figure 12. SEM micrograph of the tin coated copper wire in the crimp terminal. Note the cracked tin coating (lighter area) and the exposed copper which contained high levels of sulfur.

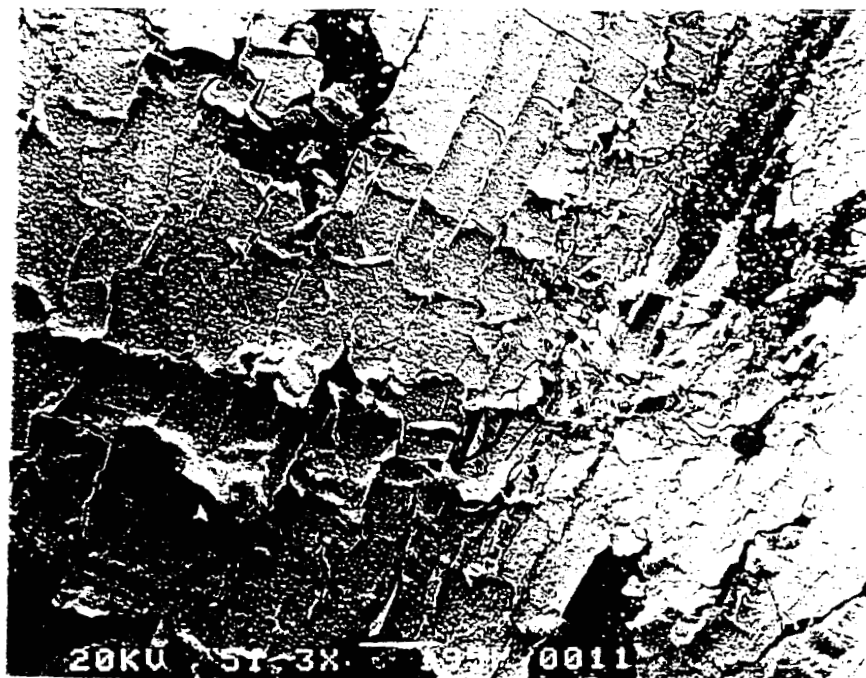
Figure 12. SEM micrograph of residue area in Figure 11. EDXS identified copper, silver, and sulfur. Mag: 51X
