DOCKET NO. **SA- 516**

EXHIBIT NO. **9D**

**NATIONAL TRANSPORTATION SAFETY BOARD
WASHINGTON, D.C**

**ACCIDENTS, INCIDENTS,
AND SAFETY RECOMMENDATIONS
REFERED TO DURING THE INVESTIGATION**

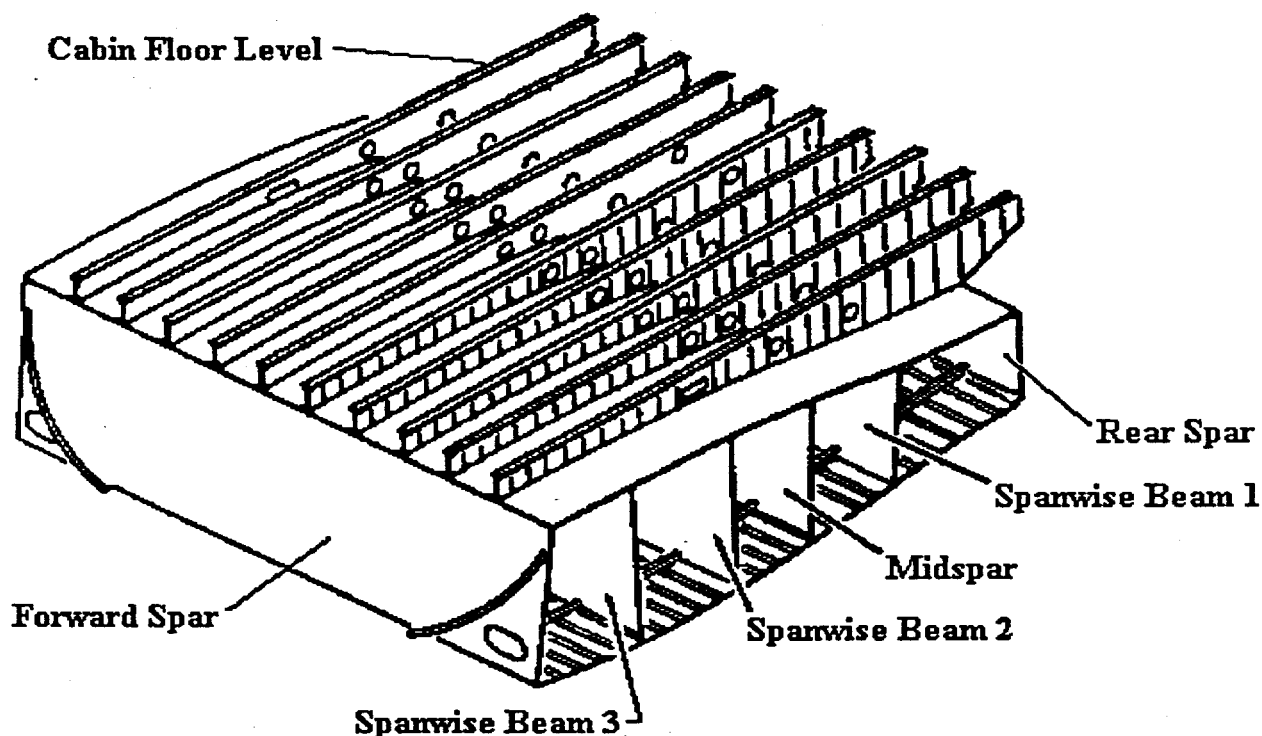
Figure 1. Center Wing Fuel Tank

On July 17, 1996, about 2031 eastern daylight time, a Boeing 747-131, N93119, operated as Trans World Airlines Flight 800 (TWA800), crashed into the Atlantic Ocean, about 8 miles south of East Moriches, New York, after taking off from John F. Kennedy International Airport (JFK), Jamaica, New York. All 230 people aboard the airplane were killed. The airplane, which was operated under Title 14 Code of Federal Regulations (CFR) Part 121, was bound for Charles De Gaulle International Airport (CDG), Paris, France. The flight data recorder (FDR) and cockpit voice recorder (CVR) ended simultaneously, about 13 minutes after takeoff. Evidence indicates that as the airplane was climbing near 13,800 feet mean sea level (msl), an in-flight explosion occurred in the center wing fuel tank (CWT);¹ the CWT was nearly empty.

A substantial portion of the airplane wreckage has been recovered from the ocean floor. Among the debris found along the first part of the wreckage path were CWT parts from spanwise beam Nos. 2 and 3, the forward spar, and debris from beneath and forward of the center wing section (see Figure 1). The cockpit of the airplane and pieces of the forward fuselage were found in a second debris field that was more than 1 mile from the beginning of the wreckage path. Fragmented wing and aft fuselage parts were recovered from a third debris field farther along the wreckage path.

Portions of the airplane have been reconstructed, including the CWT, the passenger cabin above the CWT, and the air conditioning packs and associated ducting beneath the CWT. The reconstruction thus far shows outward deformation of the CWT walls and deformation of the internal components of the tank that are consistent with an explosion originating within the tank. Airplane parts² from in and around the CWT recovered and identified to date contain no evidence

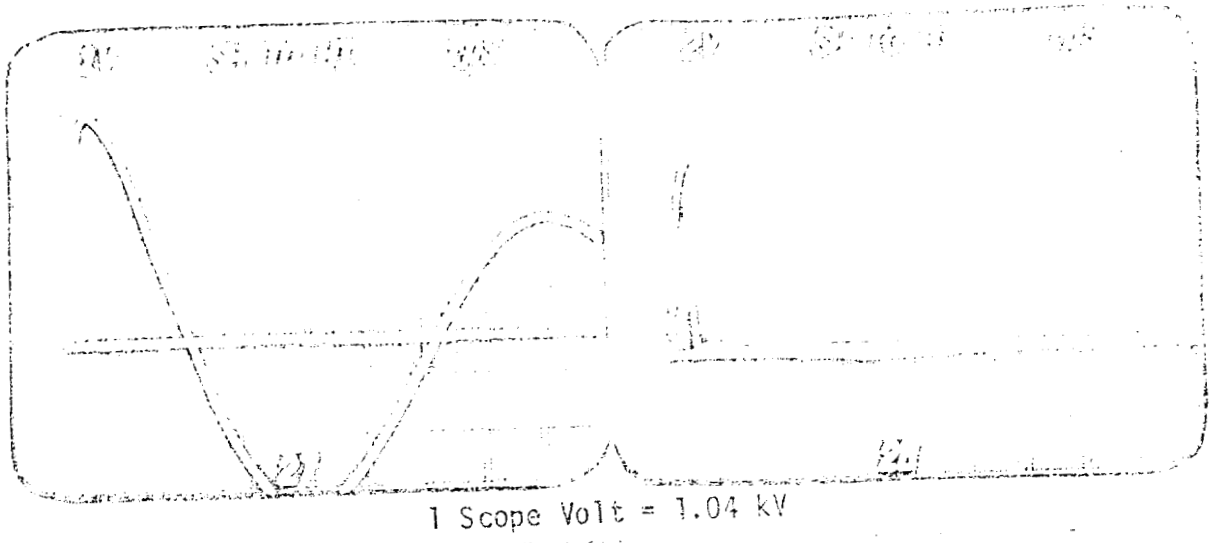
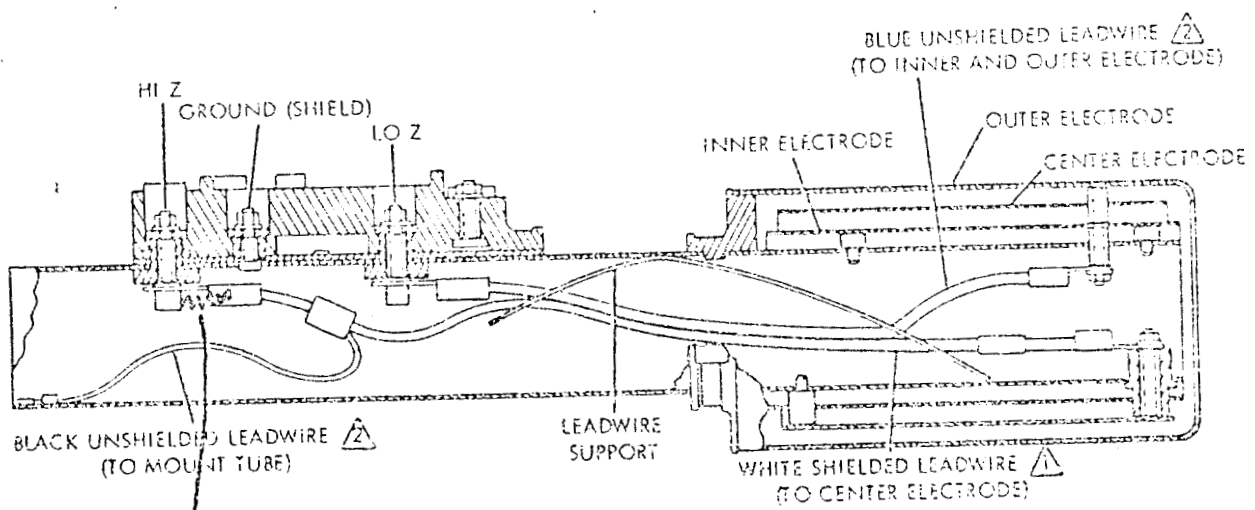
Figure A-6

- Flashover from End of Shield to HI Z Terminal
- NOTES:
- 1. USE MIL-W-16878/5, NO. 22 AWG SHIELDED INSULATED LEADWIRE.
 - 2. USE MIL-W-16378/5, NO. 22 AWG UNSHIELDED LEADWIRE.
 - 3. FG6C1 CONFIGURATION SHOWN.

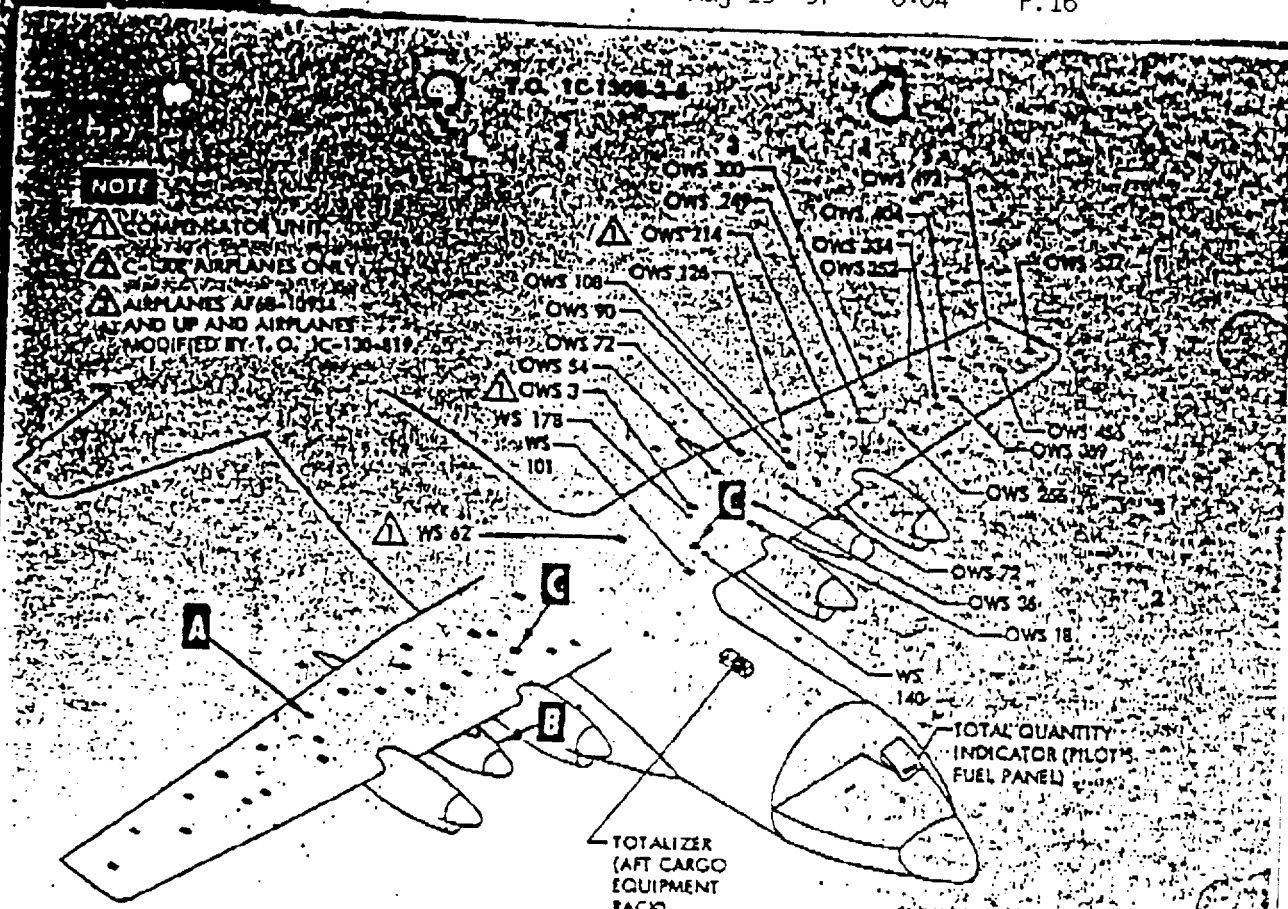
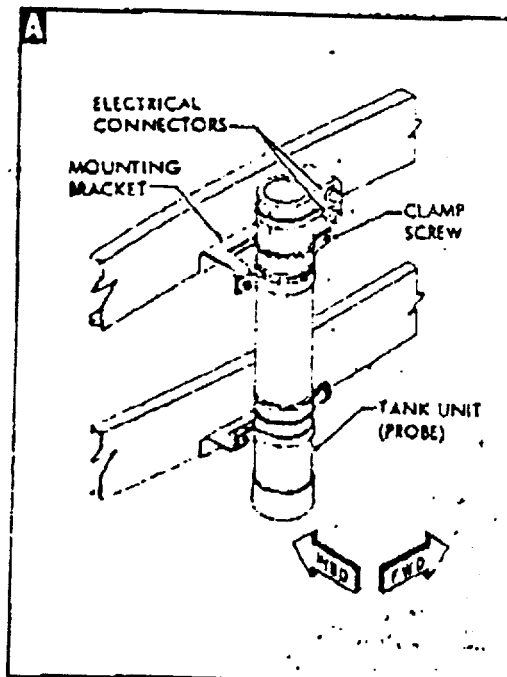
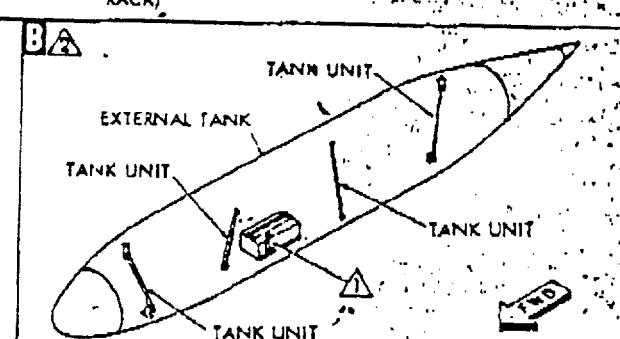
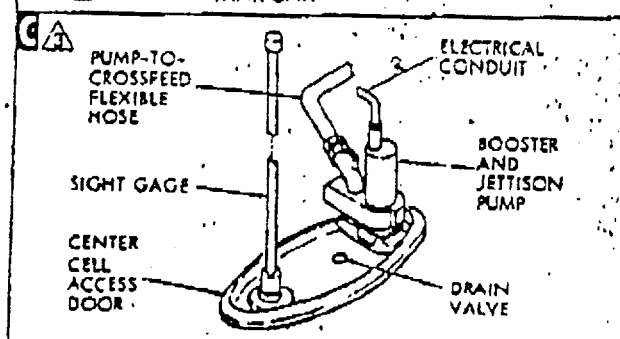
Fuel Quantity Indicating System Components Locations

Examination of a section of coaxial wire 18129 (tank extension of wire 18109) at the approximate location of the explosion disclosed two segments which appeared to have been burned by arcing.
