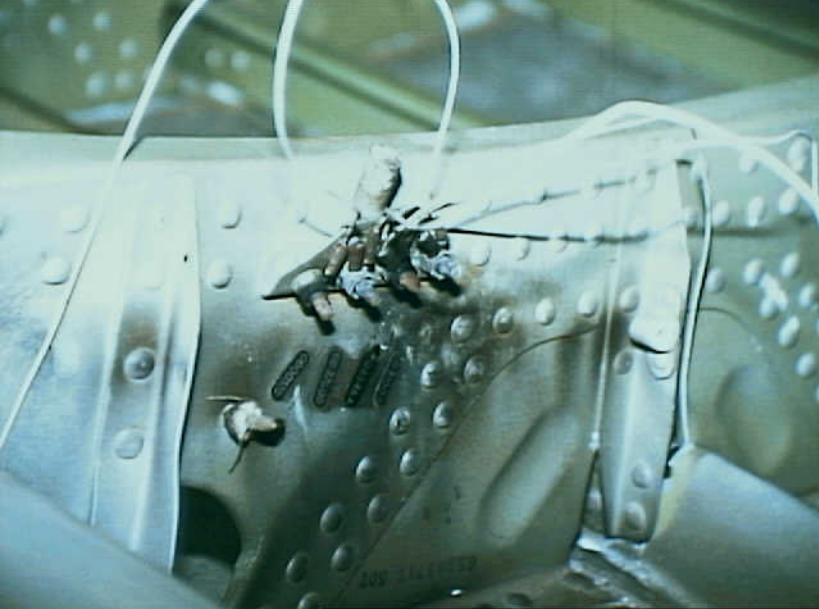
Systems 9 - Exhibit No. 9E - Photo No. 2 - Evidence of arcing along emergency light wire routing (to right of upper deck - N93119). ATA 24-50-00.
