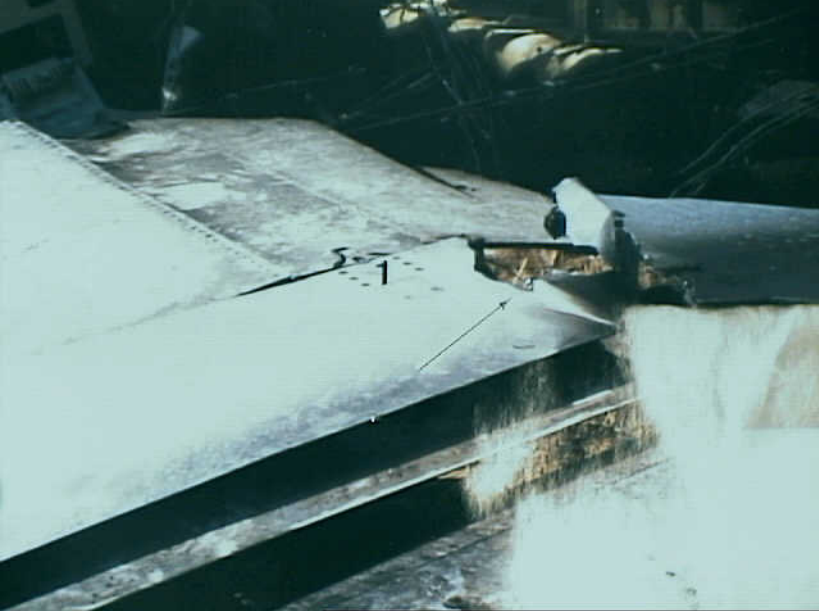
Systems 9 - Exhibit No. 9B - Photo 3. View (looking forward) of left inboard ground spoiler panel. Note the fracture (arrow) just inboard of actuator hinge (1) and extensive soot damage.
