**DOCKET NO.: SA-517**  
**EXHIBIT NO. 9F**

**NATIONAL TRANSPORTATION SAFETY BOARD**  
**WASHINGTON, D.C.**

**SYSTEMS GROUP CHAIRMAN'S FACTUAL REPORT**  
**ATTACHMENT 5**  
**KOREAN AIR POST ACCIDENT TESTS**

**Attachment 5**  
**Korean Air Post Accident Tests**

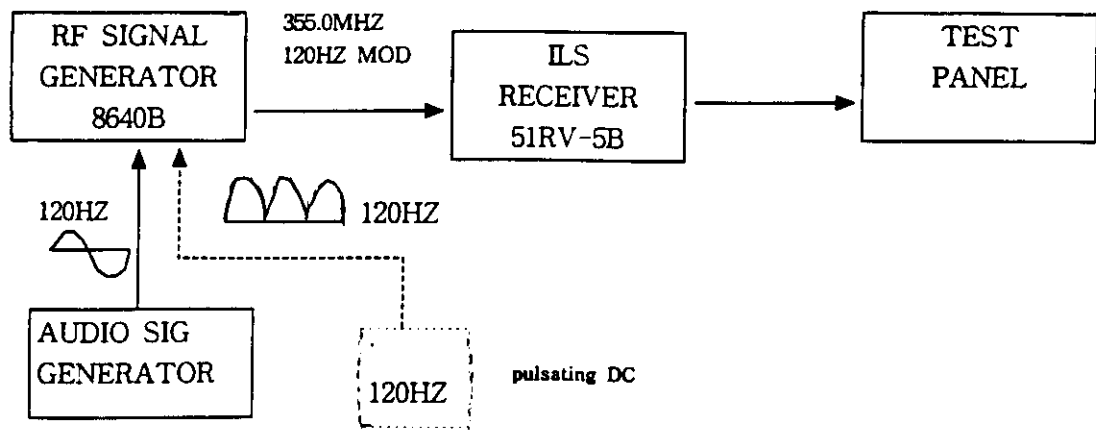
[Fig 1]

A 335 MHz test signal (ILS frequency of 110.3 MHz), -90dBm, 120 Hz modulation at 100% was applied to the ILS receiver under test while the glide slope indicator and flag were monitored for movement. *Reference Figure 1 of block diagrams for test setup* The following results were noted:

| <u>Receiver</u> | <u>Glide Slope indicator deviation</u> | <u>Flag</u> |
| 51RV-5B | -58 mV | out of view |
| 51RV-1 | -5 mV (centered) | out of view |
| 51RV-2B | -58 mV | out of view (at 270mV) |
| ILS-70 | -1.01 V | out of view |
| RIA-32A | n/a | in view |
| ILS-700 series | n/a | NCD (no computed data) |

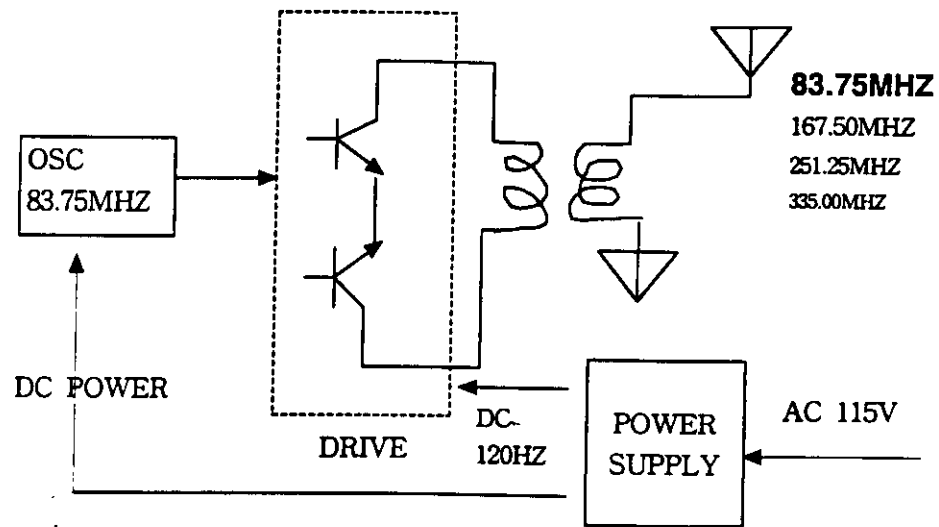
[Fig 2]

The test was repeated with the same results using a radio transmitter powered by a full wave rectified DC with the oscillator frequency set at 83.75 MHz (one fourth of 335 MHz). *Reference Figure 2 of block diagrams for test setup.*

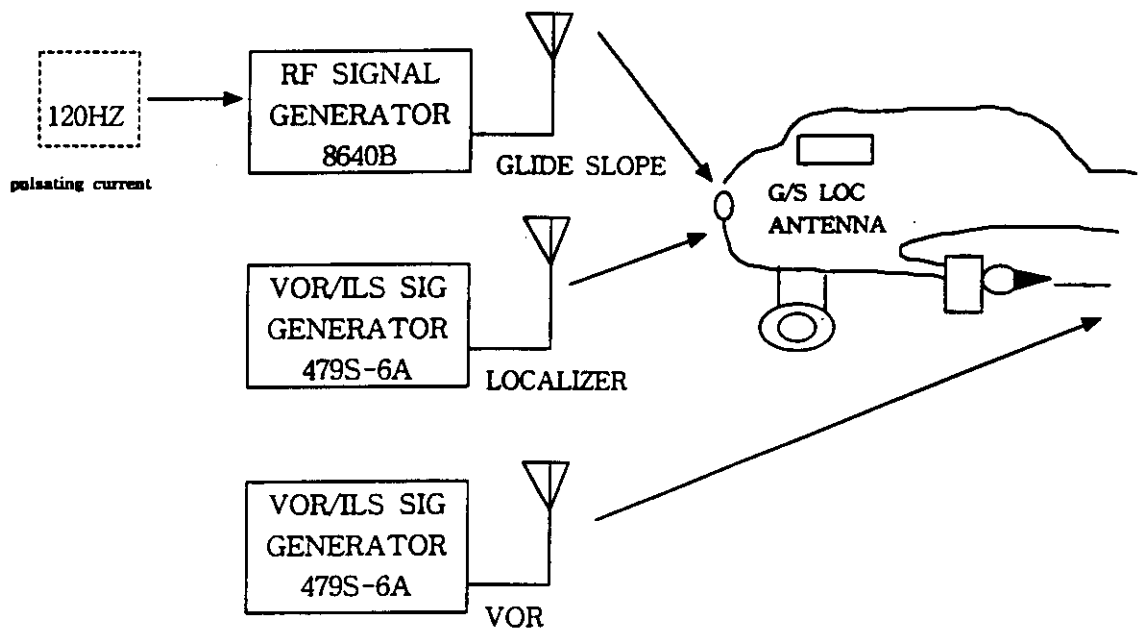
[Fig 3]

The test was repeated on an airplane on the ground with 120 Hz pulsating current feeding the RF signal generator. *Reference Figure 3 of block diagrams for test setup* The indications recorded were:

VOR tuned to 115.3 MHz, course set as 063: NAV capture  
NAV tuned to 110.3 MHz: LOC, GS flag out of view  
LOC Center, GS 0.8 Dot up  
FD Green NAV, White GS
