## MATERIAL ANALYSIS REPORT

**TO:** Bob Heath cc: Distribution  
**FROM:** Bob Cashman  
**DATE:** November 18, 2002  
**SUBJECT:** LR 207400

### **SUMMARY**

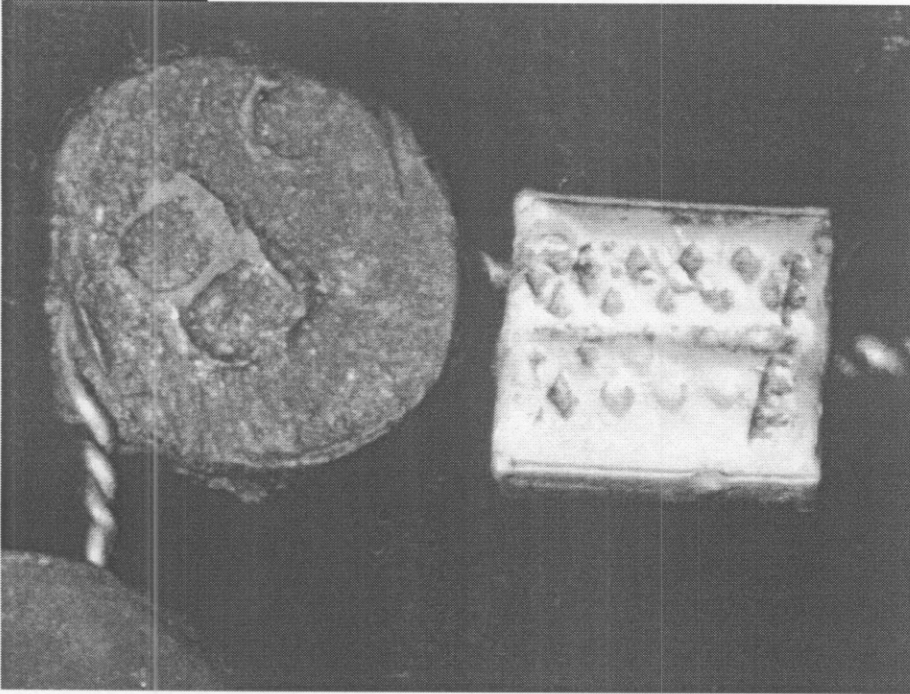
A portion of the 747-400 lower rudder manifold had broken completely off the main unit in the area of the retaining cap for the yaw damper modulating piston (mod) and sleeve assembly. The lock wire on the upper cap had a seal that did not have the Parker markings on it, indicating that this had been opened at some time in the past. The two seals are illustrated in Figure I.

**Figure 1:** The round lock wire identification on the left was connected to the broken end of the manifold. All other lock wires on the remainder of the manifold were rectangular as noted on the right side of the photo.

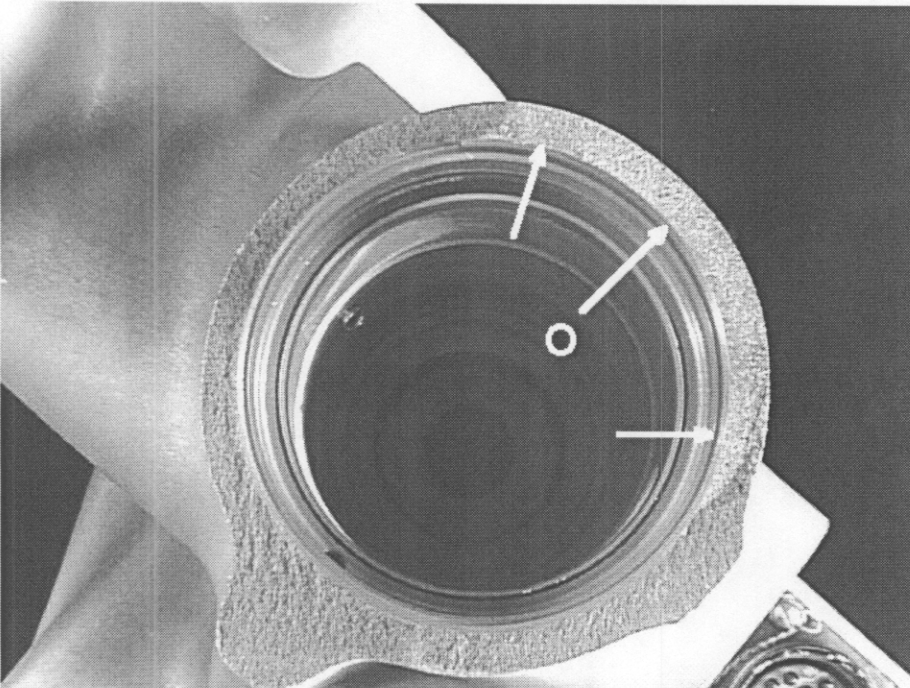
An overall view of the fracture surface is illustrated in Figure 2. Examination of this surface on the Scanning Electron Microscope (SEM) identified three separate crack initiation sites. No mechanical damage or other part defect was visible at these sites. In particular, there was no evidence of corrosion cracking and no evidence of stress corrosion cracking. One of these three areas exhibited clamshell markings that are characteristic of fatigue (Figure 3).

Each of these crack sites had fatigue striations at a number of locations, including the origin. The examination identified that each crack initiation site was located along the first full thread root radius. The primary crack (the crack that extended from the inner wall of the yaw damper cavity to the outer surface) had propagated entirely across the wall in fatigue. The wall thickness at this location was .226 inches. A fatigue striation count estimated the number of cycles to failure as 7760.

After the crack had penetrated the wall, the remainder of the surface had dimple rupture features that are characteristic of overload.

**Figure 2:** A view of the yaw damper cavity and the fracture surface of the broken end. The origin is located at O. The dull area outside of the arrows is the area of overload.
