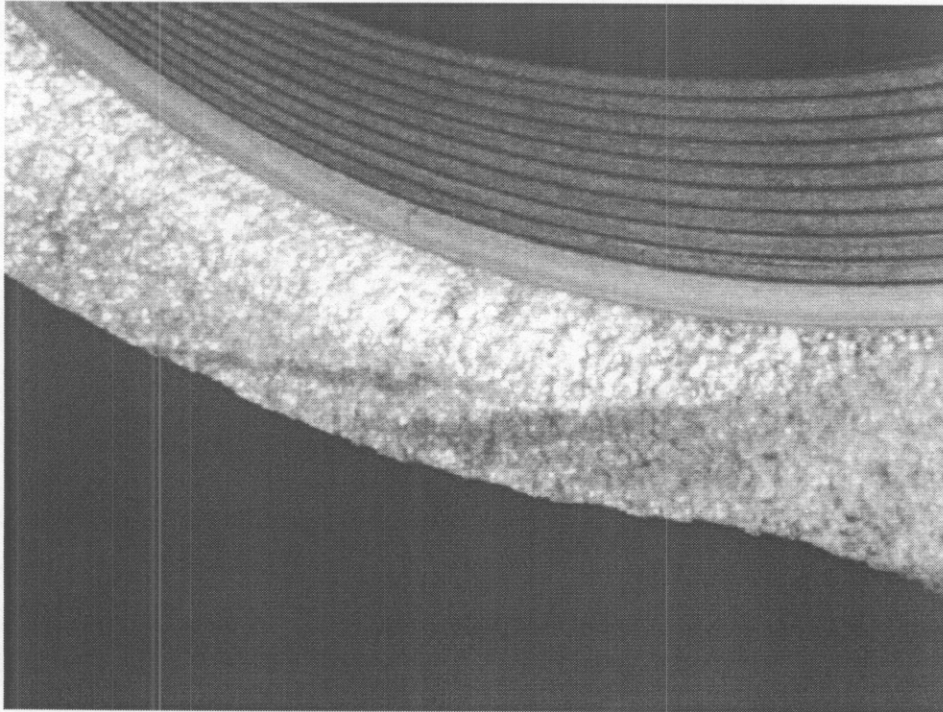
Figure 3: A clamshell appearance is evident on one side of the fracture surface on the threaded portion of the cavity.

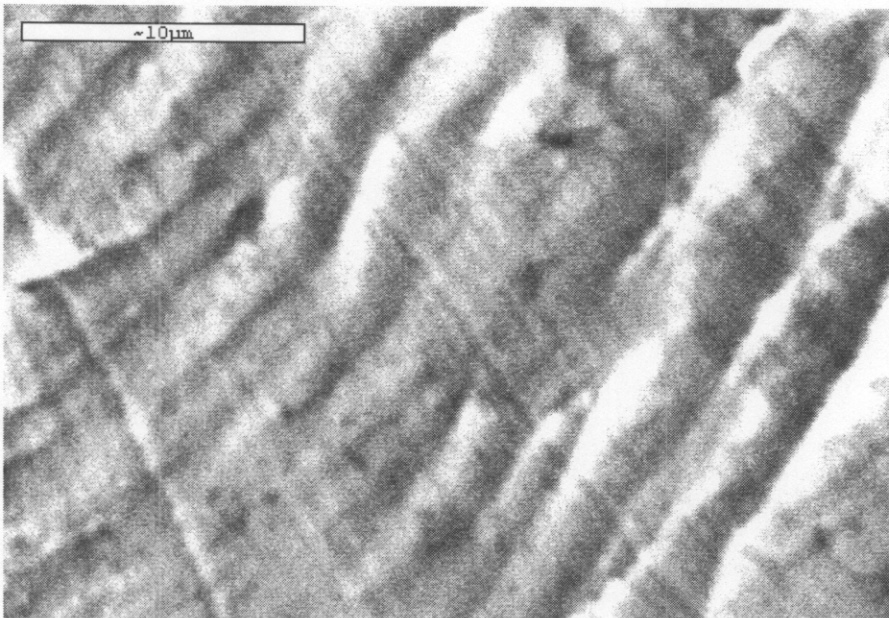
Figure 4: Fatigue striations are visible across the thickness of the wall at the area of the origin. (SEM photo at 4000X)

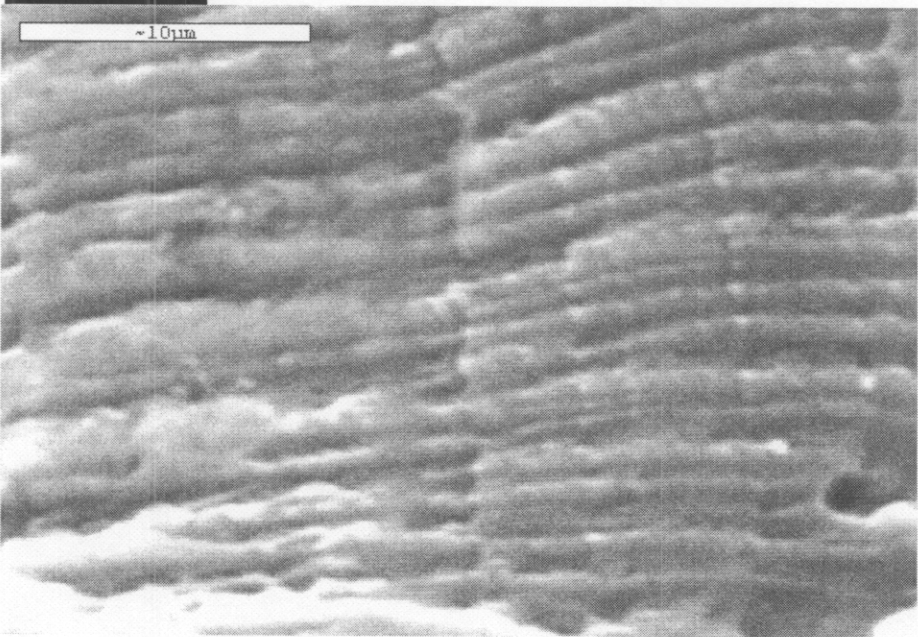
Figure 5: *Fatigue striations at a location near the outside surface of the manifold (SEM photo)*

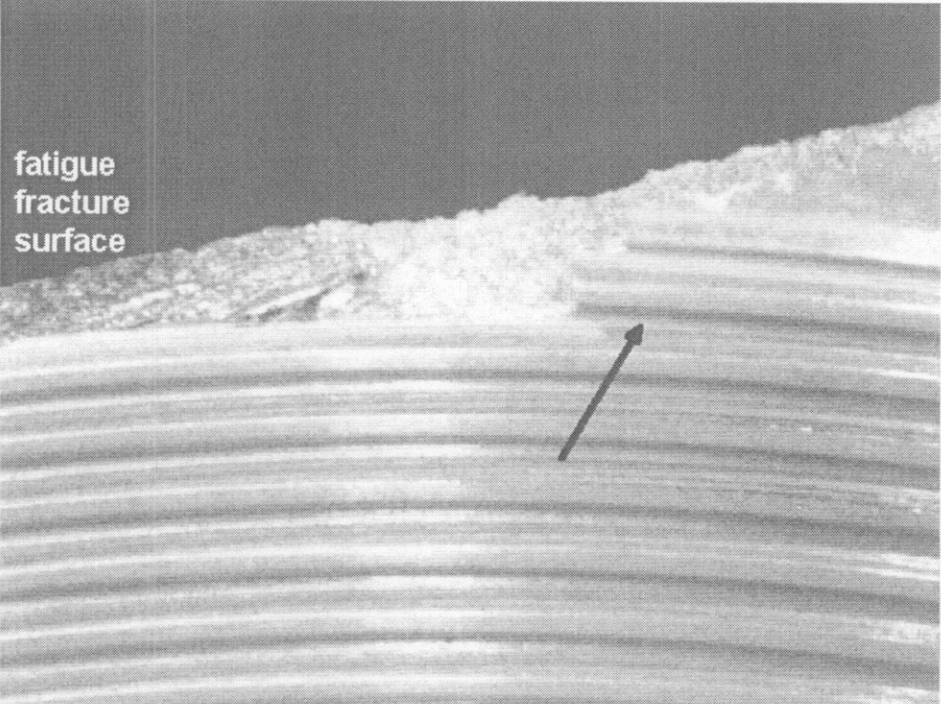
Figure 6: *The arrow locates the thread root radius of the first full thread. The fatigue fracture originated at the radius.*

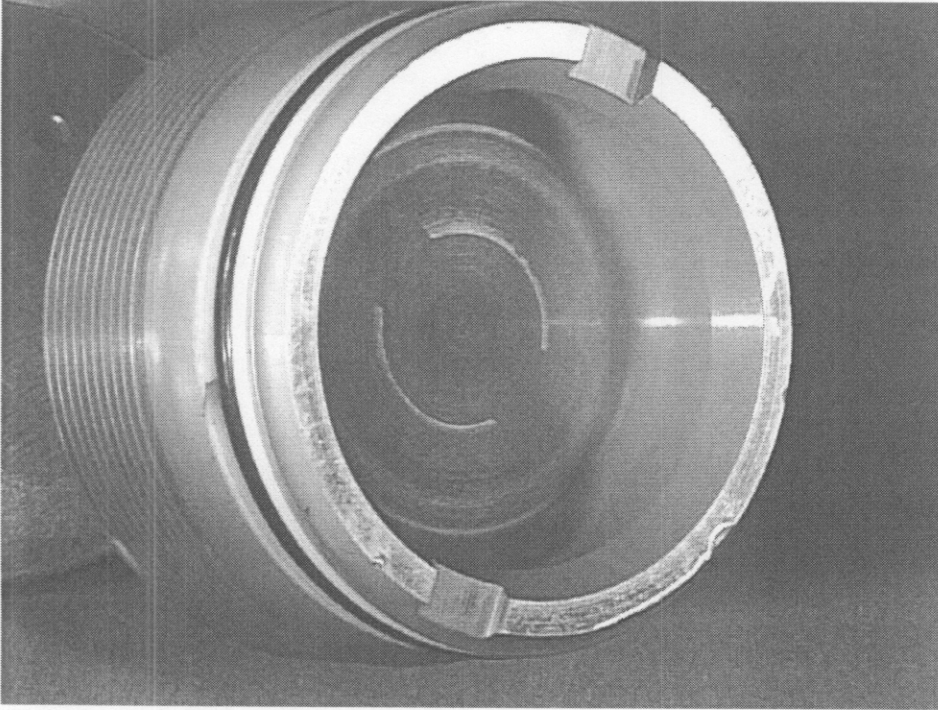
Figure 7: *Viewing the cap from the broken end. Witness marks from the piston are visible on the ID.*

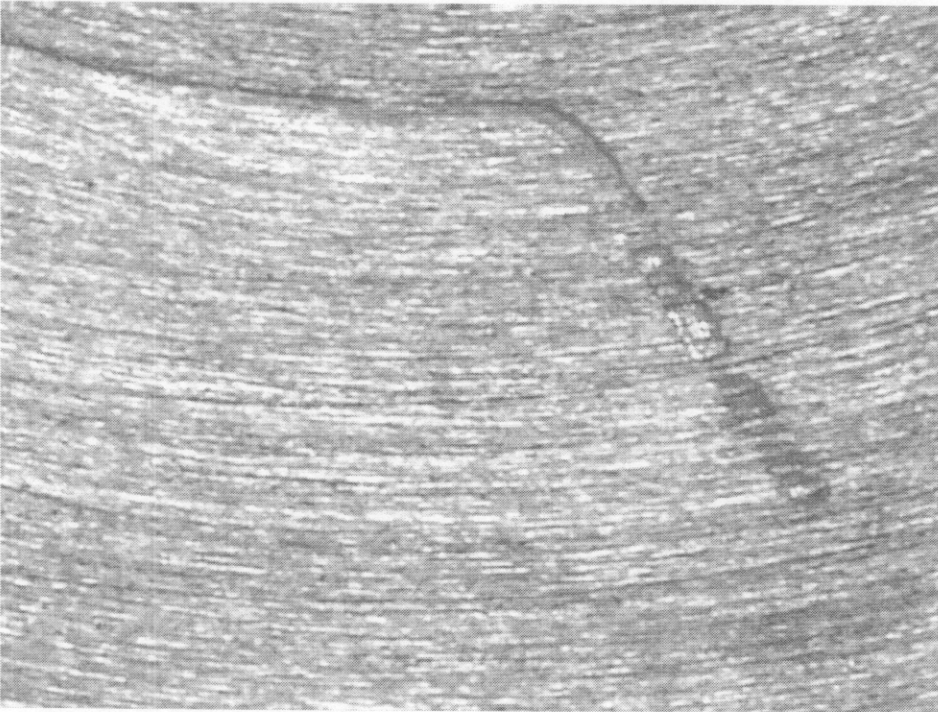
Figure 8: *A view of the witness marks at higher magnification.*
