**NATIONAL TRANSPORTATION SAFETY BOARD
OFFICE OF AVIATION SAFETY
WASHINGTON, D.C. 20594**

SYSTEMS GROUP CHAIRMAN'S FACTUAL REPORT

NTSB ID No.: DCA11IA015

Location: Jackson Hole Airport (JAC), Jackson Hole, Wyoming
Date: December 29, 2010
Time: About 1138 Mountain Standard Time (MST)
Aircraft: Boeing 757-200
Registration Number: N668AA
Serial Number: 25333

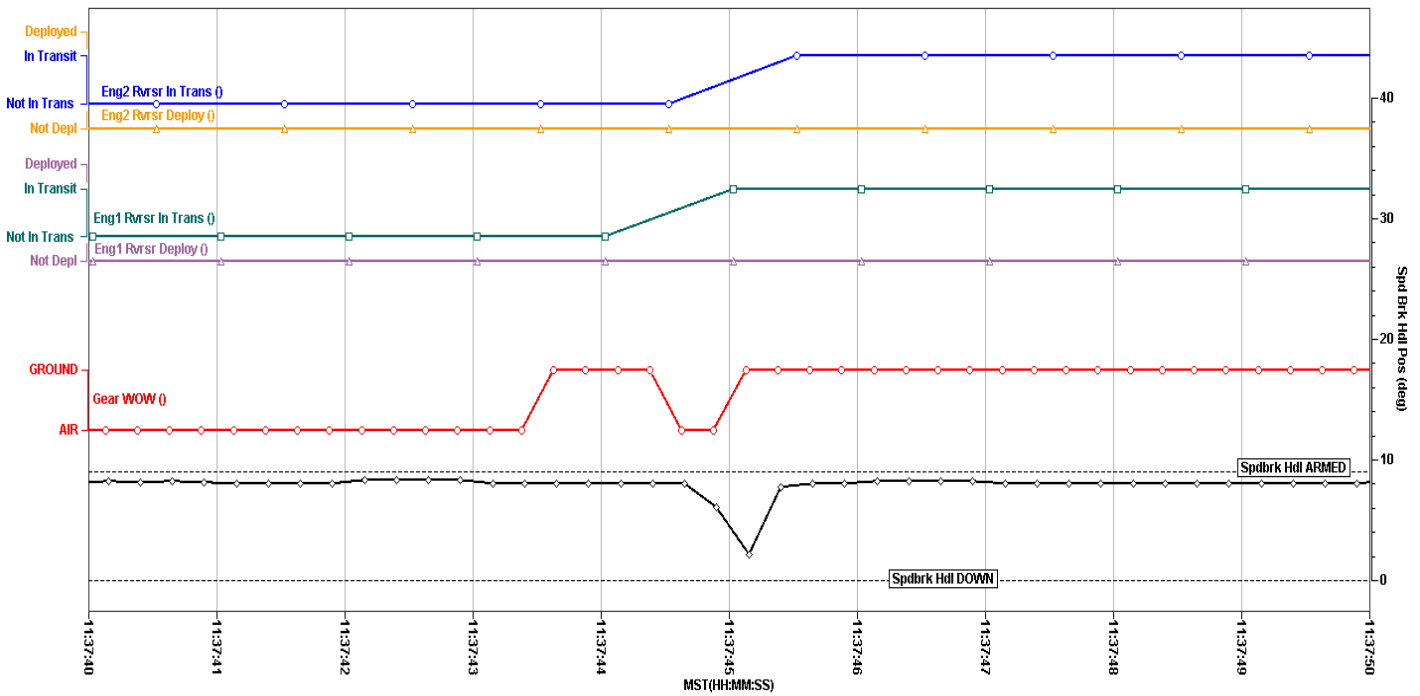
Figure 7 Data from December 29, 2010 landing in Jackson Hole, Wyoming

A review of the data from the fourteenth landing (Jackson Hole) indicates that the airplane touched down at 11:37:36 MST. Upon touchdown, the air/ground discrete transitioned to “Ground” for about one second (Figure 7). While indicating “Ground”, the speedbrake lever position remained at about 8 degrees. Approximately one second later, the air/ground discrete indicated “Air” for about 0.5 seconds before transitioning back to “Ground” for the remainder of the landing. During the momentary transition to “Air”, the speedbrake lever retracted from about 8 degrees to about 2 degrees. When the air/ground discrete indicated “Ground” a second time, the engine 1 (left) thrust reverser discrete indicated “in-transit” followed by the engine 2 (right) thrust reverser discrete indicating “in-transit” and the speedbrake lever extended from about 2 degrees to about eight degrees “armed” and remained at eight degrees throughout the remainder of the landing.

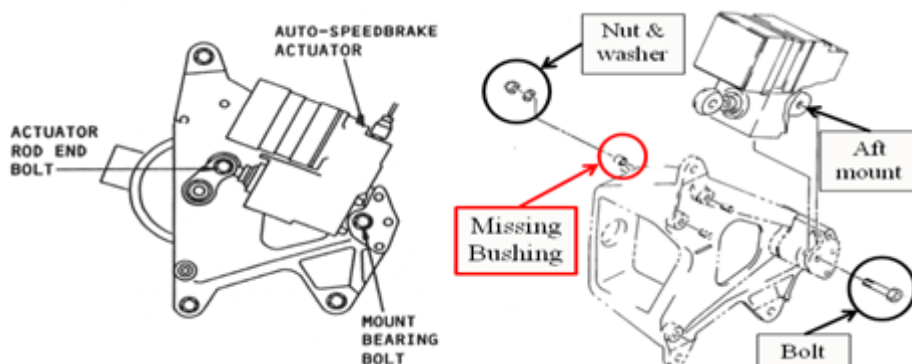
Figure 8 Schematic showing the location of the missing bushing

On January 4, 2011, the speedbrake lever was moved aft out of its down detent to a position that “visually” appeared to be “armed”. However, a visual inspection of the speedbrake actuation mechanism showed that the detent lever roller was not in its fully engaged position within the switch operating cam detent; the roller was found positioned on the down side of the roller detent. It was noted that when the speedbrake lever was cycled, the lever roller and the notch in the cam did not always align the same.

Troubleshooting found that when a rotational force (by hand) was applied to the auto speedbrake actuator output, the entire speedbrake mechanism assembly (inner shaft, outer shaft, and actuator) could be moved. The auto speedbrake actuator was not providing a solid ground point. Further inspection revealed that the motion was possible because the rear attachment hardware for the auto speedbrake actuator was loose. The actuator’s aft mount bearing bolt and the attachment hardware (nut and one washer) were removed from the actuator’s attachment point. A review of Boeing IPC 27-62-51-02, “Lever installation-speed brake control and actuator”, dated May 28, 2007, indicated that a bushing should have been present in the installation (Figure 8). According to American Airlines maintenance records, the actuator, S/N 1543, was installed on January 31, 2008 in John F. Kennedy International Airport (JFK), Queens, New York.

The actuator's aft mount bearing bolt and the attachment hardware were then reassembled with the required bushing. The installation of the bushing fixed the discrepancy.

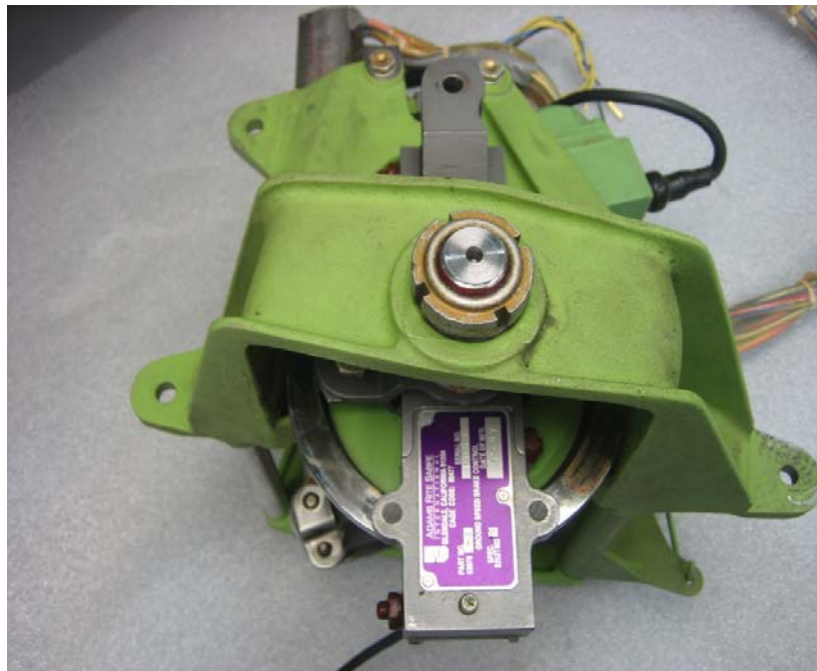
Figure 11 The GSBCA after removal from the speedbrake assembly

The speed brake mechanism assembly was dismantled to remove the GSBCA from the assembly. Refer to Figure 11. Once removed, an external inspection of the GSBCA revealed that it remained sealed with its original lock wire and anti-tamper compound. Adams Rite records indicated that the GSBCA was manufactured in September 1997, and had not been returned to Adams Rite Aerospace since that date.

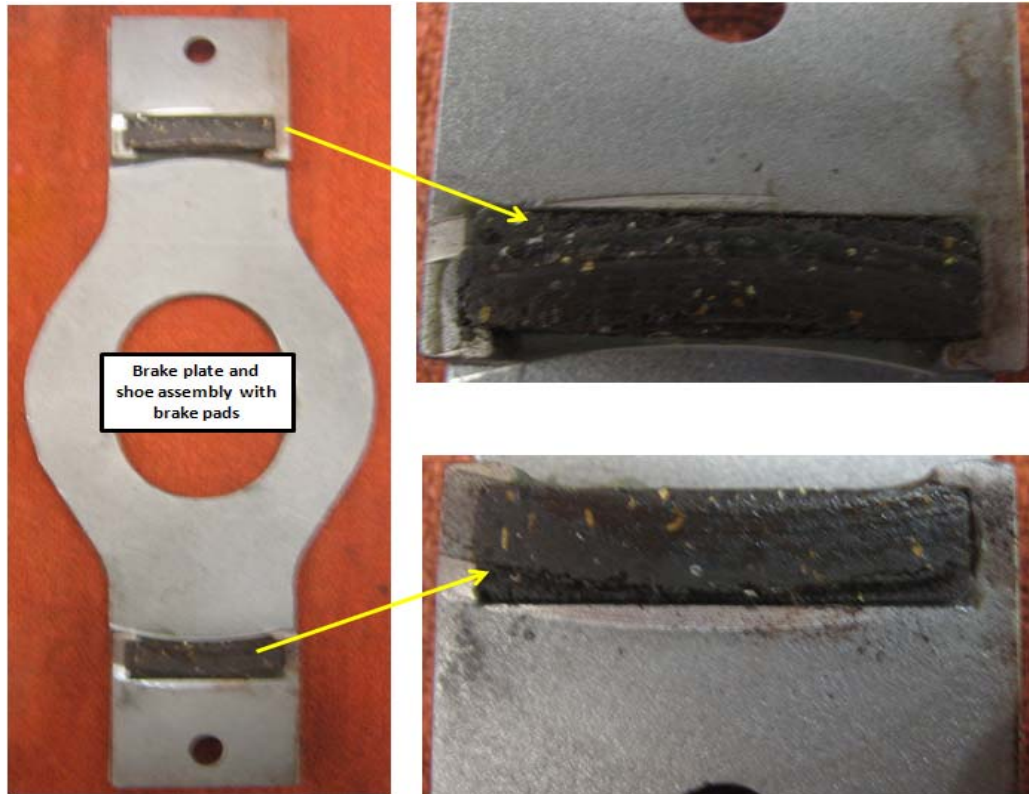
Figure 13 Brake plate assembly

Radial burnishing was noted on the semi-circular brake pads, with a light oil-like film present on all friction surfaces. Refer to figure 13 for a view of the brake pads. Removal of the input lever assembly revealed the four circular brake pads, which displayed similar burnish markings as the brake pads on the brake plate and shoe assembly. Refer to figure 14 for a view of the brake pads.

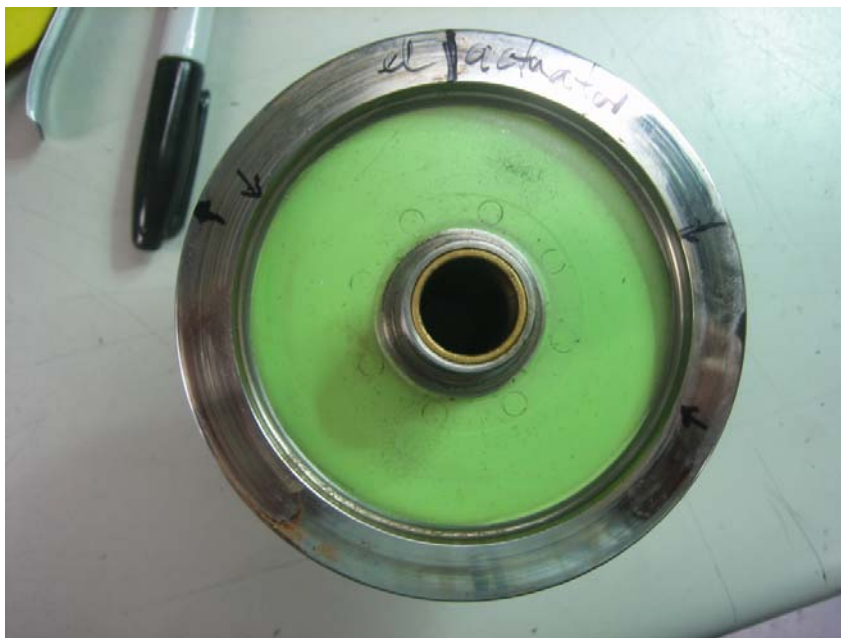
Figure 15 Hub assembly showing the location of the flat spots

Three flat spots were noted on the inner race of the hub assembly with one flat spot noted on the outer race. The flat spot positions were measured from an index line (center of hub assembly through the center of the clevis). The inner wear points measured clockwise at the 75, 118, and counterclockwise 56 degrees point relative to the index. The outer race spot was measured counterclockwise 65.3 degrees relative to the index. Refer to Figure 15. The output assembly appeared free of damage.

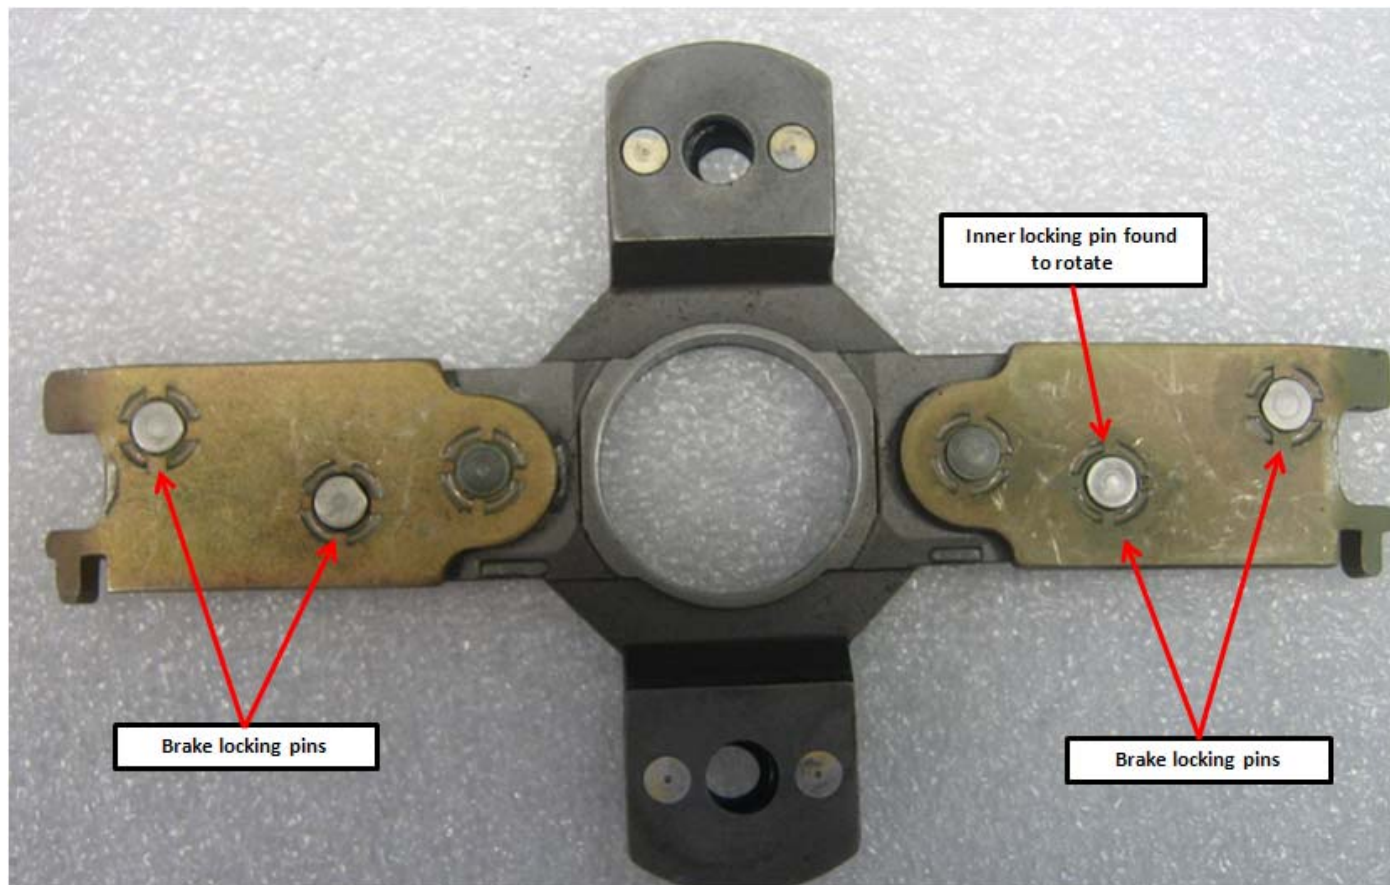
Figure 16 Output lever and shoe assembly

The outer brake locking pins and the inner brake locking pin adjacent to output lever displayed flat spots on their friction surfaces. The inner brake locking pin, located opposite to output lever, displayed no flat spots and was found to rotate within its plate (Figure 17).

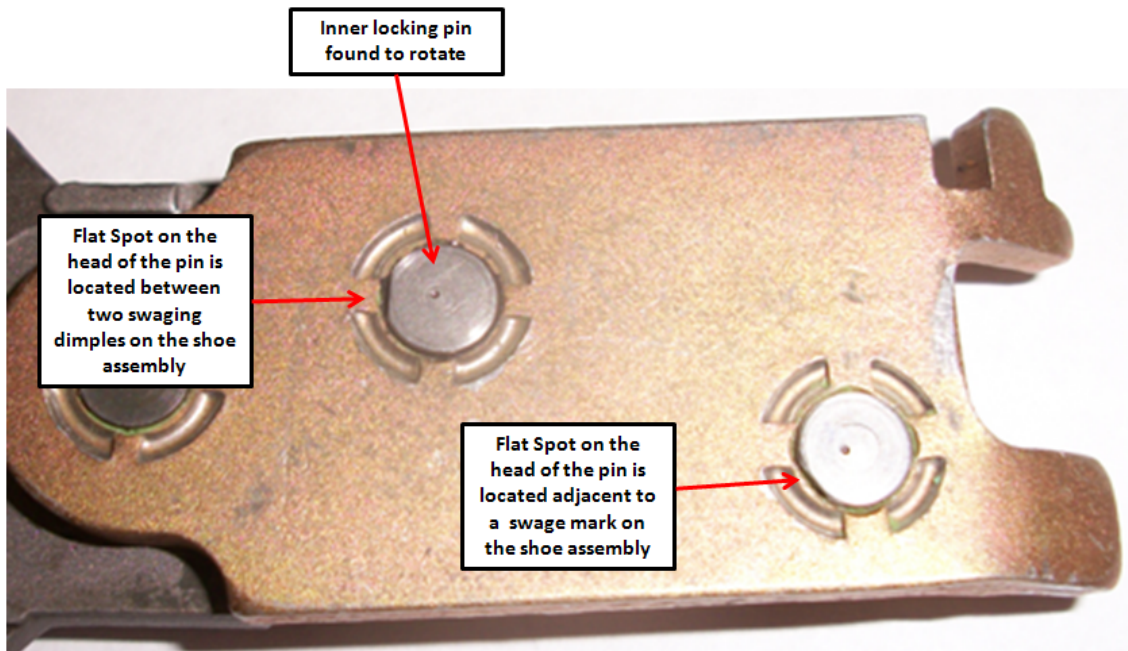
Figure 17 Brake pins installed on the GSBCA

Grease was subsequently removed from the surfaces of each brake locking pin and all pins were visually examined. The head of each pin appeared to incorporate anti-rotation flats consistent with design drawings. Examination of the staking area on the shoe plates revealed a segmented 4-tooth staking die had been utilized (Figure 17). A review of the manufacturer's drawing for the shoe plate assembly revealed that there was no information denoting the need to orient the anti-rotation flats on the pins with the swage prior to staking. The drawing also indicates that the 4-tooth staking die is an alternate method for attaching the pins to the shoe plate. The fully circular swaging method referenced in early drawing revisions is also acceptable.

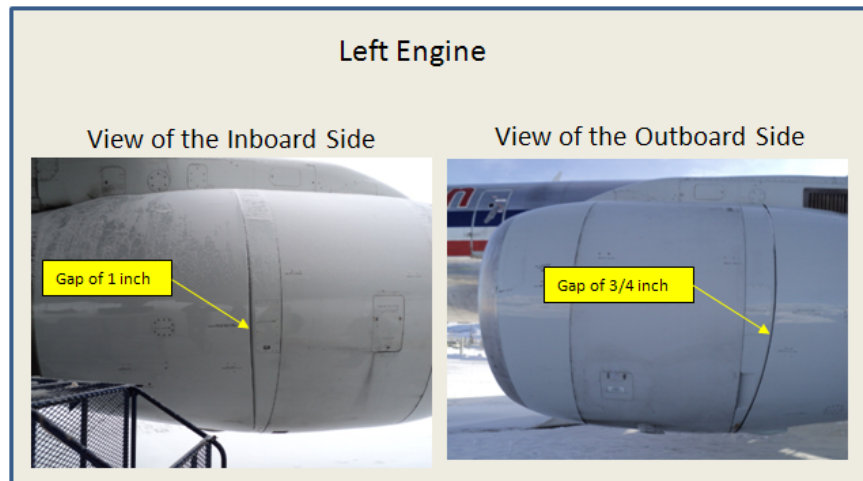
Figure 21 Position of the translating sleeves on the left engine

- Inboard side translating sleeve remained open about 1 inch. There was equal distance between the upper and lower leading edge.
- Outboard side translating sleeve remained open about $\frac{3}{4}$ inch. There was equal distance between the upper and lower leading edge.

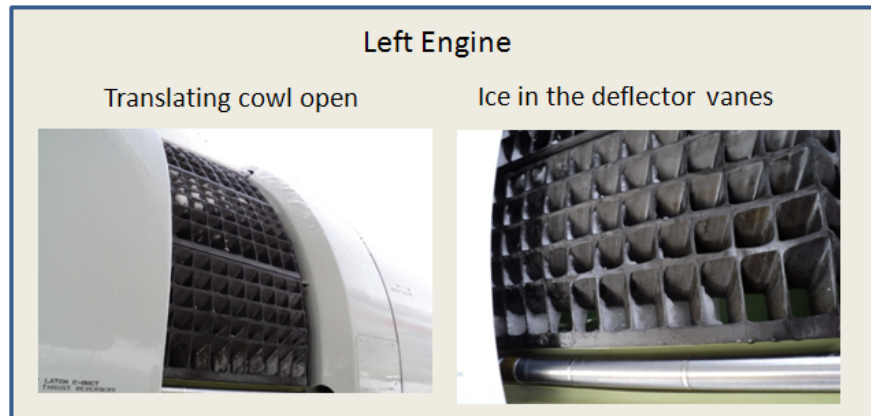
Figure 22 Ice in left engines thrust reversers

Prior to actuating the translating sleeves hydraulically, a visual inspection (through the gap) was conducted to ensure nothing would restrict their movement. The inspection found a significant amount of ice build-up between the left engine translating sleeves. Using propane heaters, heat was applied to the area around the thrust reversers in an attempt to melt the ice. After approximately 3 hours of applying heat, the translating sleeves could be manually extended using a hand crank at the external drive socket on the left thrust reverser. Once fully opened, inspection found significant quantities of ice within the reverser assembly and cascade elements (Figure 22).

Using propane heaters, heat was applied to the area around the thrust reversers to melt the ice within the reverser. Once melted, the reverser was fully closed (stowed) using the left hydraulic system. The reverser was then cycled by moving thrust reverser (piggyback) levers. During this procedure, the speedbrake handle moved fully aft and the ground spoilers deployed when the thrust reverser (piggyback) levers were moved to their interlock position.

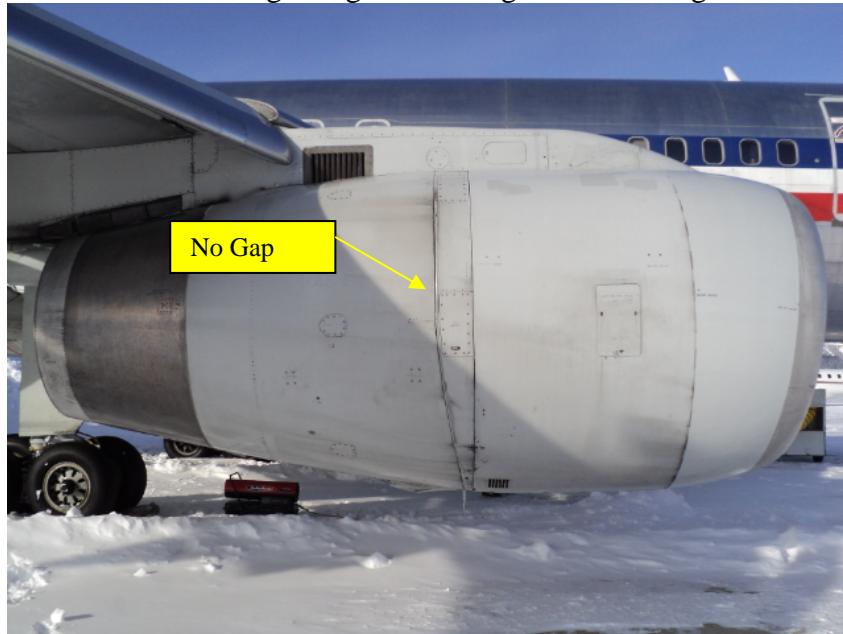
Figure 23 View of the right engine showing the translating sleeves closed

Using the BITE capability of the PSEU, the position of the Number 2 engine's auto stow sensors indicated a NEAR condition, indicating that translating sleeves were fully stowed. Inspection of the Number 2 engine's translating sleeves found that both the inboard and outboard translating sleeves were fully stowed (Figure 23) and that all three lock indicators were found in their locked position.

The translating sleeves were manually opened about 12 inches using a hand crank. A visual inspection found significant amounts of ice within the reverser assembly similar to the amount of ice found in the left engine. Using propane heaters, heat was applied to the area around the thrust reversers to melt the ice.
