**NATIONAL TRANSPORTATION SAFETY BOARD
OFFICE OF AVIATION SAFETY
WASHINGTON, D.C. 20594**

SYSTEMS GROUP CHAIRMAN'S FACTUAL REPORT

NTSB ID No.: DCA09MA021

Location: Denver International Airport
Date: December 20, 2008
Time: About 18:18 PM Mountain Standard Time (MST)
Aircraft: Boeing 737-500

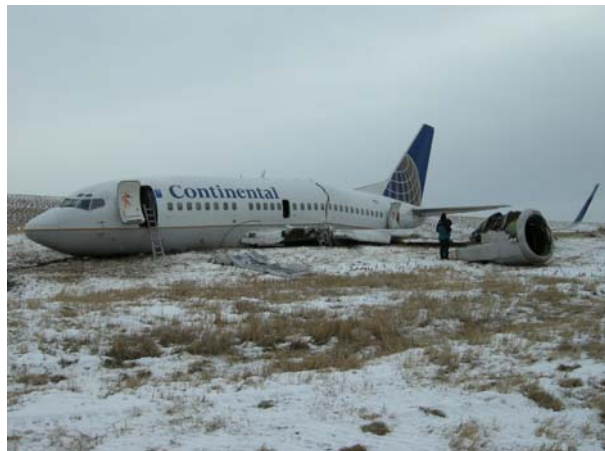
Figure 1 Photograph of N18611 at the accident site

Airplane N18611 came to rest essentially intact in a drainage basin about 40 feet below the runway elevation. The fuselage, wings, and engines sustained extensive impact damage resulting in fuselage and wing fracture, buckling, and major component separation (Figure 1). Additionally, during the crash sequence, both main landing gears and the left engine separated from the wings. Finally, the nose landing gear (NLG) strut was driven aft into the E&E bay resulting in the fuselage collapse and denying wheel well access.

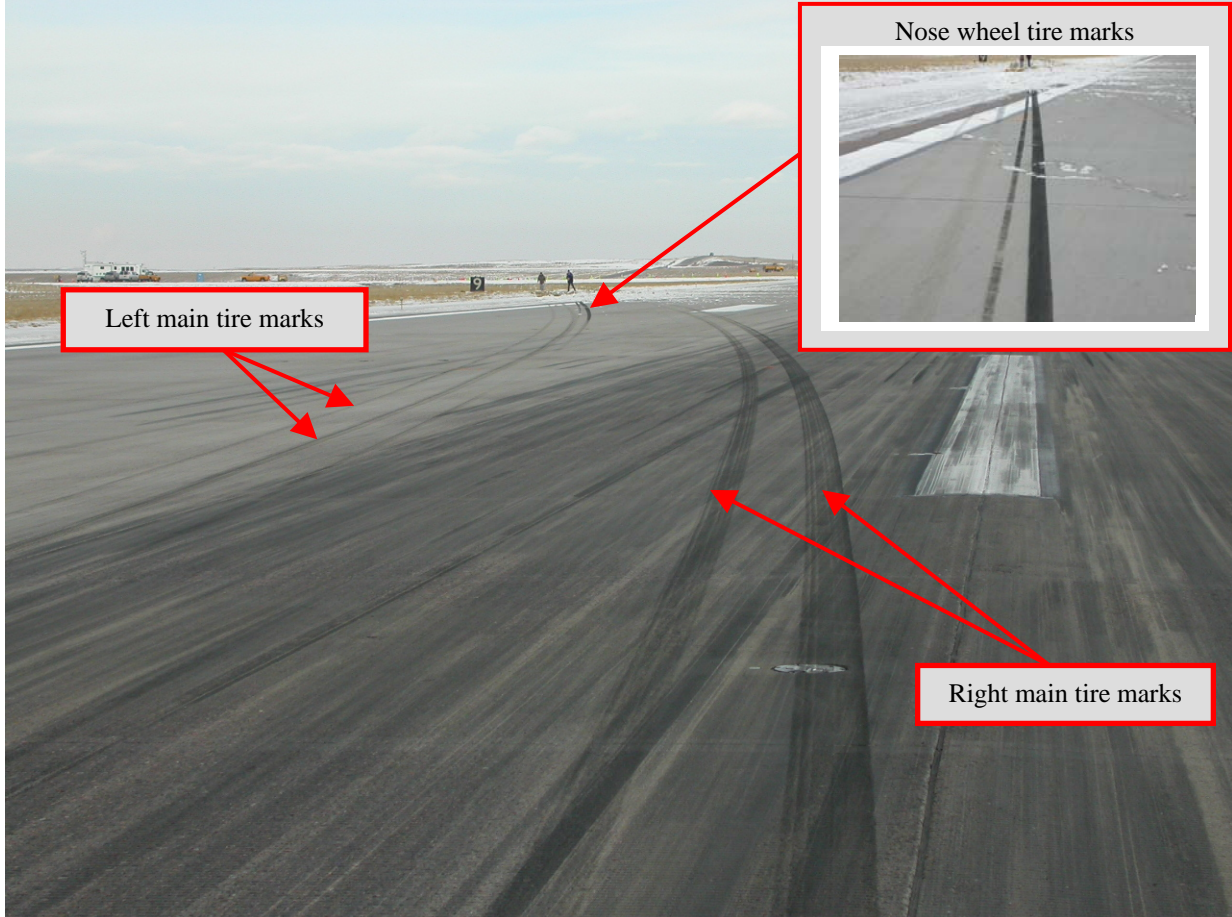
Examination of runway 34R revealed tire deposits on the runway surface near the area where N18611 veered off the runway at approximately 2,500 feet from the threshold. Tire deposits consistent with those from the left and right main landing gear were observed on the runway surface starting at approximately 1,910 feet from the threshold and continued approximately 600 feet in a direction towards the left side of the runway (Figure 2). Tire marks consistent with those from the nose gear were observed on the left side of the runway near the point of runway excursion. The main gear tire marks continued through a grassy area at an approximate angle of 10° to the left of the runway centerline, with no nose gear mark visible.

Figure 2 Tire marks on runway 34R

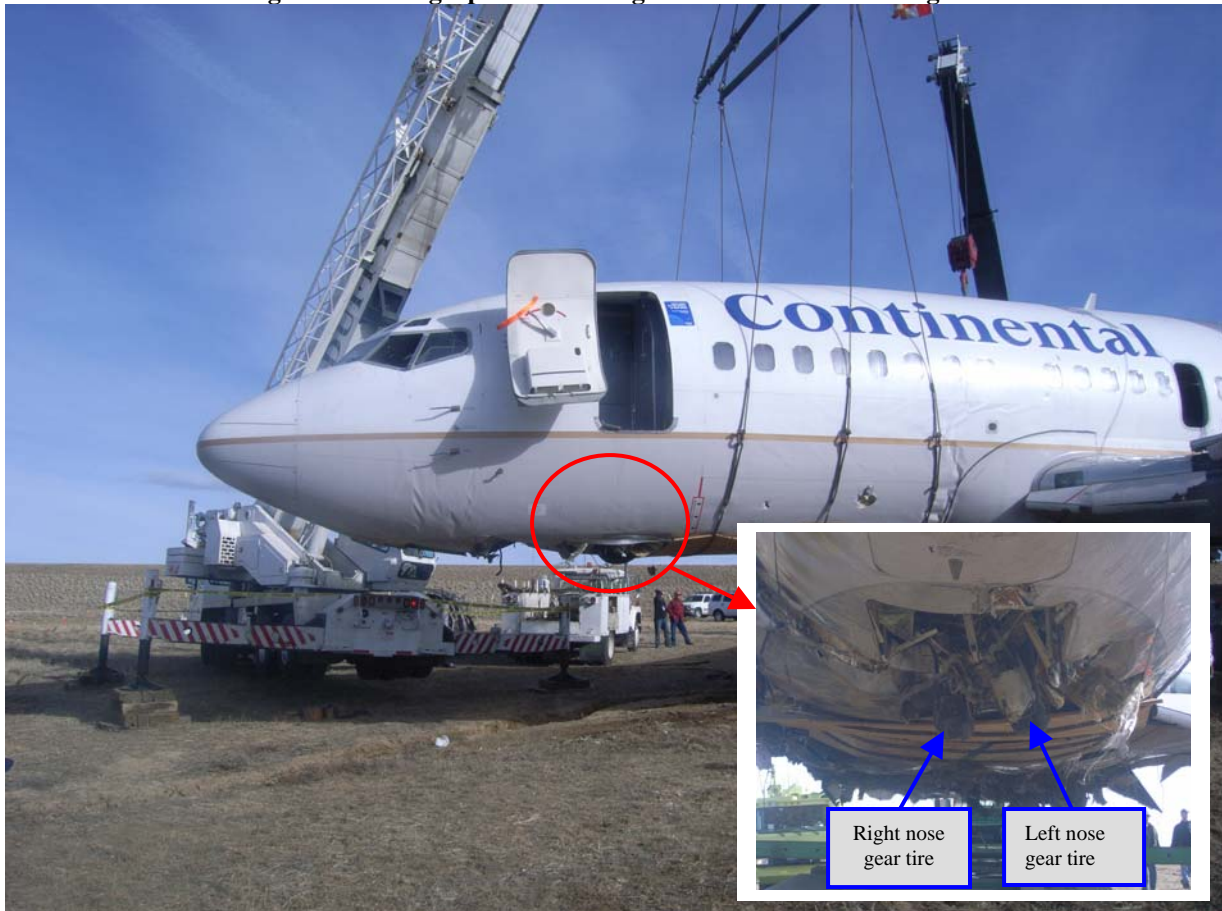
The NLG was found folded aft and impacted into the lower fuselage (Figure 3). The tires had entered the main electrical equipment (“E/E”) compartment through the E/E door and frame, lodging on the edge of the doorframe. The structure between the nose gear wheel well and the E/E door was found crushed upward and around the displaced NLG strut. Both the forward and the left side E/E racks were found displaced upward.

The aft portion of the NLG wheel well, where the nose gear shock strut trunnions are located, was found displaced upward approximately 12 inches, thus allowing the gear to pivot aft without fracturing either the upper or lower drag braces (both of the drag braces were found damaged, but intact). All gear trunnion points (upper drag brace trunnions and shock strut trunnions) were found intact and rotated without difficulty using hand pressure.

Figure 3 - Photograph of the nose gear folded into the fuselage

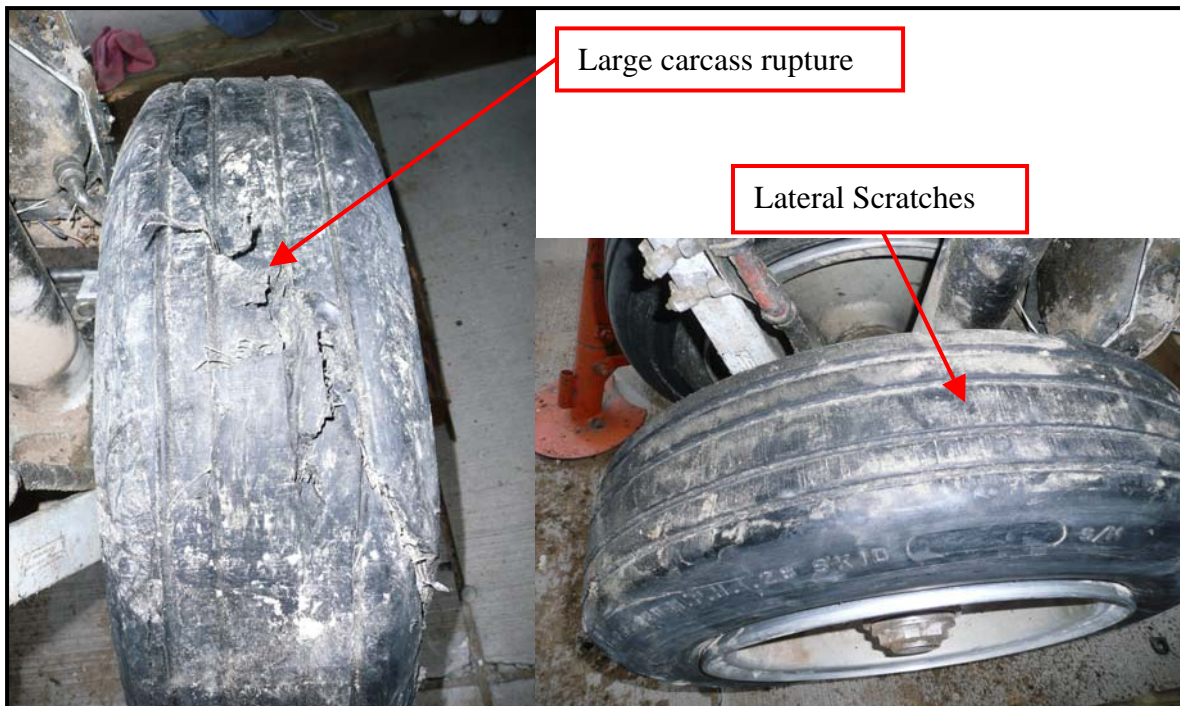
The right nose wheel tire was found deflated and contained a large carcass rupture extending from shoulder-to-shoulder (Figure 4). The center of the rupture was in the crown of the tire with broken cords not on the bias angle of the tire, which is consistent with puncture or foreign object damage. The tire had significant lateral marks (scratches) on the surface of the tread around the full circumference of the tire. The outboard side of the innermost tread groove had notable damage, consistent with runway abrasion. This damage resulted in a 45-degree chamfer worn off of the top edge of this tread groove. The tire had a discolored area of about 2 inches by 1 inch on its outboard sidewall. The appearance of this area is consistent with heat damage but not from runway abrasion. It appears more consistent with external burn damage. The retread level of this tire was R-6 (sixth retread).

Figure 4 - Photograph of the rupture in the right nose gear tire

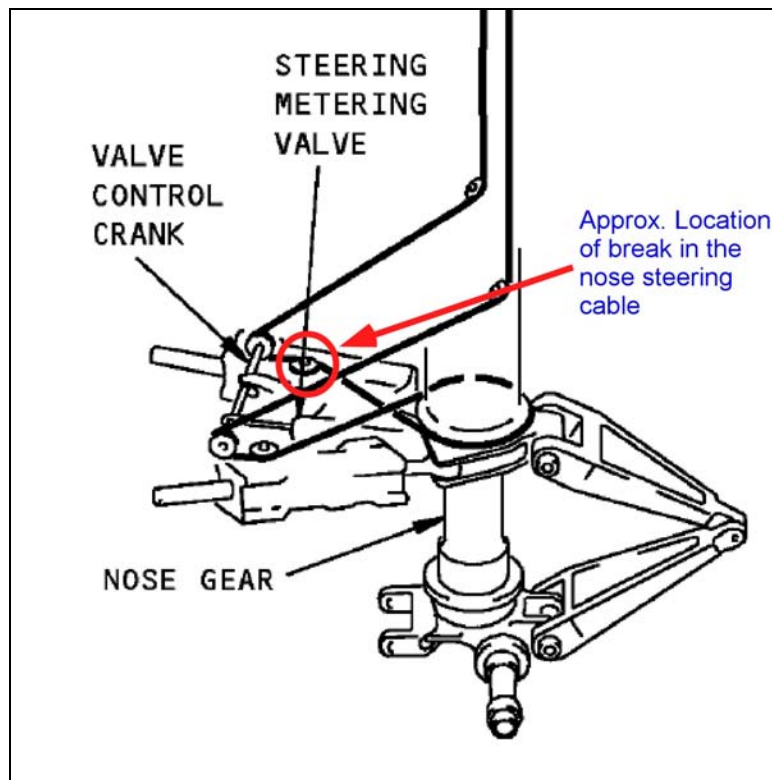
Inspection of airplane N18611's NWS cable revealed that cable NWSB (right section of cable NWSA/B) was broken in the area of the horizontal pulley mounted on the right side of the lower steering plate (Figure 6) with the remaining cable found intact. Boeing states a cable break at this location may result in the nose gear steering (rotating) left approximately seven degrees. Cable (NWSA/B) was inspected in the area of the pressure seal located at the left strut trunnion. No notable wear or damage was found on the

Figure 6 Figure showing the location of the cable break

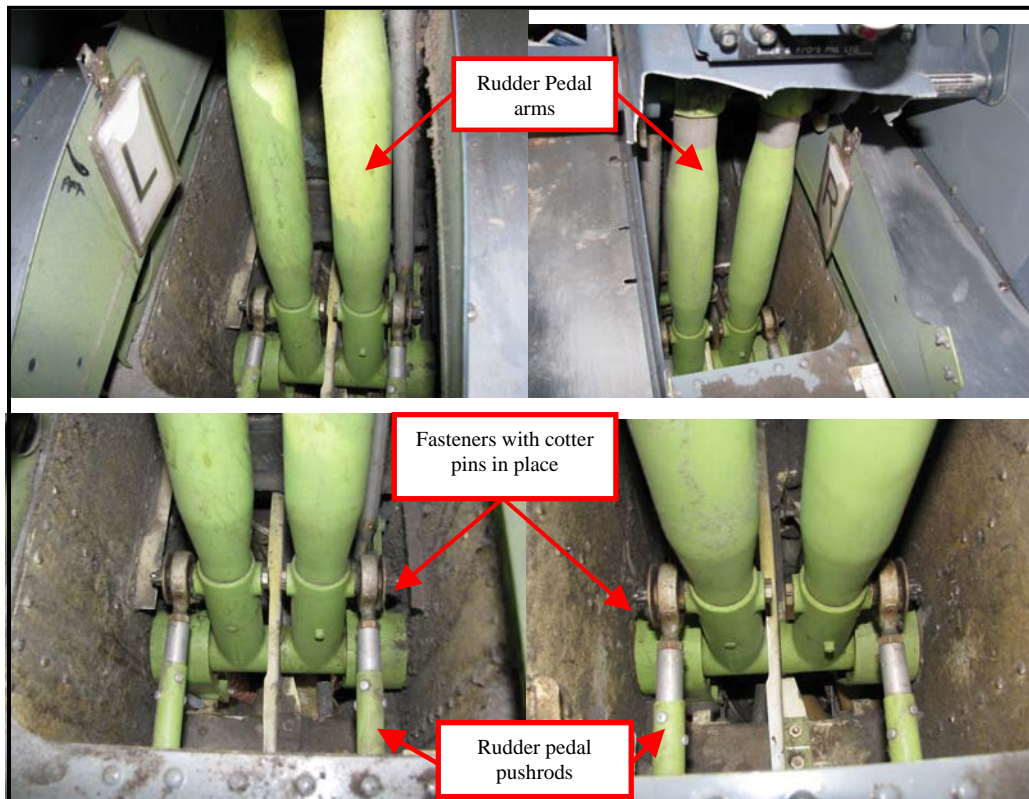
Visual inspection of the captain's and the first officer's rudder pedal assemblies revealed all attachment hardware was in place and intact as required by AD 2001-22-13. There was no evidence of binding or loose hardware ([Figure 8](#)).

Figure 8 Photograph's of rudder pedal control

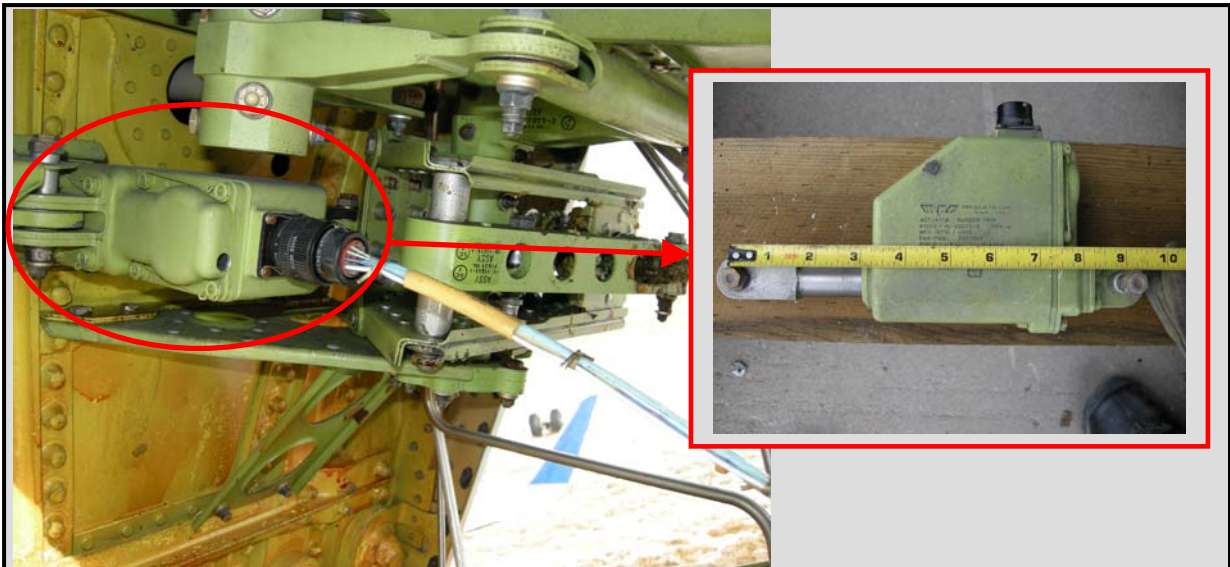
Visual inspection revealed the rudder trim knob remained centered and the trim indicator displaying the “OFF” flag. Visual inspection of the rudder trim actuator revealed it was intact and remained connected to the rudder feel and centering unit and to fixed airplane structure via attachment hardware (Figure 10). Measurements of the “as found” actuator extension were taken to determine the last commanded position of rudder trim. Using a tape measure, the distance from bolt to bolt on the trim actuator was measured and found to be about 9.25 inches.

Figure 10 Photograph of the rudder trim actuator
