NATIONAL TRANSPORTATION SAFETY BOARD  
Office of Aviation Safety  
Washington, D.C. 20594

Systems Group Chairman's Factual Report

MIA-01-FA-029

Operator: American Airlines  
Location: Miami, Florida  
Date: November 20, 2000  
Time: Approximately 12:00 PM EST  
Airplane: Airbus A300-600, N14056

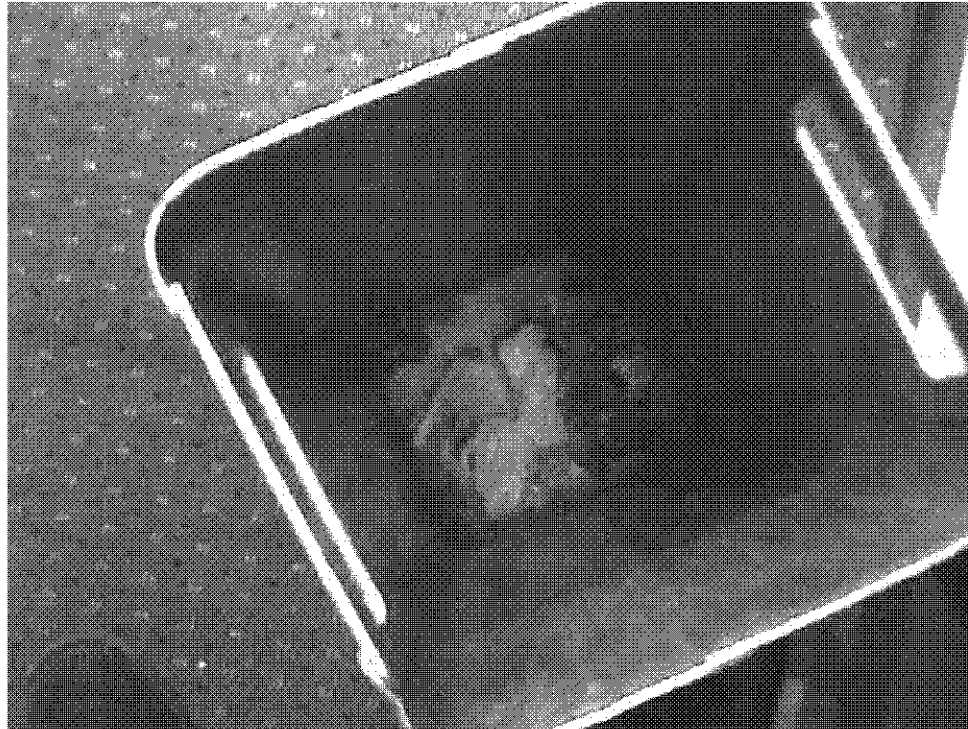
All 7 of the aircraft's lavatories were inspected to look for any signs of smoke or fire. The lavatories' waste bins, water heaters, and overhead spaces were all checked and no signs of soot or fire were found. A cigarette was found at the bottom of the waste bin for lavatory Y (see figure 1).

Figure 1 – Cigarette Found at the Bottom of the Waste Bin for Lavatory Y

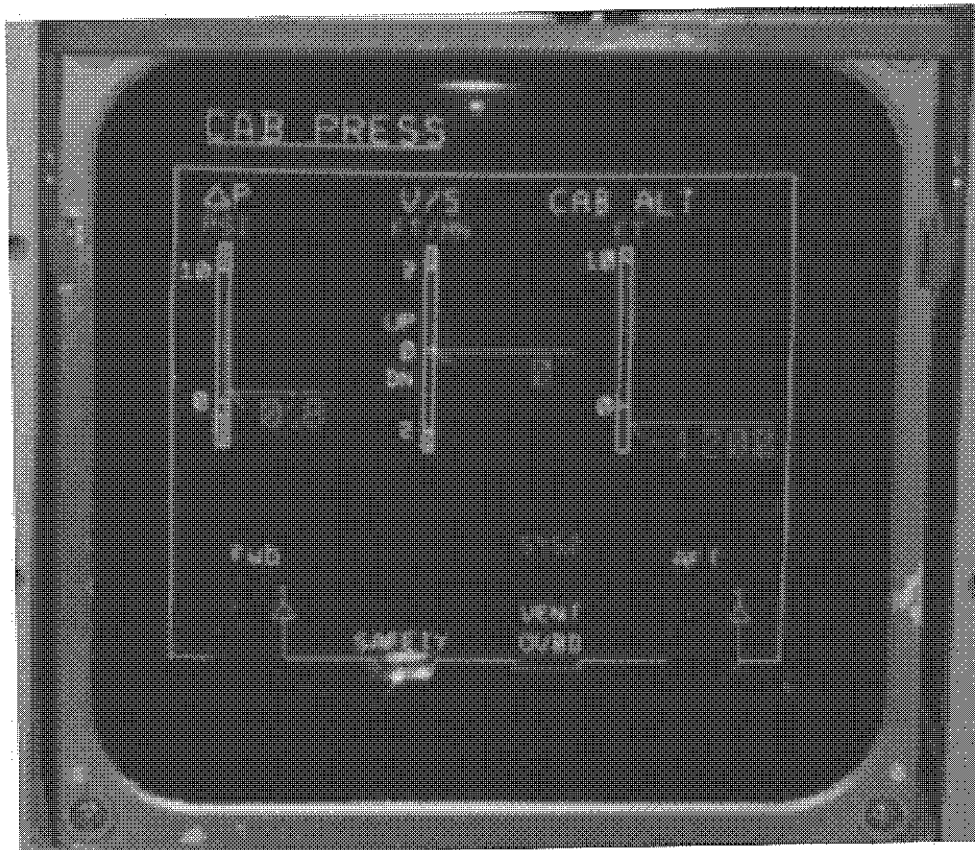
(4) During portions of this test point, the blanket blocking the forward outflow valve moved from the partially blocking position to a position where 90% of the valve was blocked. The automatic mode could not maintain the desired rate of climb, and the outflow valves were commanded to the full open

position. This resulted in an ECAM presentation where the cabin altitude was very low (and descending slightly) and the outflow valves were at the full open position (see figure 3). When the blanket was reset to the partially blocking position, the outflow valve moved towards the closed position, and contacted some of the wires on the outflow valve intake screen.

Figure 3 – ECAM Display of Cabin Pressurization Indicators and Controls with Both Outflow Valves Blocked by Insulation Blankets

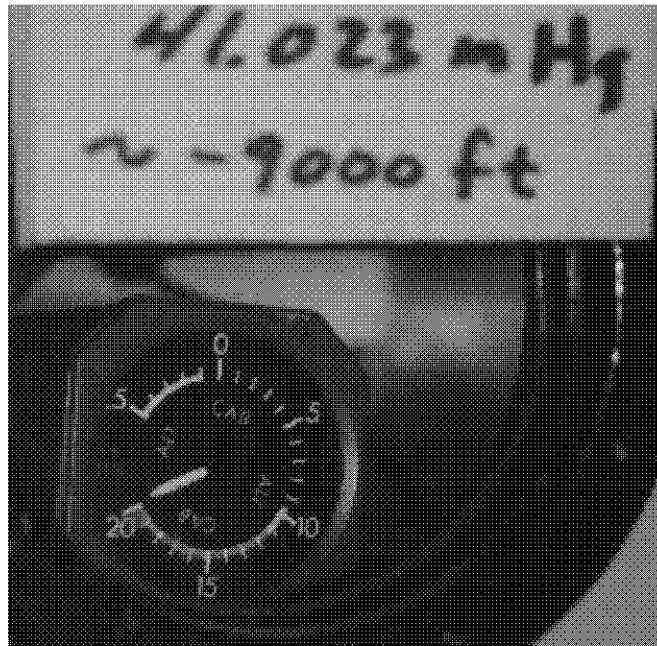
The cabin altimeter (pressure gauge) was bench tested in the American Airlines test laboratory on 11/30/00. The gauge was placed inside a pressure chamber, and the pressure was varied through a range of +20,000 ft to –11,000 ft. The cabin altimeter part number was 37000-3, the serial number was 246, and the control date was 12/88. The ambient pressure in the laboratory was 29.556 in Hg or 338 ft MSL. During the tests, the cabin altimeter indicated +20,000 ft when the actual pressure was approximately –9,000 ft (see figure 4).

Figure 4 – Cabin Altitude Indicator During Pressure Testing at 41.023 in. Hg (approximately –9,000 ft)

Testing of the cabin altimeter indicated that the cabin altimeter consistently read between 1000 and 1350 ft lower than the calibrated test equipment. These values were outside of the allowed tolerance bands for the component. The cabin altimeter was exposed to increased pressure to determine at what value of increased pressure the indicator would read 20,000 ft. This value was found to be 1351.9 mb (40.03 in. Hg or 19.61 psia). Disassembly of the unit did not reveal any evidence of mechanical stops that would stop the pointer at the ends of the marked ranges on the dial.

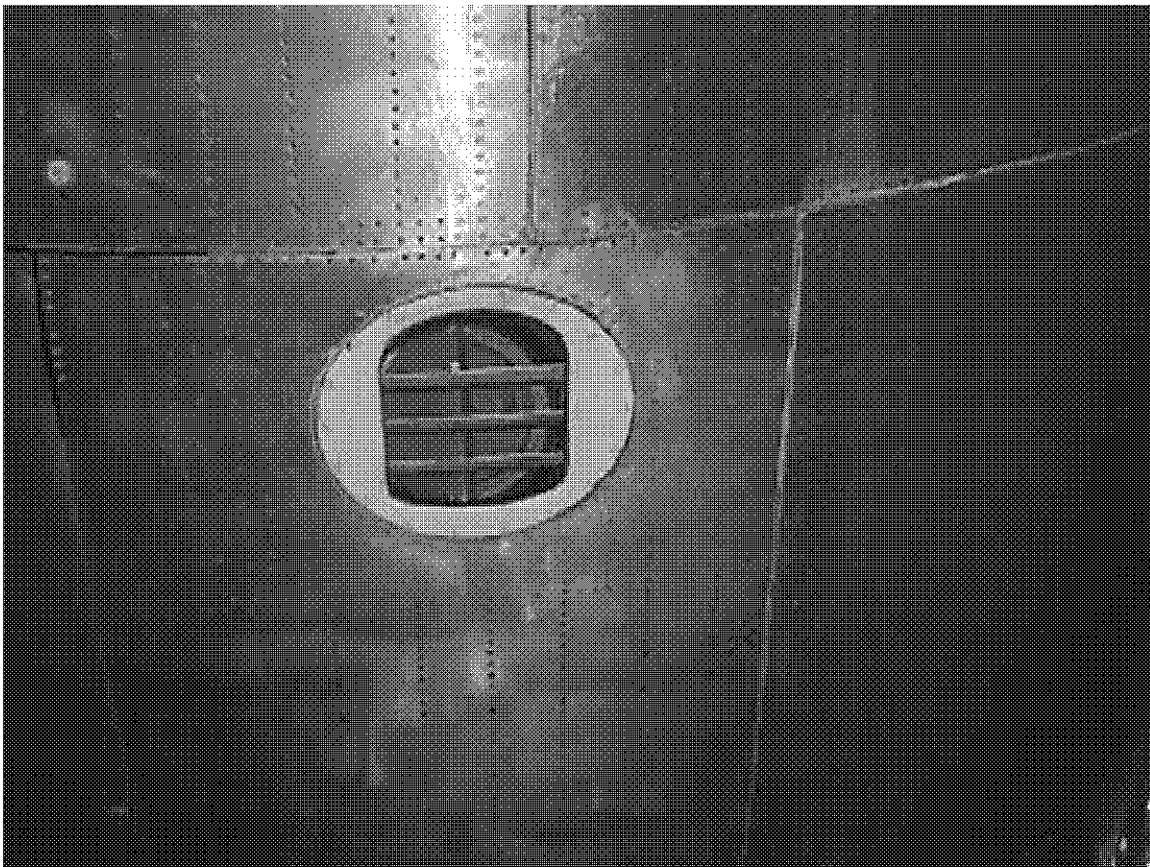
the flight crew. The aft outflow valve was noted to be in the fully closed position, and the forward outflow valve was in the  $\frac{1}{4}$  to  $\frac{3}{8}$  open position (see figures 5 and 6). Closer inspection of the aft outflow valve found that an insulation blanket was obstructing the intake side of the valve, and the blanket was drawn through the intake screen in some areas (see figures 7, 8, and 9). In addition, many of the insulation blankets in the compartment containing the aft outflow valve were displaced from their proper positions and were not secured in place (see figures 10, 11, 12, and 13). Closer inspection of the forward outflow valve found that an insulation blanket was partially obstructing the intake side of that valve (see figure 14). This insulation blanket had impressions on it that were of the same size and shape as the complete intake grill (see figure 15). Inspection of the compartment containing the forward outflow valve and the forward cargo compartment found that many of the insulation blankets in these compartments were displaced from their proper positions and were not secured in place (see figures 16, 17, and 18).

Figure 5 – Aft Outflow Valve as Found in Closed Position

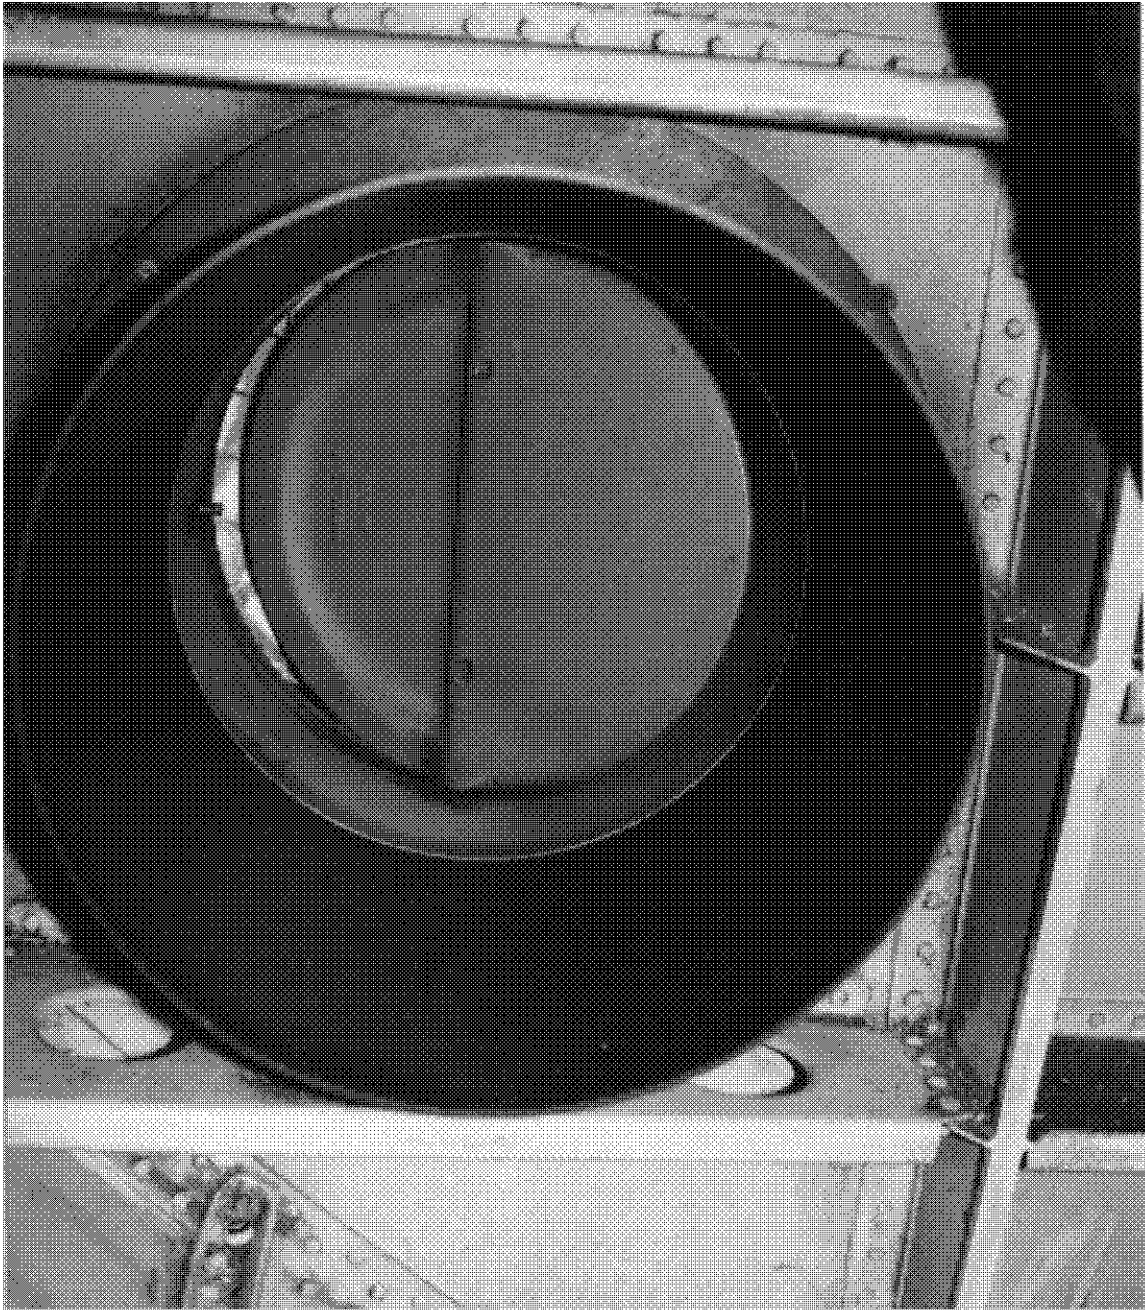
Figure 6 – Forward Outflow Valve as Found in  $\frac{1}{4}$  to  $\frac{3}{8}$  Open Position

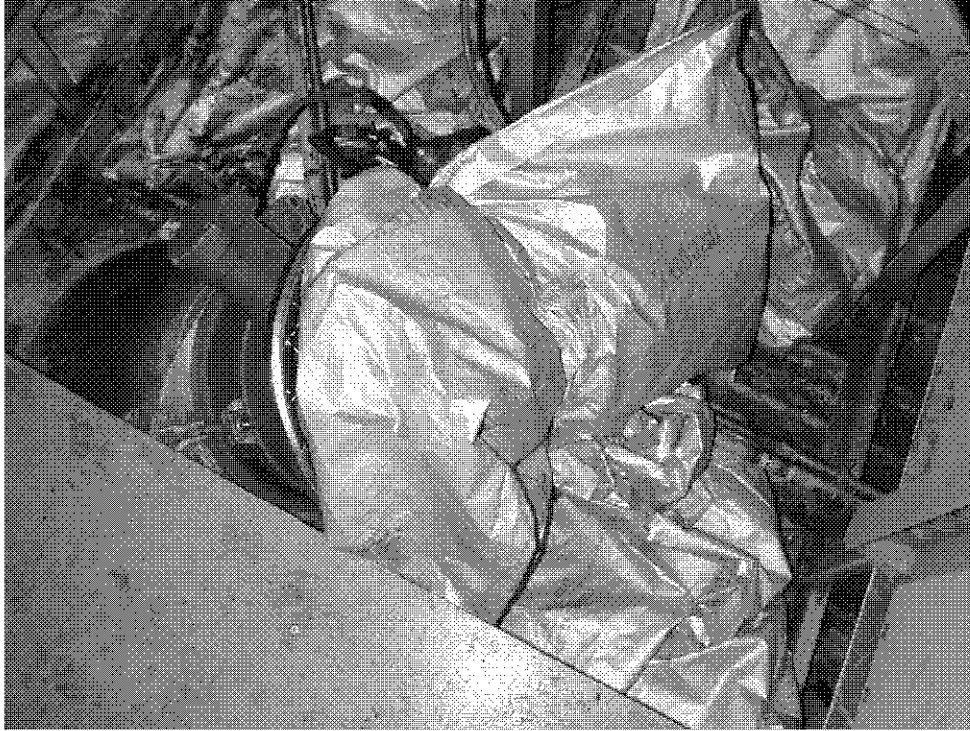
Figure 7 – Aft Outflow Valve With Insulation Blanket Obstructing Intake

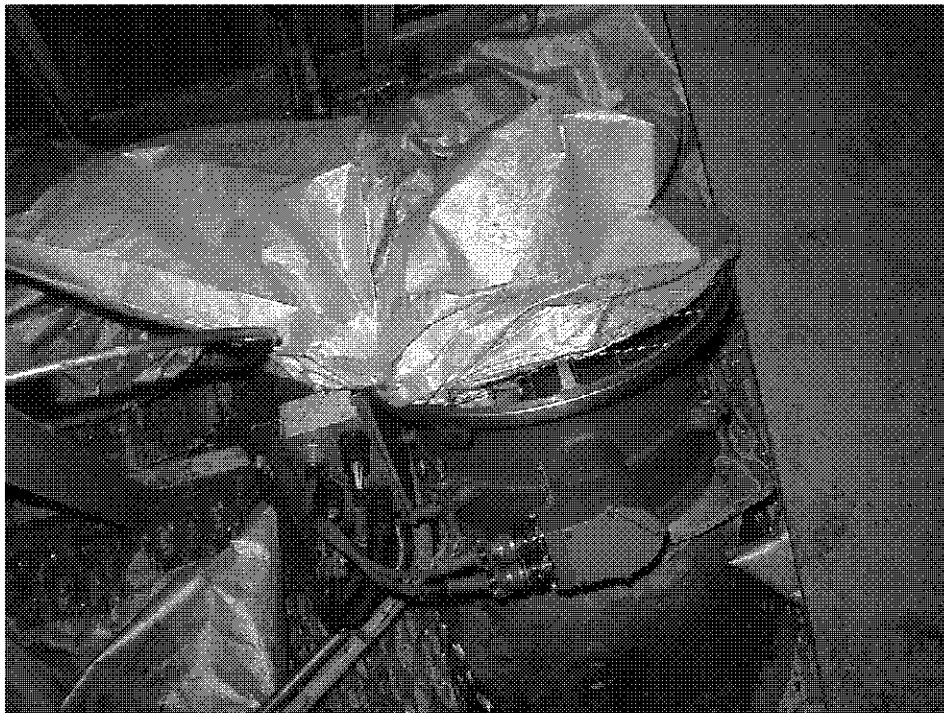
Figure 8 – Aft Outflow Valve With Insulation Blanket Obstructing Intake

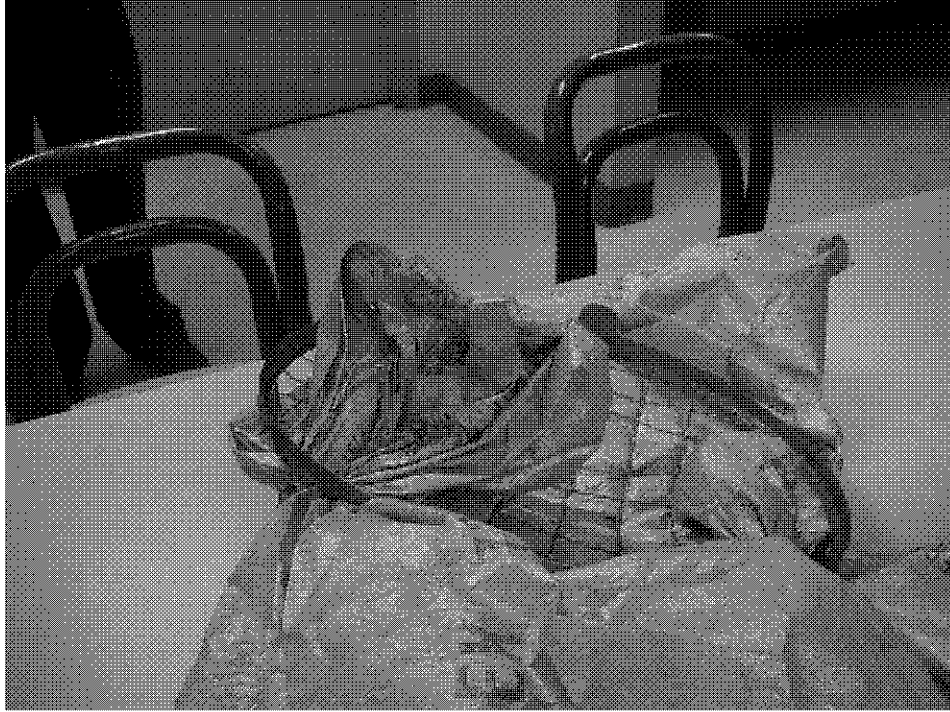
Figure 9 – Intake Screen From Aft Outflow Valve With Insulation Blanket Protruding Through The Intake Screen

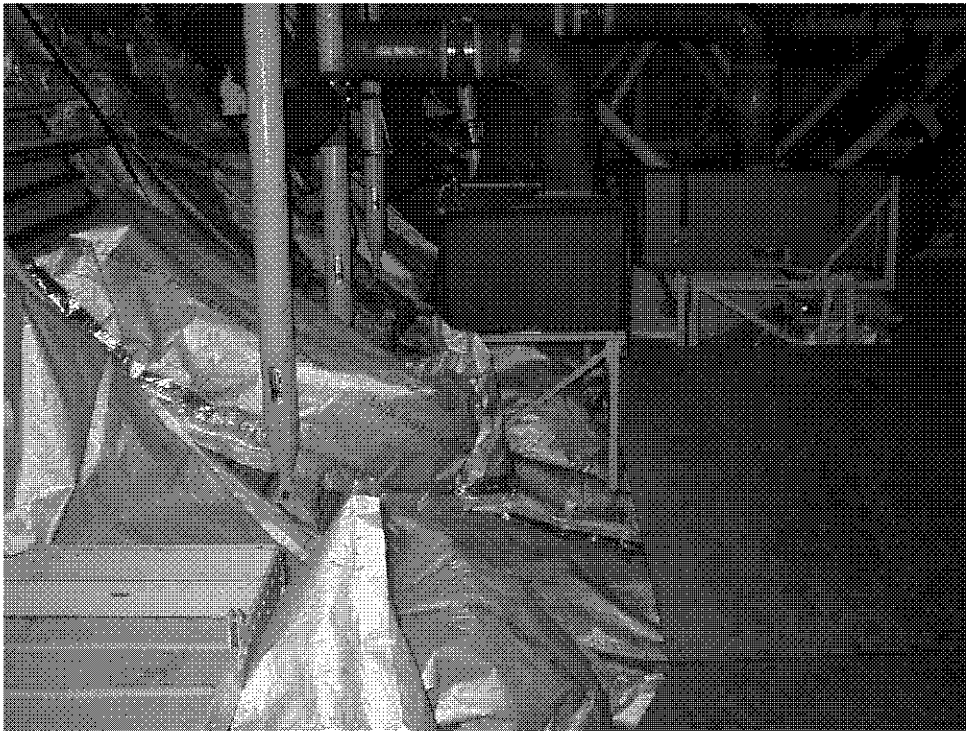
Figure 10 – Left Side Of Compartment Containing Aft Outflow Valve Showing Displaced Insulation Blankets

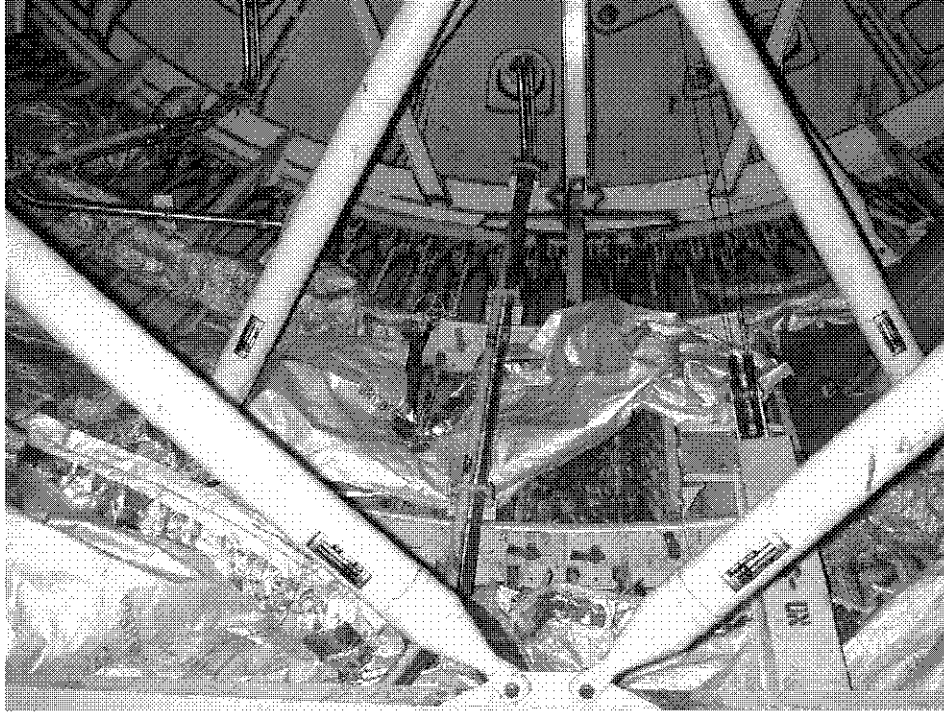
Figure 11 – Center Section Of Compartment Containing Aft Outflow Valve Showing Displaced Insulation Blankets

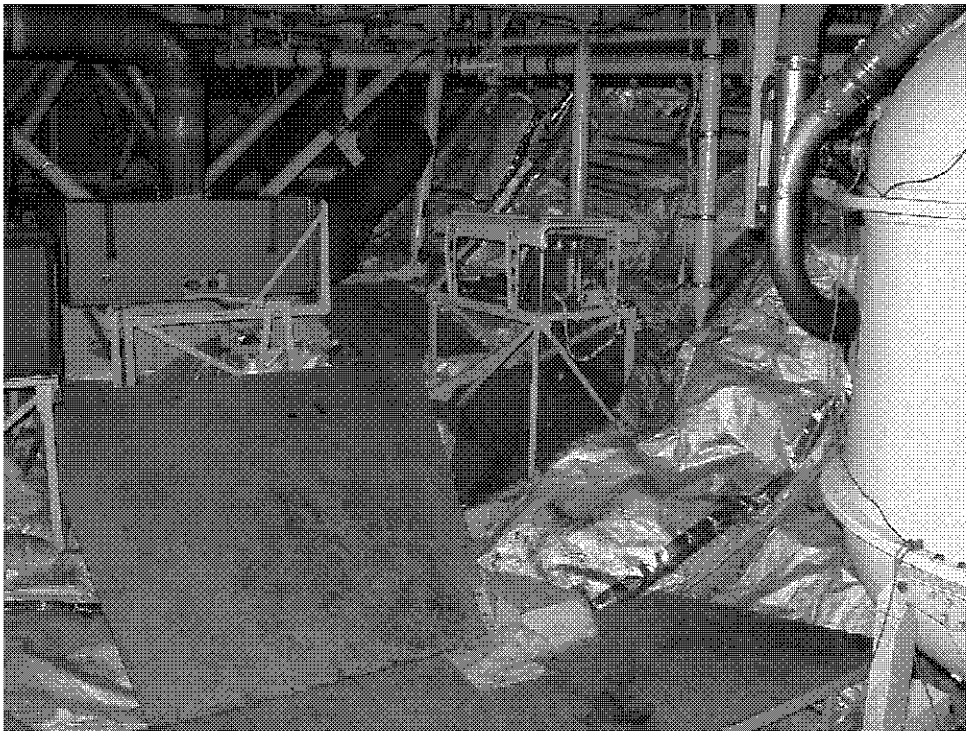
Figure 12 – Right Side Of Compartment Containing Aft Outflow Valve Showing Displaced Insulation Blankets

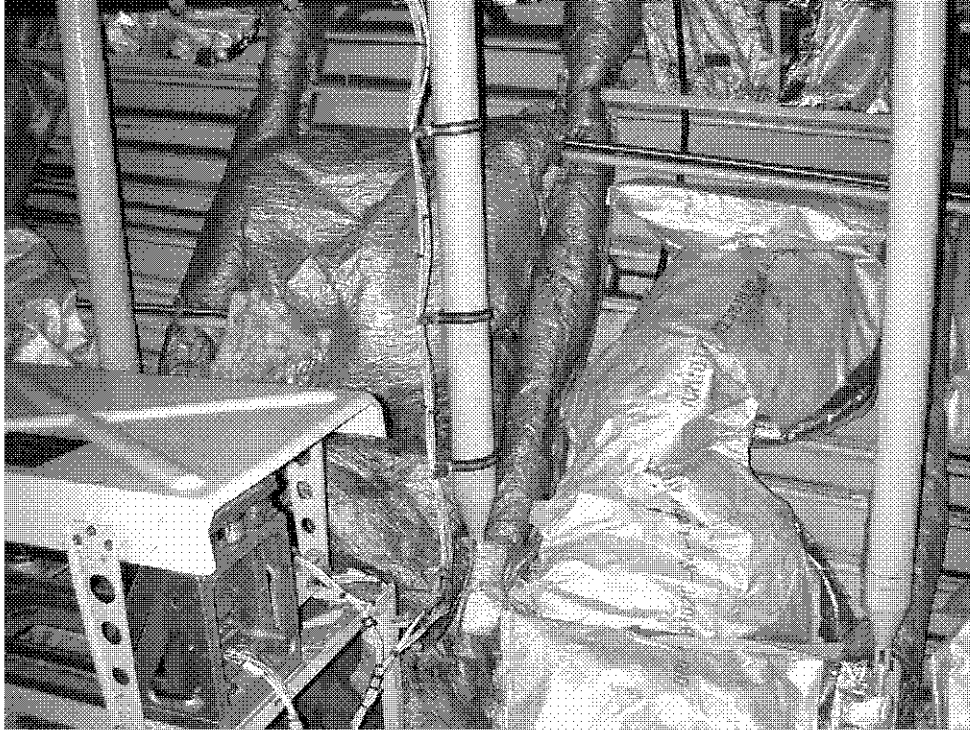
Figure 13 – Close Up View Of Right Side Of Compartment Containing Aft Outflow Valve Showing Displaced Insulation Blankets

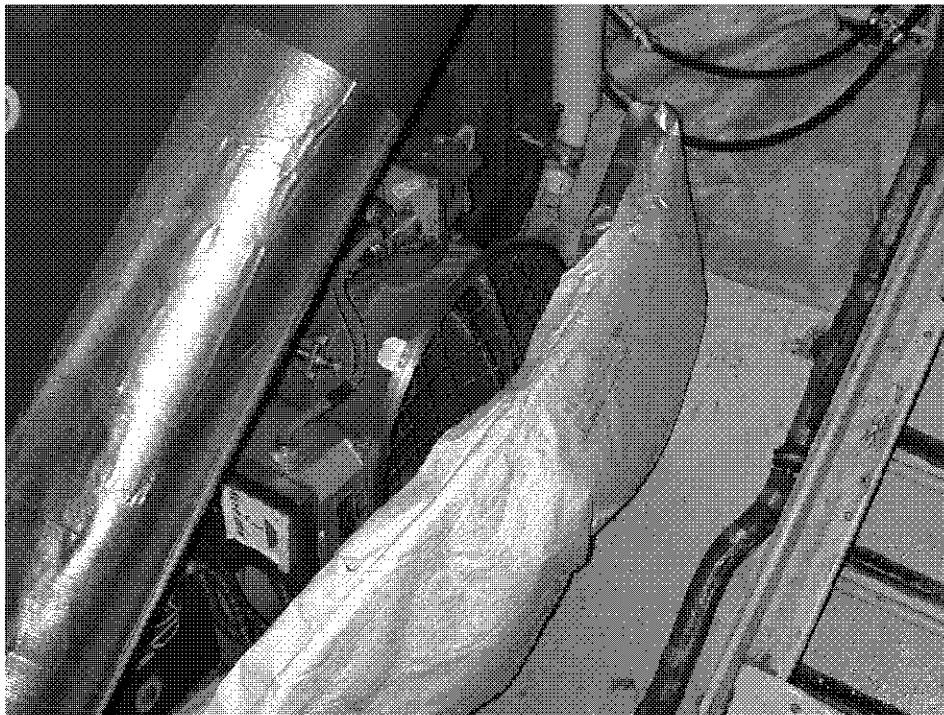
Figure 14 – Forward Outflow Valve With Insulation Valve Partially Obstructing the Intake

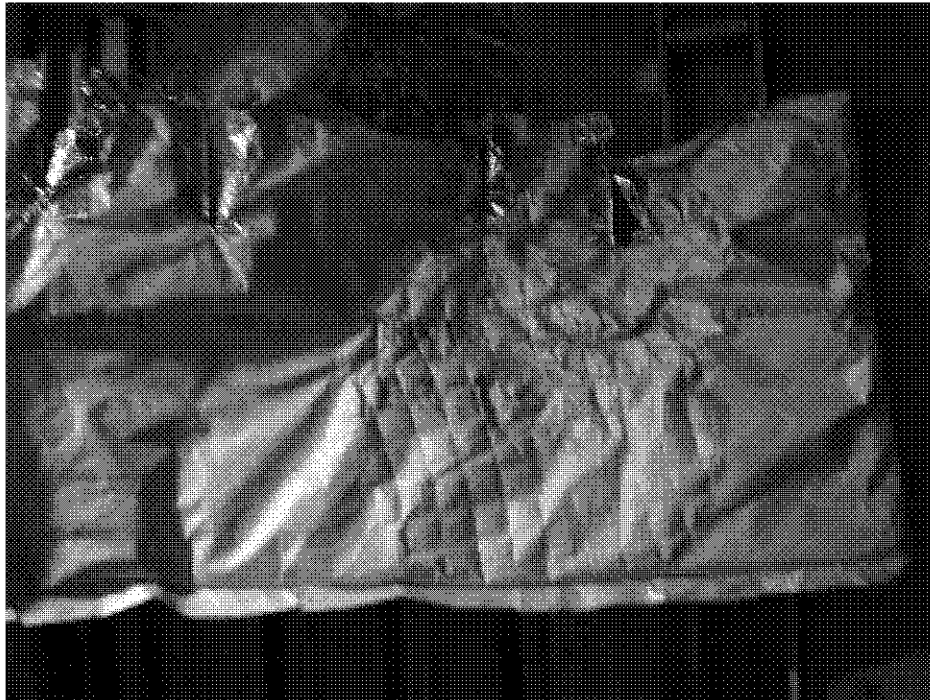
Figure 15 – Insulation Blanket That Was Obstructing The Forward Outflow Valve  
Showing The Impressions From The Intake Screen

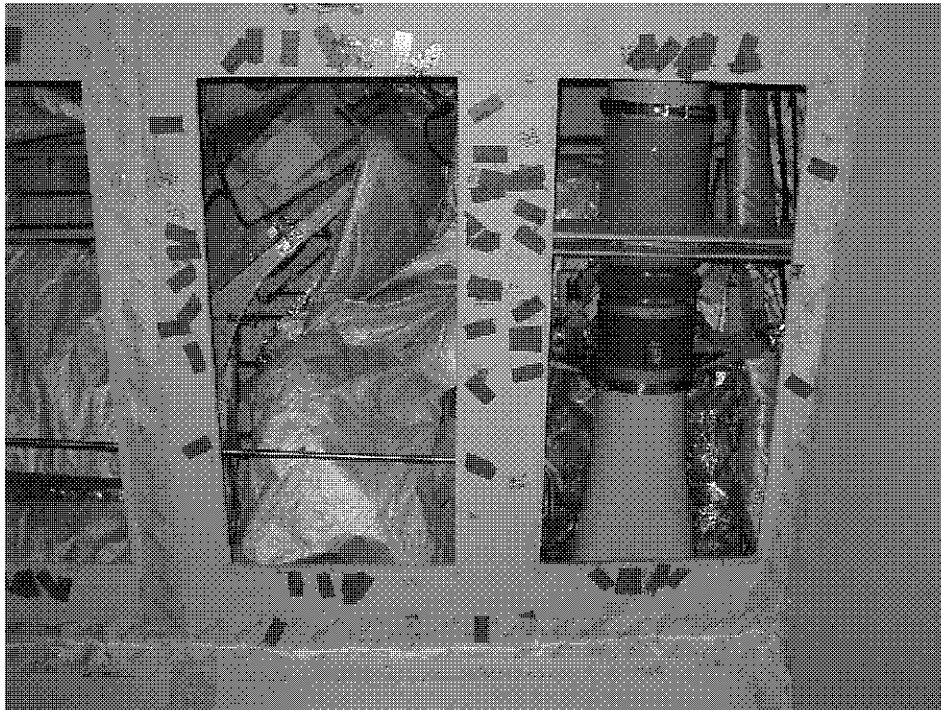
Figure 16 – Right Side Of Compartment (Behind Cargo Compartment Removable  
Panels) Containing Forward Outflow Valve Showing Displaced Insulation Blankets

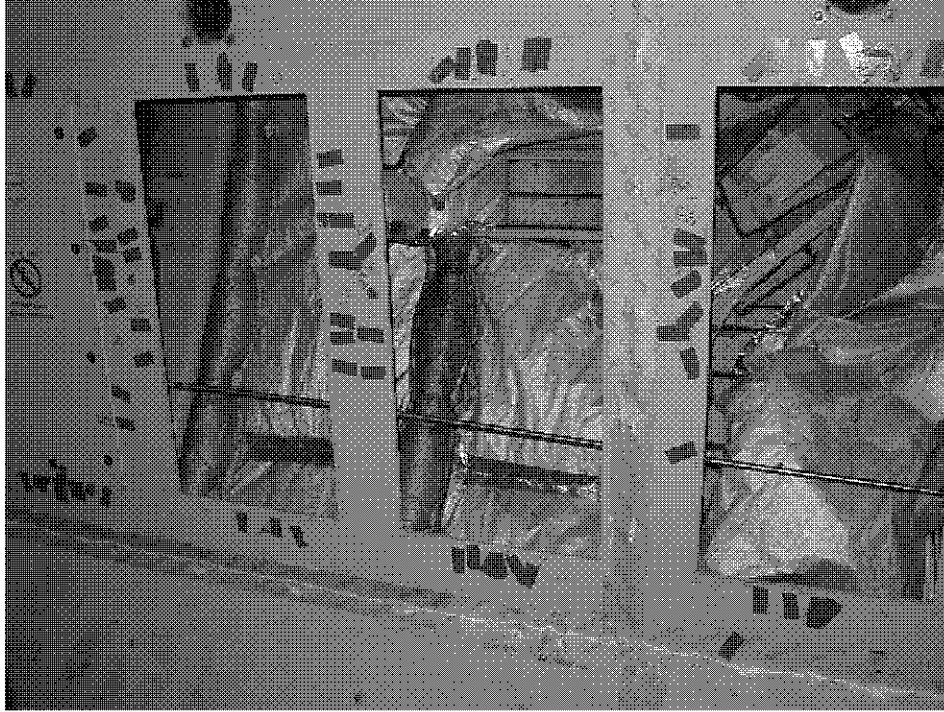
Figure 17 – Right Side Of Compartment (Behind Cargo Compartment Removable Panels) Containing Forward Outflow Valve Showing Displaced Insulation Blankets

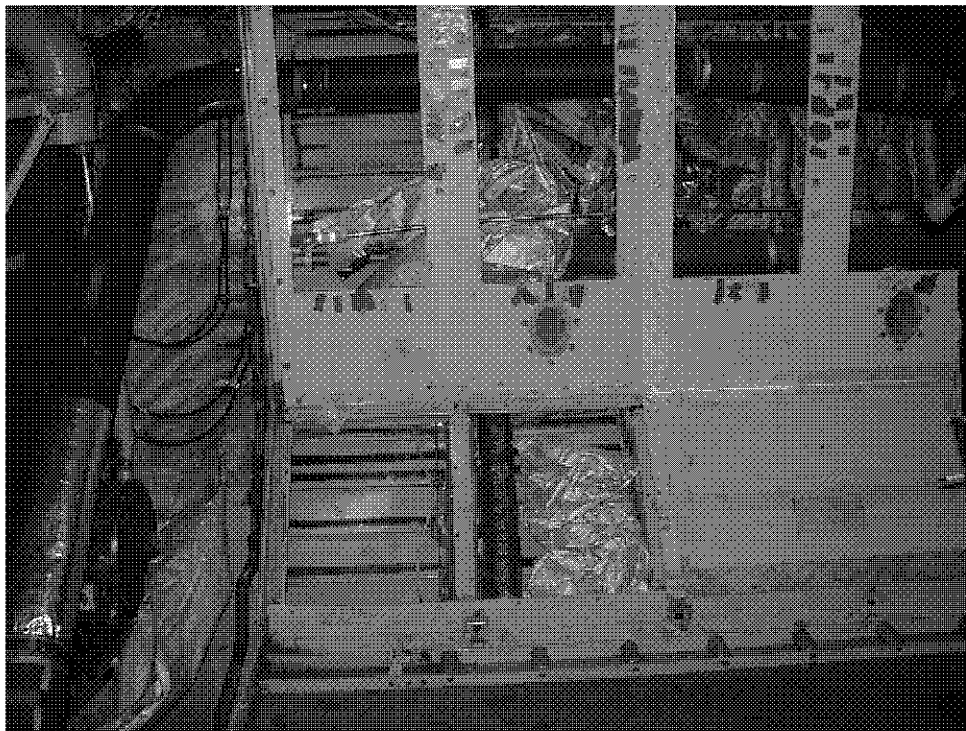
Figure 18 – Right Side Of Compartment (Behind Cargo Compartment Removable Panels) Containing Forward Outflow Valve Showing Displaced Insulation Blankets
