**NATIONAL TRANSPORTATION SAFETY BOARD
OFFICE OF AVIATION SAFETY
WASHINGTON, DC 20594**

SYSTEMS GROUP CHAIRMAN'S FACTUAL REPORT

ANC03IA001

Location: Anchorage, Alaska
Date: October 9, 2002
Time: 1740 Alaska daylight time (ADT)
Aircraft: Boeing 747-400, N661US
Northwest Airlines Flight 85

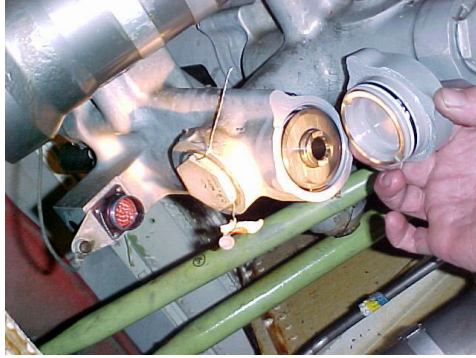
During a visual inspection of the airplane in Anchorage, the forged aluminum housing of the Lower Rudder Power Control Module (PCM), P/N 333200-1003, S/N 0005, was observed to be fractured. As seen in Figure 1, the end portion of the manifold housing located near the yaw damper actuator portion of the PCM had completely separated from the PCM housing. This fractured portion contained an end cap which is normally safety wired to the main PCM housing; the separated portion was retained by this safety wire.

Figure 1 –PCM with Fractured Manifold

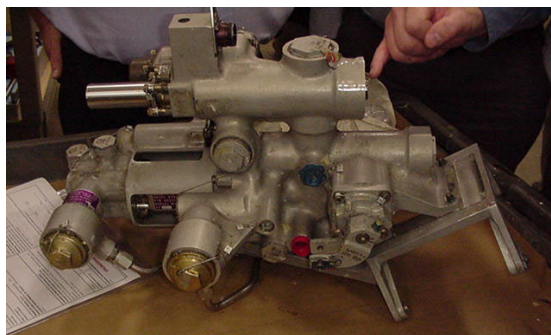
Initial visual examination of the PCM confirmed the reported failure. A portion of the manifold that included the end cap had broken completely off of the main unit in the vicinity of the yaw damper piston, as seen in Figures 4 and 5. The lockwire that secures the access port cap to the piston cavity end cap was observed to have a seal that did not have Parker markings on it, signifying that one or both caps may have been opened at some point after leaving the Parker manufacturing facilities. However, no records were found to indicate any maintenance on, or removal of, the cap.

Figure 4 – Lower Rudder PCM

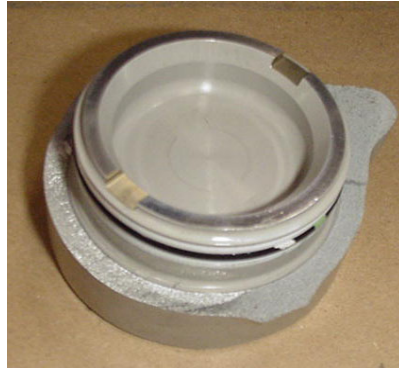
Figure 5 – Fractured Piece of Manifold with End Cap

The initial visual examination of the fractured manifold was done at the NTSB's Materials Laboratory in Washington, DC. This examination revealed a mode of crack initiation and growth consistent with fatigue; multiple points of crack origin were noted.

The initial laboratory work was performed by Parker Hannifin. The manifold was made from the correct material, and the material exhibited mechanical properties consistent with and within the tolerance of the material and heat-treat specifications. The failure mode was identified as multiple origin fatigue, which originated in the first full thread root radius. No corrosion was found. Based on an examination using the Scanning Electron Microscope (SEM), the fatigue crack was complete from the inner diameter (ID) through the wall of the manifold. No defects were found in the threads. See Appendix A for a copy of the report provided by Parker. A later examination of the grain structure in the manifold found no discrepancies.

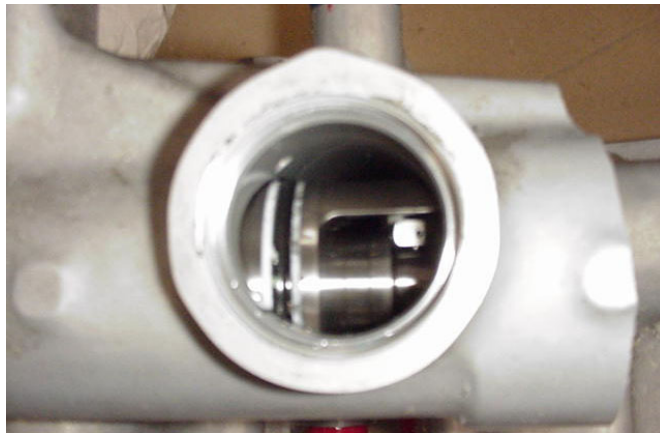
The yaw damper piston assembly was visibly protruding from the manifold. As shown in Figure 6, an O-ring and two back-up rings could be seen through the broken portion of the manifold. These items are not normally visible, but instead are in the sealing bore.

Figure 6 – Interior of Manifold
