NATIONAL TRANSPORTATION SAFETY BOARD

Systems Group Chairman's Factual Report

DCA06MA009

Location: Midway Airport, Chicago, Illinois
Date: December 8, 2005
Time: 1914 Local Time (CST)
Aircraft: Southwest Airlines Flight 1248, a Boeing 737-7H4, N471WN

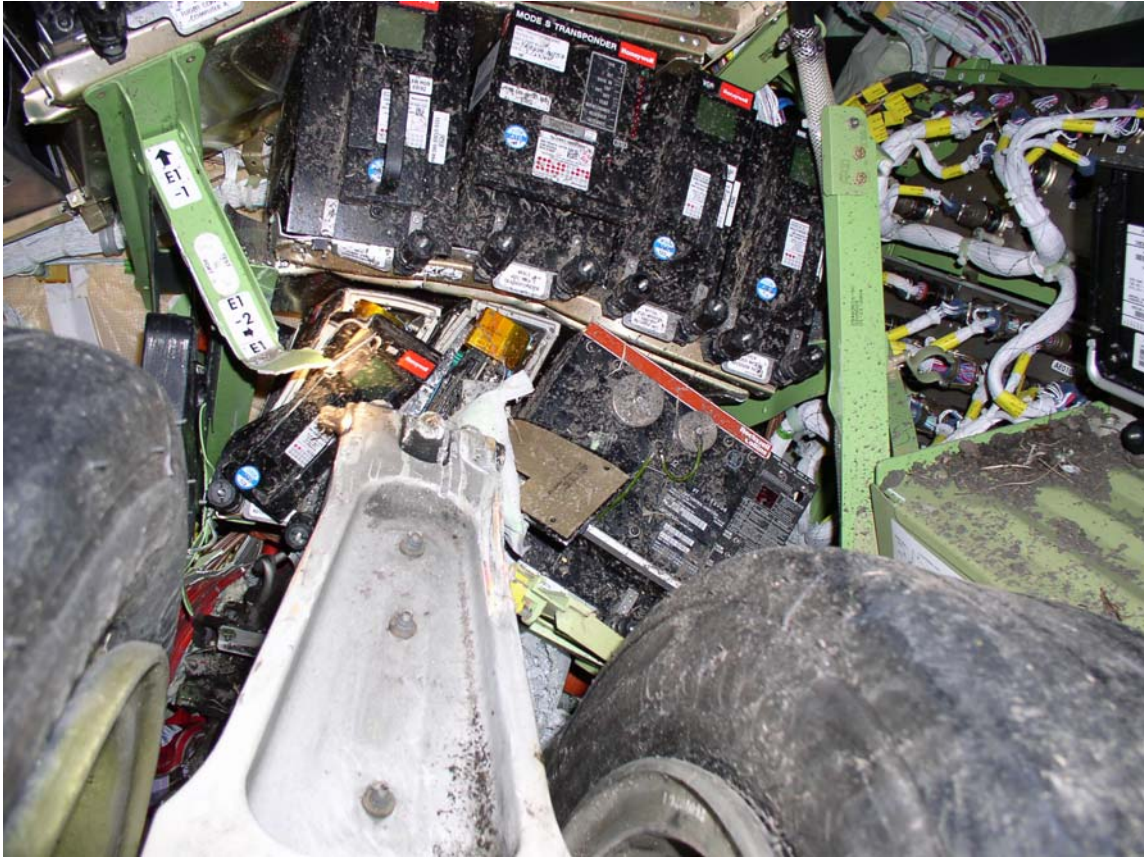
The displaced nose gear assembly impacted the forward Electronic Equipment (EE) bay. The nose gear pushed the bay hatch door up and into the forward EE bay; the hatch door was found on top of the J23 Box, with the door side notation "AFT" facing the nose and the external side of the door facing up. Several racks and many components were splattered with mud and snow.

The E1 equipment racks were dislodged and pushed up by the displaced nose gear (see Figure 1) entering the forward EE bay. Each of the E1 racks were damaged and/or bent. Components located on the racks were wedged underneath the above shelf, dislodged from the shelf, and/or broken open. No attempt was made to determine whether the components on these shelves were still connected to their respective shelf connector.

Figure 1 - Damage to Forward EE Bay. Note nosegear assembly.

The nose landing gear structure was found imbedded in the E&E bay, pushed back and up into the compartment. The gear was broken from its support structure at the pin of the lower drag link, with the summing mechanism and lower structure found in the E&E bay. The gear assembly was rotated 180° from its normal orientation. The gear wheels were found in the hatch opening, with the bottom of the lower wheel slightly below the floor level of the E&E bay. The gear wheel that was found lower in the compartment (left wheel) had a tire pressure of 185 psi, measured following the accident. The right nose gear tire was imbedded further up into the compartment and was pinched against the surrounding structure.

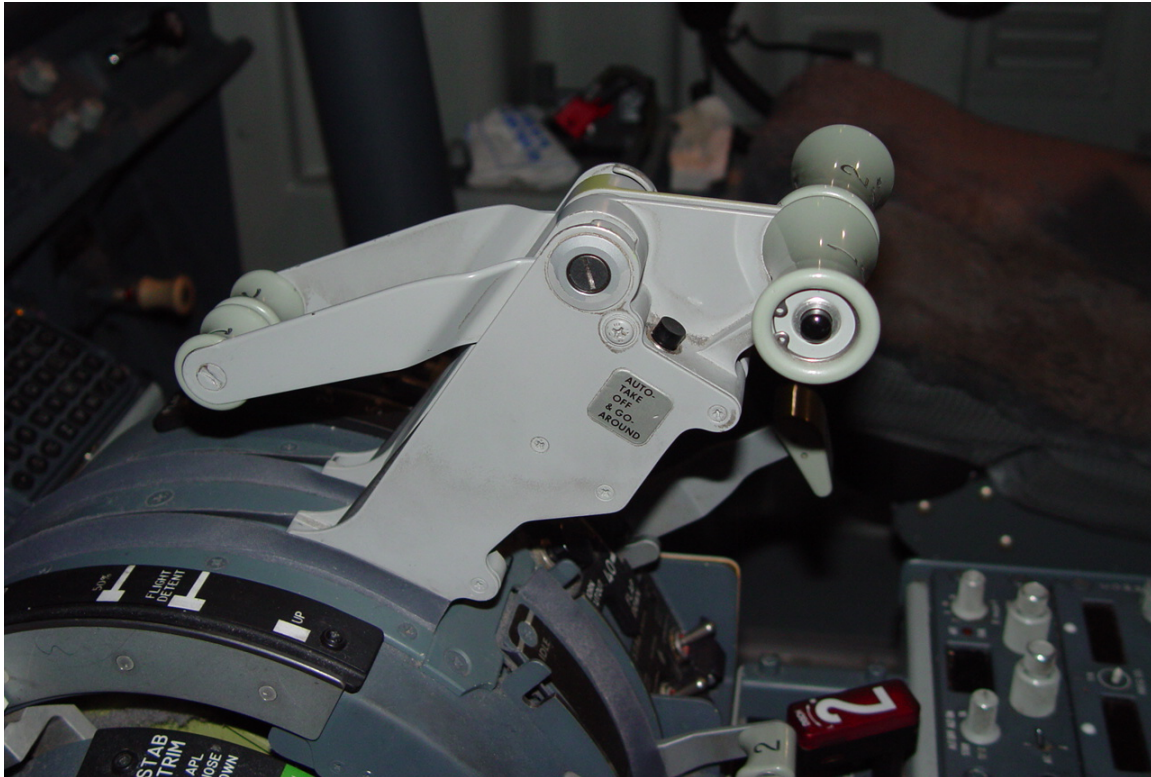
The area of the throttle quadrant (see Figure 2) was examined and documented for thrust reverser operation in both the flight deck area and the linkages below the cockpit floor level. The area of the throttle quadrant linkages, push-pull rods, and microswitch package were examined. Portions of the Reverse Thrust Lever (Difficult to Move In Reverse Thrust) – Fault Isolation procedure (76-05-00-810-805-F00) were performed on the airplane, without disconnecting any components during the procedure.

Figure 2 - Thrust Levers Against Idle Stops.

The blue torque stripe material in the area of the throttle quadrant linkage, push-pull rods and fasteners were unbroken and undisturbed. The blue torque stripe materials on the push-pull rod attachment hardware and adjustment nuts were undisturbed. The area looked clean, and the throttles and associated hardware moved smoothly and without binding. There were no materials on the white insulation blanket material beneath the throttle quadrant that appeared to have been jammed or stuck in the throttle linkage area.

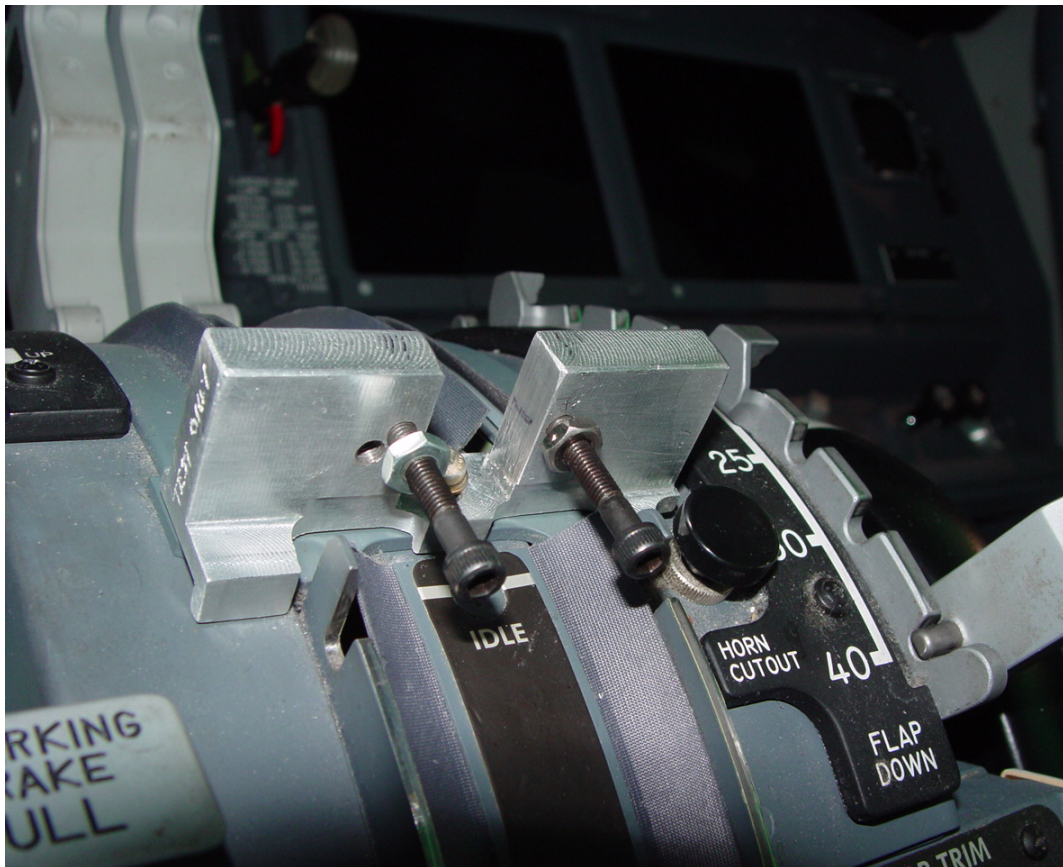
At the group's request and coordination, Boeing created a tool to more precisely measure the resolver position by use of adjustment screws. The tool (see Figure 3) attached to the thrust idle stop by the center idle stop plate screw and allowed the user to rotate the adjustment screw to determine a repeatable (and more precise) TRA for the position of the reverse thrust interlock latch.

Figure 3 - Tool, shown as installed, used to assist TRA measurement.

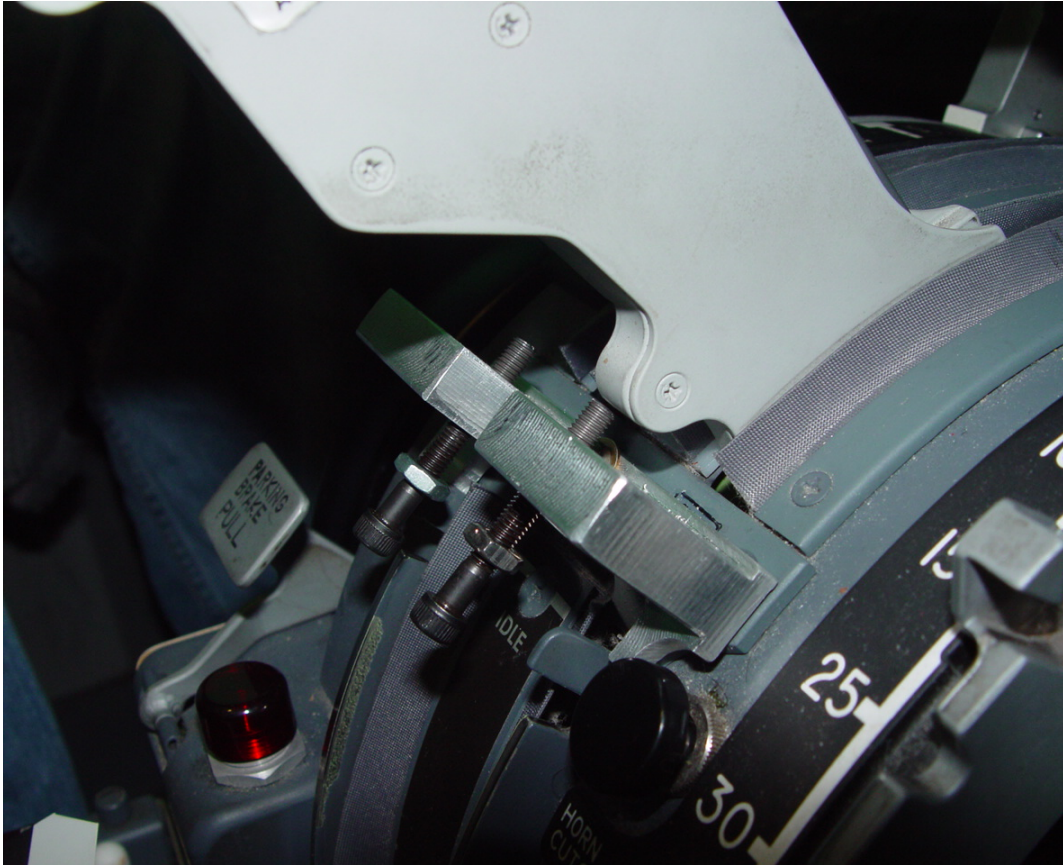
The group re-measured the accident airplane using the tool (see Figure 4). In addition, a revised test procedure (revised from previous tests) was used for the test (see Attachment 3). Power could not be applied to the airplane, so the thrust resolver angle was

Figure 4 - Measurement tool and Number 2 Throttle.
