**NATIONAL TRANSPORTATION SAFETY BOARD
OFFICE OF AVIATION SAFETY
WASHINGTON, D.C. 20594**

SYSTEMS GROUP CHAIRMAN'S FACTUAL REPORT OF INVESTIGATION

DCA06MA010

Operator: Flying Boat, Inc. DBA, Chalk's Ocean Airways
Aircraft: Grumman Mallard G-73T, N2969
Location: Miami, FL
Date: December 19, 2005
Time: 1439 Eastern Standard Time

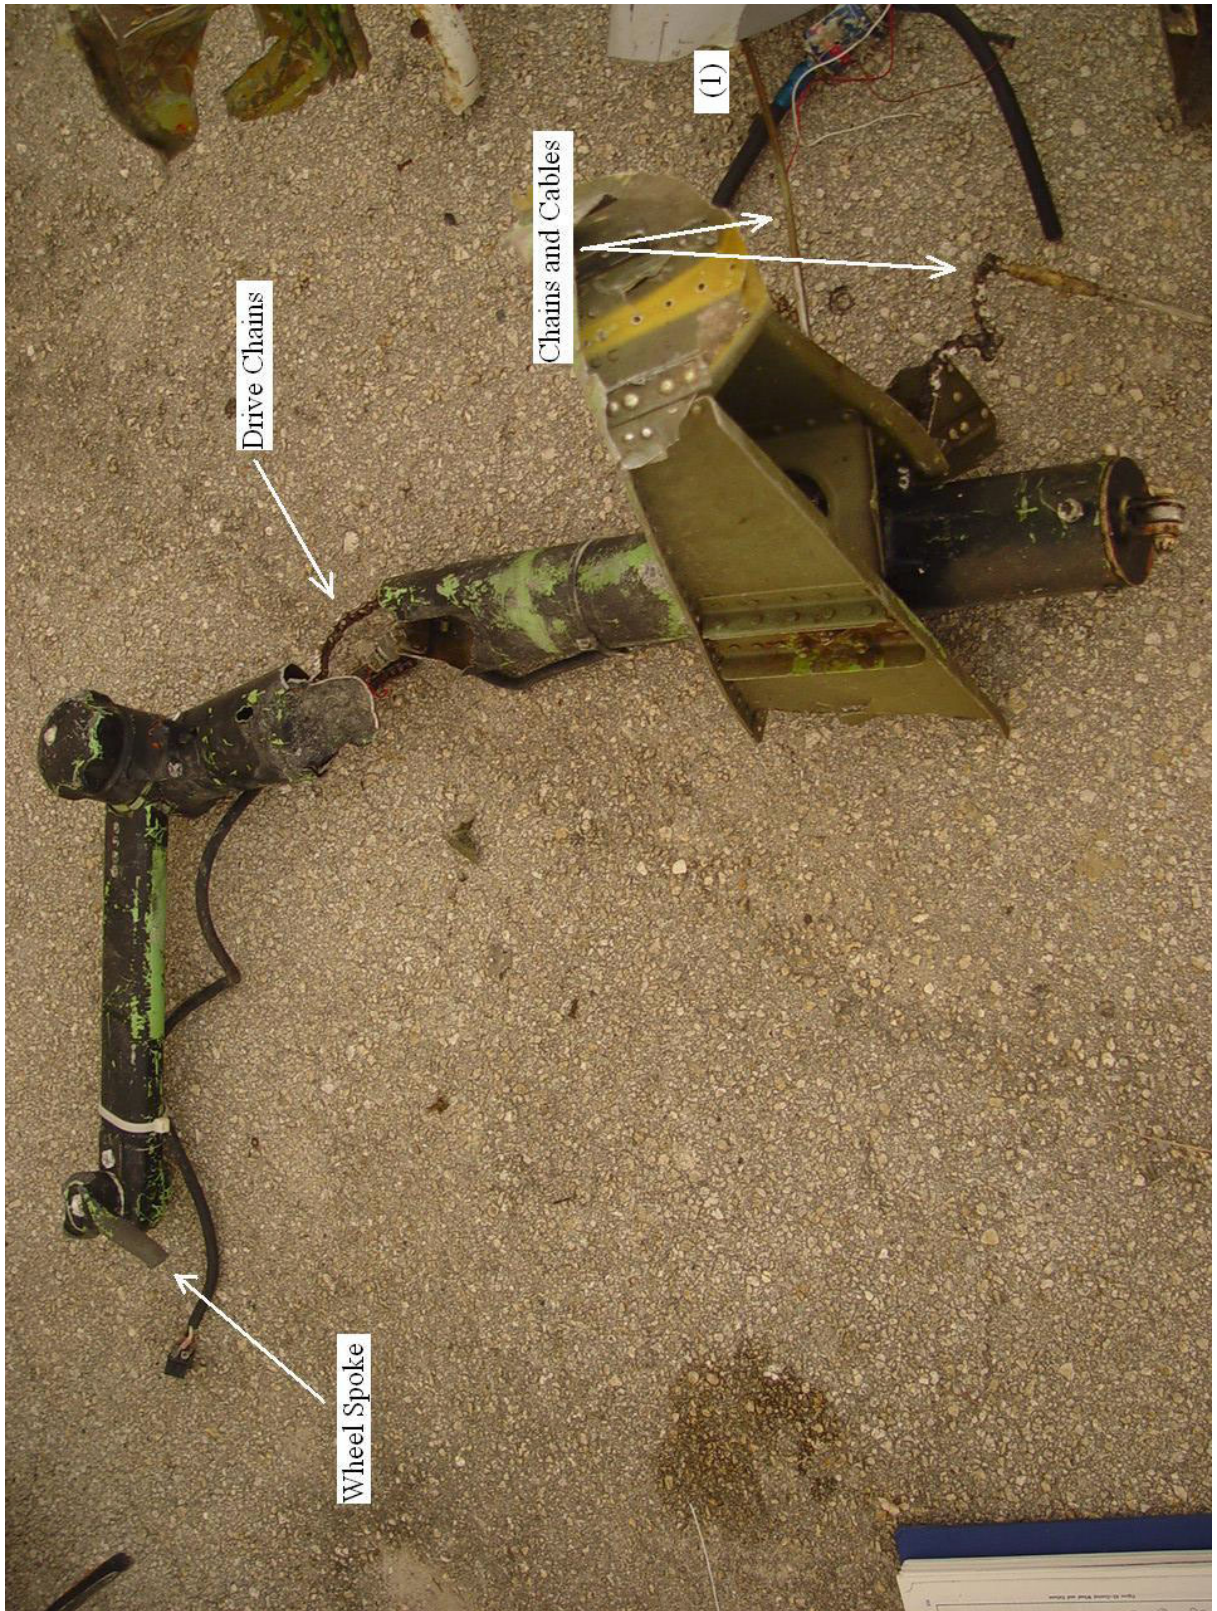
Figure 3. Control wheel and column

The control wheel and column was recovered from the accident site (Figure 3). The wheel had only one spoke remaining. Each end of the lower chain was connected to a cable segment. The upper chain was fractured, but the control orientation could be determined. A clockwise (left turn) motion of the wheel caused the upper cable exiting the control column to retract toward the column. This control cable segment identified by (1) in Figure 3 was fractured approximately 16 inches from the chain attach point, the other cable segment was fractured approximately 19 inches from the chain attach point. By measuring cable segment lengths, it was determined that this cable was attached to the forward portion of the right wing bellcrank, Figure 4. A pull on this cable caused the right wing aileron to move trailing edge down. Correct orientation of the control cables was confirmed. On both wings, the bellcranks and pushrod connections were intact to the aileron surface.

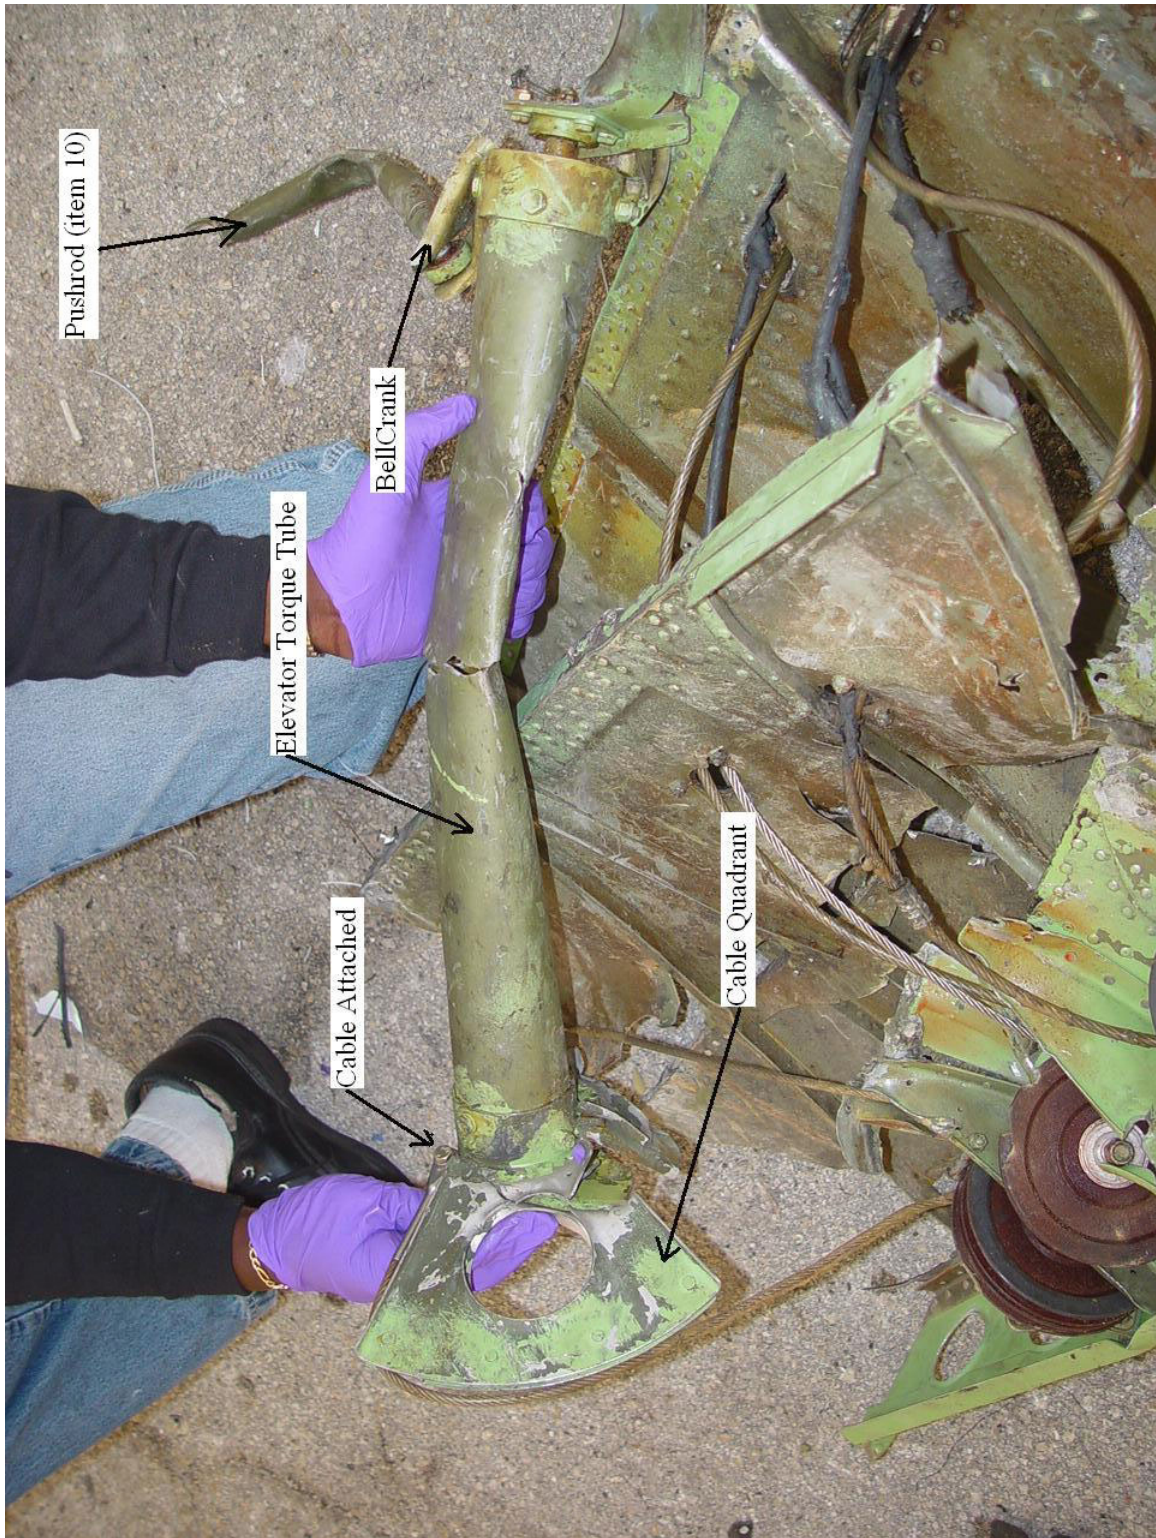
Figure 7. Forward elevator torque tube.

The elevator torque tube (Figure 5, item 8) was located in the wreckage (Figure 7). One of the control cables was detached from the quadrant, but one was still attached to a portion of the quadrant. It could be determined how the quadrant segment was attached to the damaged torque tube. The torque tube, bellcrank, and pushrod were damaged but still connected. The pushrod was fractured and separated from the base of the control column. The control cables were intact from the front cable quadrant to the aft quadrant. The elevators were found to be attached to the aft torque tubes and cable quadrant. Correct orientation of the control cables was confirmed.

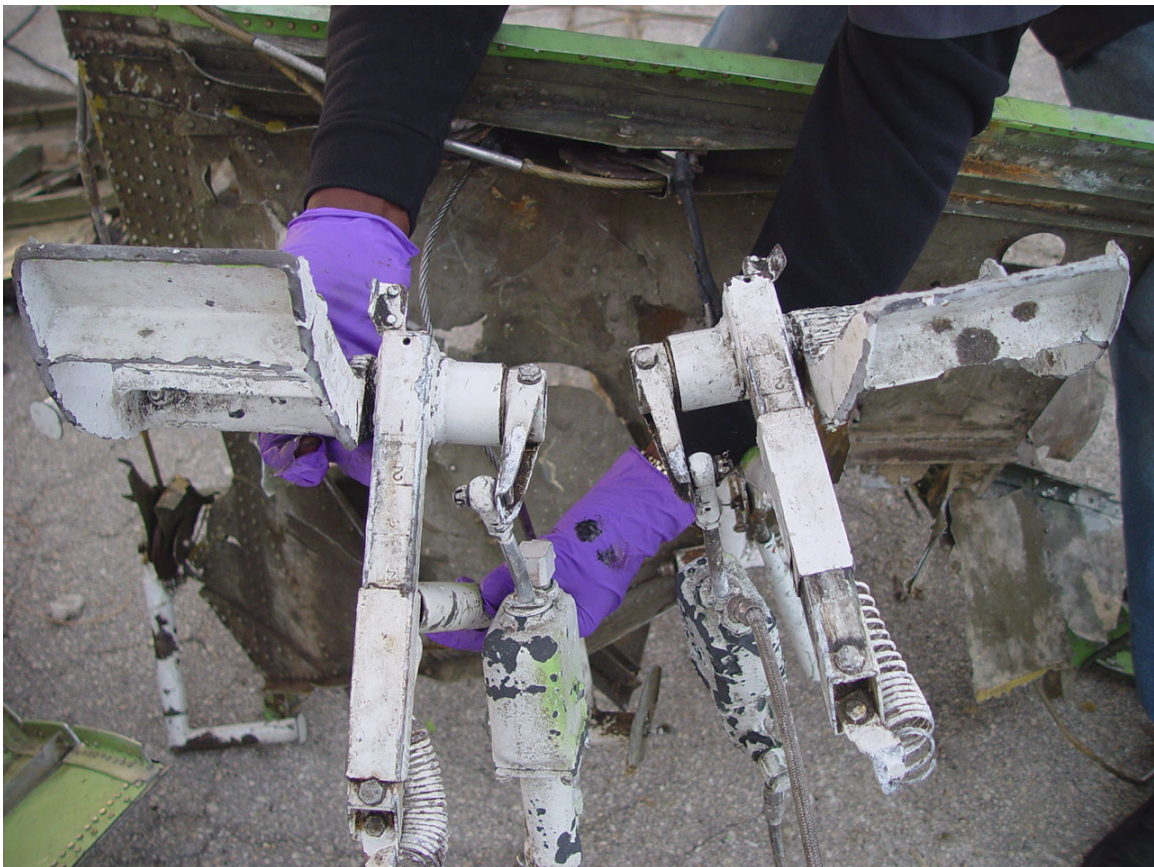
Figure 9. Captains rudder pedals.

All four pedals, though damaged, were located in the wreckage. The captains and first officers pedals are shown in Figures 9 and 10 respectively. The control cables to all four pedals were found to be still attached to pedal structure (Figure 11). The swages and cable continuity was intact from all four pedals to the rudder sector. Correct orientation of the control cables was confirmed.

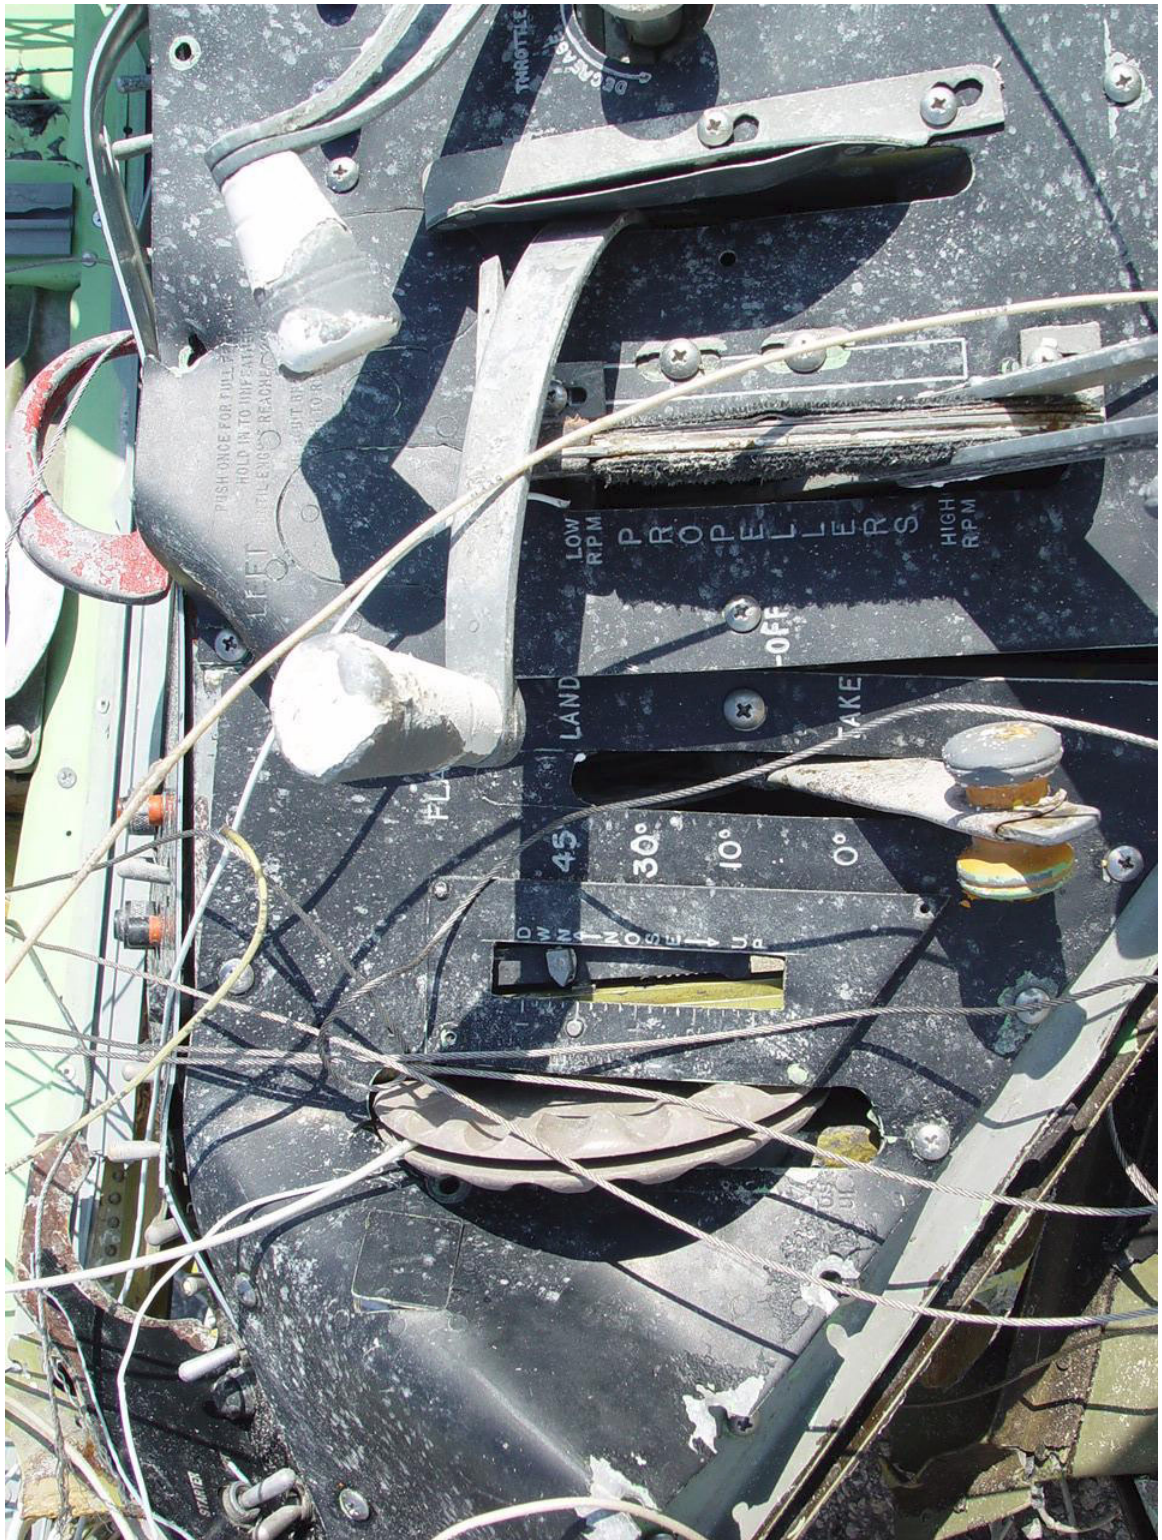
Figure 13. Flap handle position.

The flap handle was found to be in the 0 degree position (Figure 13). The hydraulic actuator was still attached to each flap. The selector valve and follow up were located in the wreckage, but the follow up was detached from the flap. The control cables were fractured.

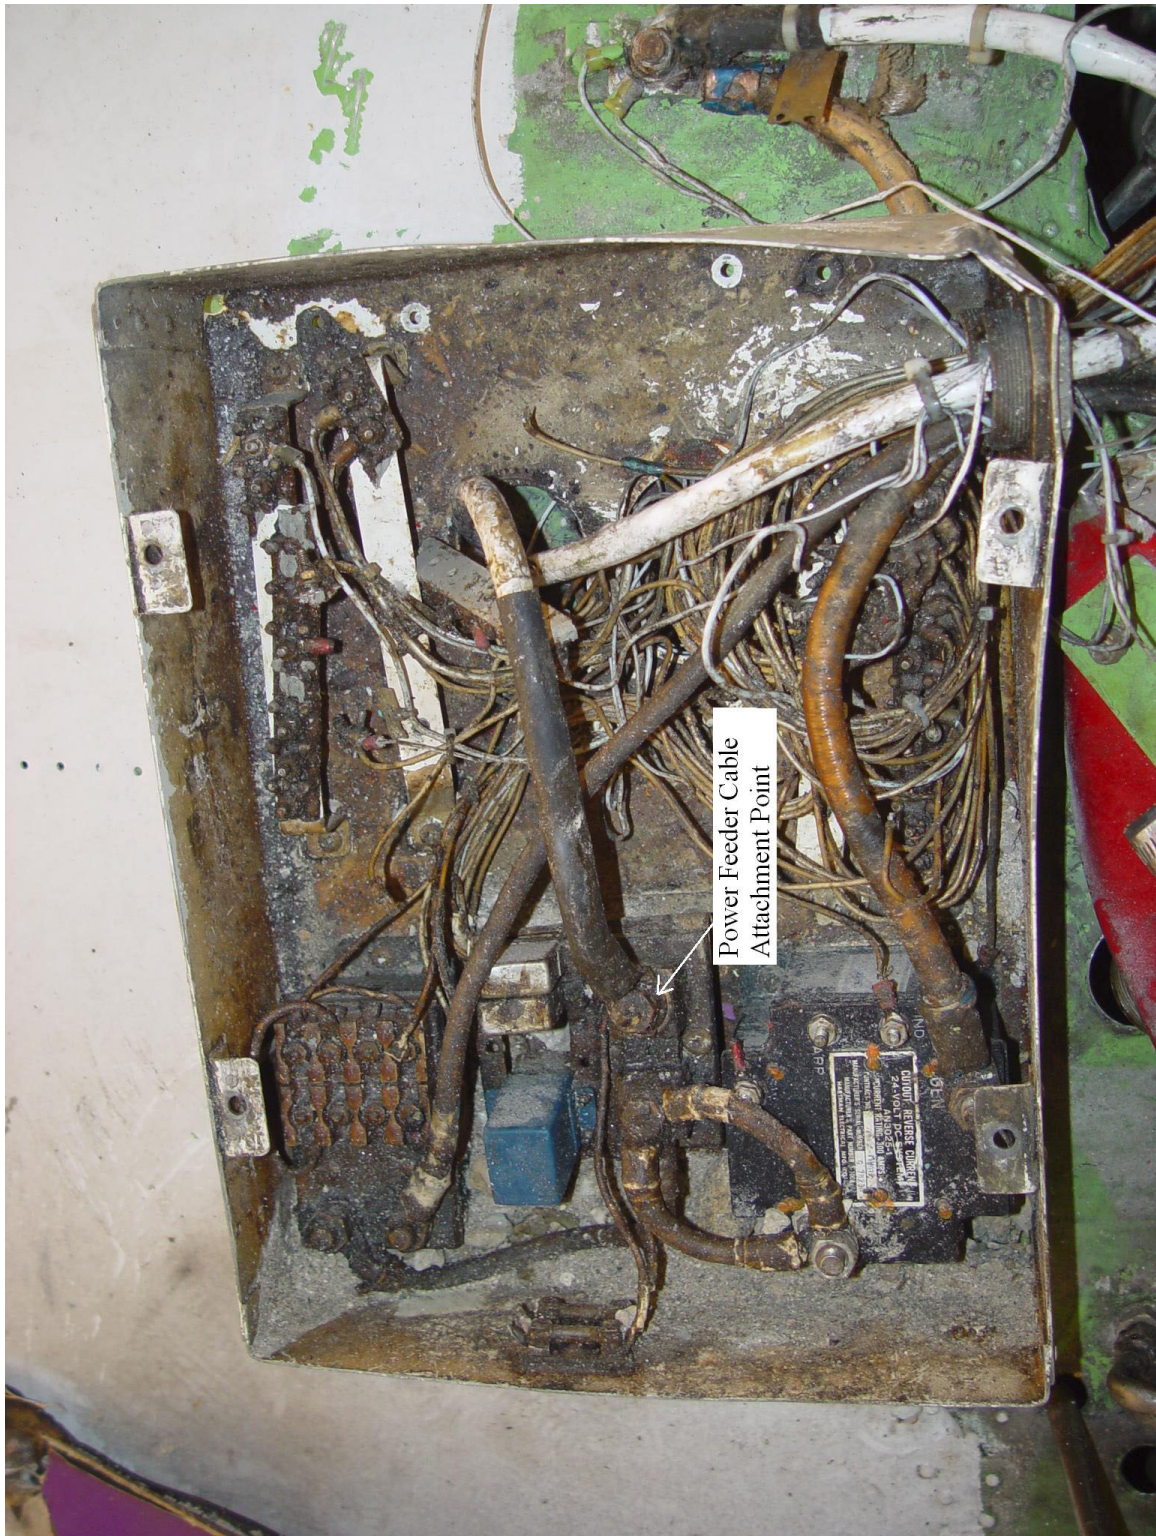
Figure 15. Right wing nacelle junction box.

The right nacelle junction box, relay box and external power connection were located in the wreckage (Figure15). The main power cable (359-0) was not connected to the shunt in the junction box. The connection was loose as though it had been connected, but had pulled away. The main junction box and power feeder cables were not located in the wreckage.
