NATIONAL TRANSPORTATION SAFETY BOARD OFFICE OF AVIATION SAFETY WASHINGTON, D.C. 20594

SYSTEMS GROUP CHAIRMAN'S FACTUAL REPORT

NTSB ID No.: DCA11IA047

On April 26, 2011 at 1:33pm central daylight time (CDT), a Boeing 737-700, U.S. registration N799SW, operated by Southwest Airlines as flight 1919, departed the left side of runway 13C after landing at Chicago Midway International Airport, Chicago, Illinois (MDW). Weather was reported as rain, with southerly winds of approximately 20 knots. There was minor damage to the airplane due to the right hand engine ingesting a taxiway light during the excursion. There were no injuries to the 2 flight crew, 3 cabin crew, and 139 passengers which included 5 lap-held children. Witness marks on the runway indicated the airplane touched down about 450 feet from the displaced arrival threshold. Runway conditions were reported as "wet and fair [braking]" by a preceding arrival.

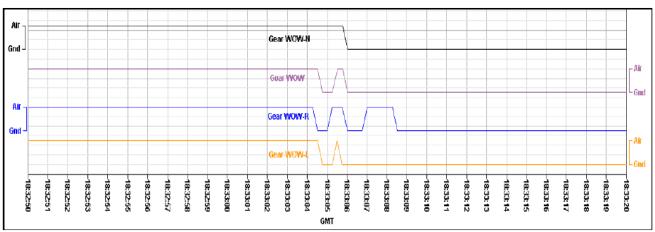
Figure 1 Air/Ground position data from the incident landing

Upon touchdown (about 18:33:05 GMT), the air/ground system indicated that both MLG transitioned from "air" to "ground" for approximately one second, then transitioned briefly back to "air" and then back to "ground" a second time. Refer to figure 1. The nose gear then transitioned from "air" to "on ground" where it remained for the landing rollout. At about 18:33:07 GMT, the right MLG transitioned to "air" and then back to "ground" one additional time.

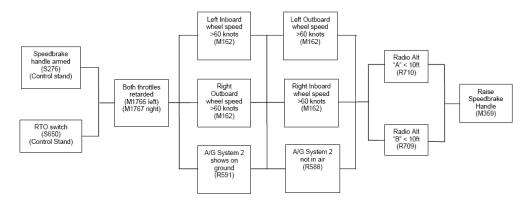
Figure 2 737-800 speedbrake logic

- 1. The speedbrake lever is in the armed position<u>or</u> speedbrake RTO switch is closed. <u>AND</u>
- 2. Both throttles are retarded (less than 44 degrees of throttle resolver angle TRA). <u>AND</u>
- Right outboard wheel speed is >60 knots or left inboard wheel speed is >60 knots or air/ground system 2 provides an "on-ground signal".
 AND
- Right inboard wheel is >60 knots <u>or</u> left outboard wheel is >60 knots <u>or</u> air/ground system 2 provides a "not in air" signal.
 AND
- 5. Either Radio altitude system "A" or system "B" indicates less than 10 feet.

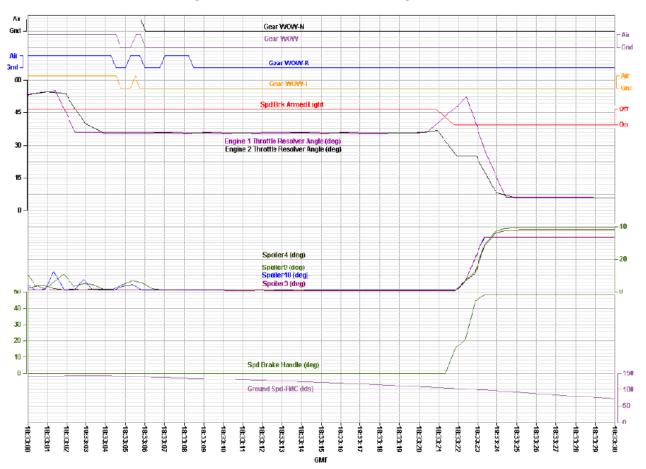
Figure 3 FDR data for the event landing

A review of the FDR data revealed that just prior to touchdown, about 18:33:04 GMT, the speedbrake lever remained at zero degrees (not armed) and the speedbrake "armed" light was not illuminated. The speedbrake lever remained in its down position upon touchdown, about 18:33:05 GMT, and for the first sixteen seconds of the landing rollout. The data also indicates that the ground spoilers did not deploy until approximately seventeen seconds after touchdown. During this time, the thrust levers were at their forward idle position of 36 deg TRA.

The data indicates that between fifteen and twenty seconds after touchdown, the thrust levers and the reverse thrust levers were positioned in a way that satisfied the logic to command the speedbrakes to be automatically deployed.

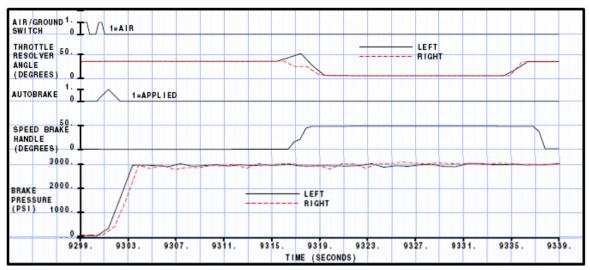
A review of the FDR data revealed that the autobrakes discrete indicated "applied" upon touchdown. Refer to figure 4. The data indicate that the left and right MLG brake pressure also began to increase at this time. After about 1 second, the autobrake discrete indicated "No Auto Brk" while the brake pressure continued to increase (without any fluctuations) up to about 3,000 psi where it remained for the rest of the landing rollout.

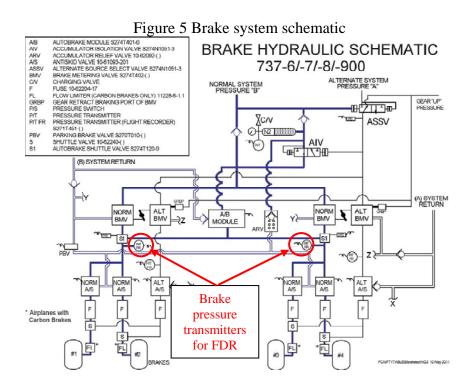
The autobrake control system comprises an autobrakes selector switch, an autobrake "disarm" light, an antiskid/autobrake control unit (AACU), an autobrake pressure control

Systems Group Chairman's Factual report NTSB Accident Number DCA11IA047 Page 7 of 10 module and two metered pressure switches (Figure 5). The autobrake selector switch and "disarm" light are located on the center flight compartment instrument panel. The switch is a rotary, six position switch that can be selected to four automatic braking levels (1, 2, 3, and MAX) and one refused takeoff (RTO) mode of automatic braking. When rotated from the off position to an automatic braking level, the switch provides 28 volts direct current (dc) to the AACU. According to the flight crew, the autobrakes had been selected to MAX autobrake² for landing.
