**NATIONAL TRANSPORTATION SAFETY BOARD
OFFICE OF AVIATION SAFETY
WASHINGTON, D.C. 20594**

SYSTEMS GROUP CHAIRMAN'S FACTUAL REPORT

NTSB ID No.: CEN11IA379

Location: General Mitchell Airport (MKE), Milwaukee, Wisconsin
Date: June 6, 2011
Time: About 2132 Central Daylight Time (CDT)
Aircraft: Bombardier CL600-2B19
Registration: N866AS
Serial Number: 7517
Operator: SkyWest Airlines

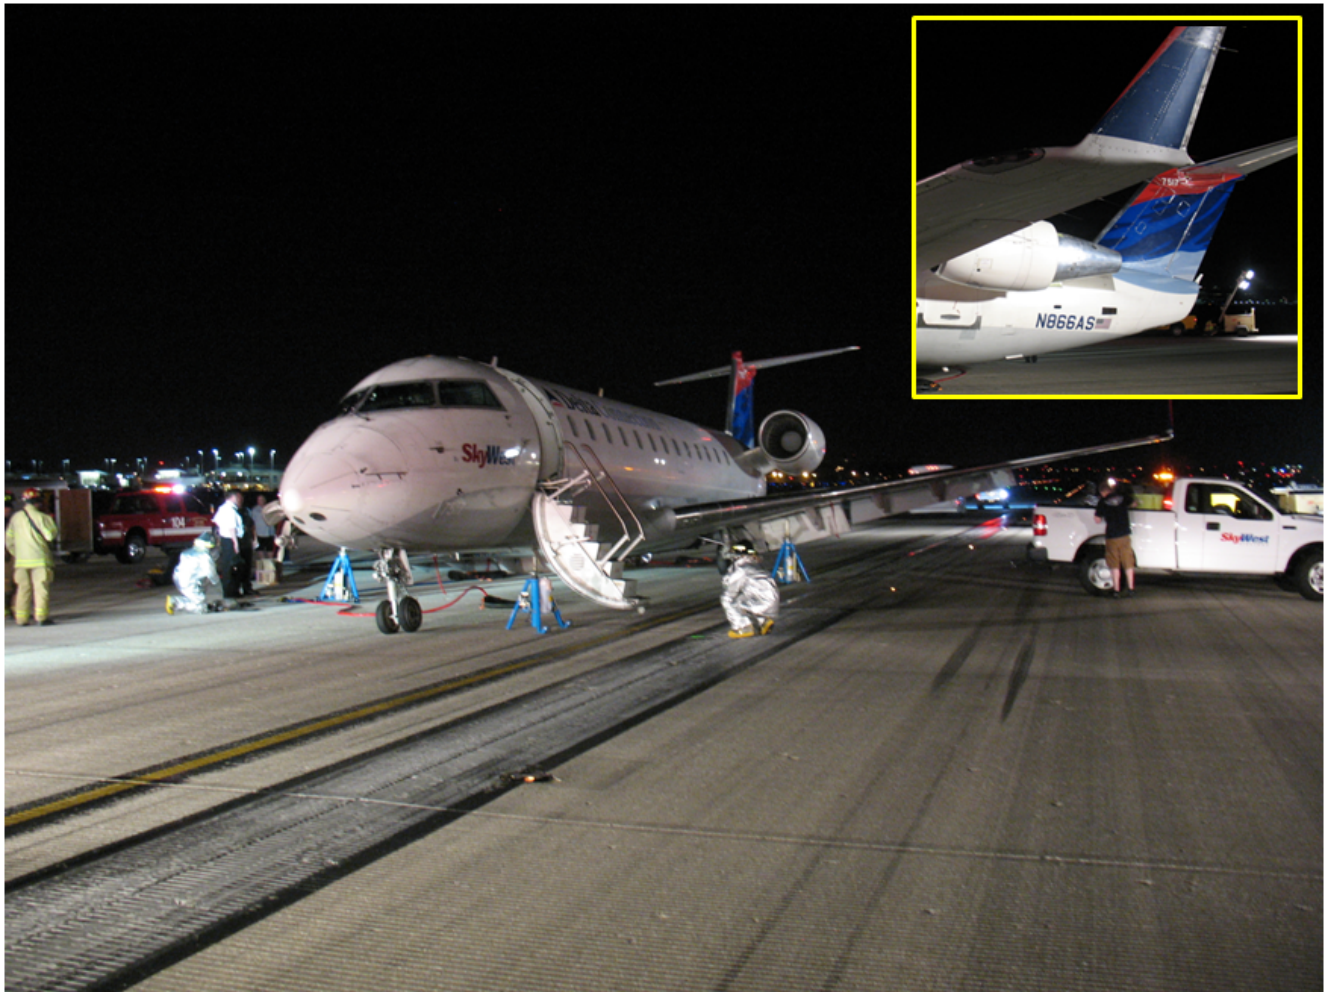
Figure 1 Airplane N866AS after landing in Milwaukee

A general visual inspection of the airplane, before it was recovered from the runway, revealed that the right main landing gear (MLG) remained within its wheel well. The nose landing gear (NLG) and left MLG were in their down and locked position. Because of this configuration, the outboard end of the right wing and its trailing edge flaps were resting on the ground.

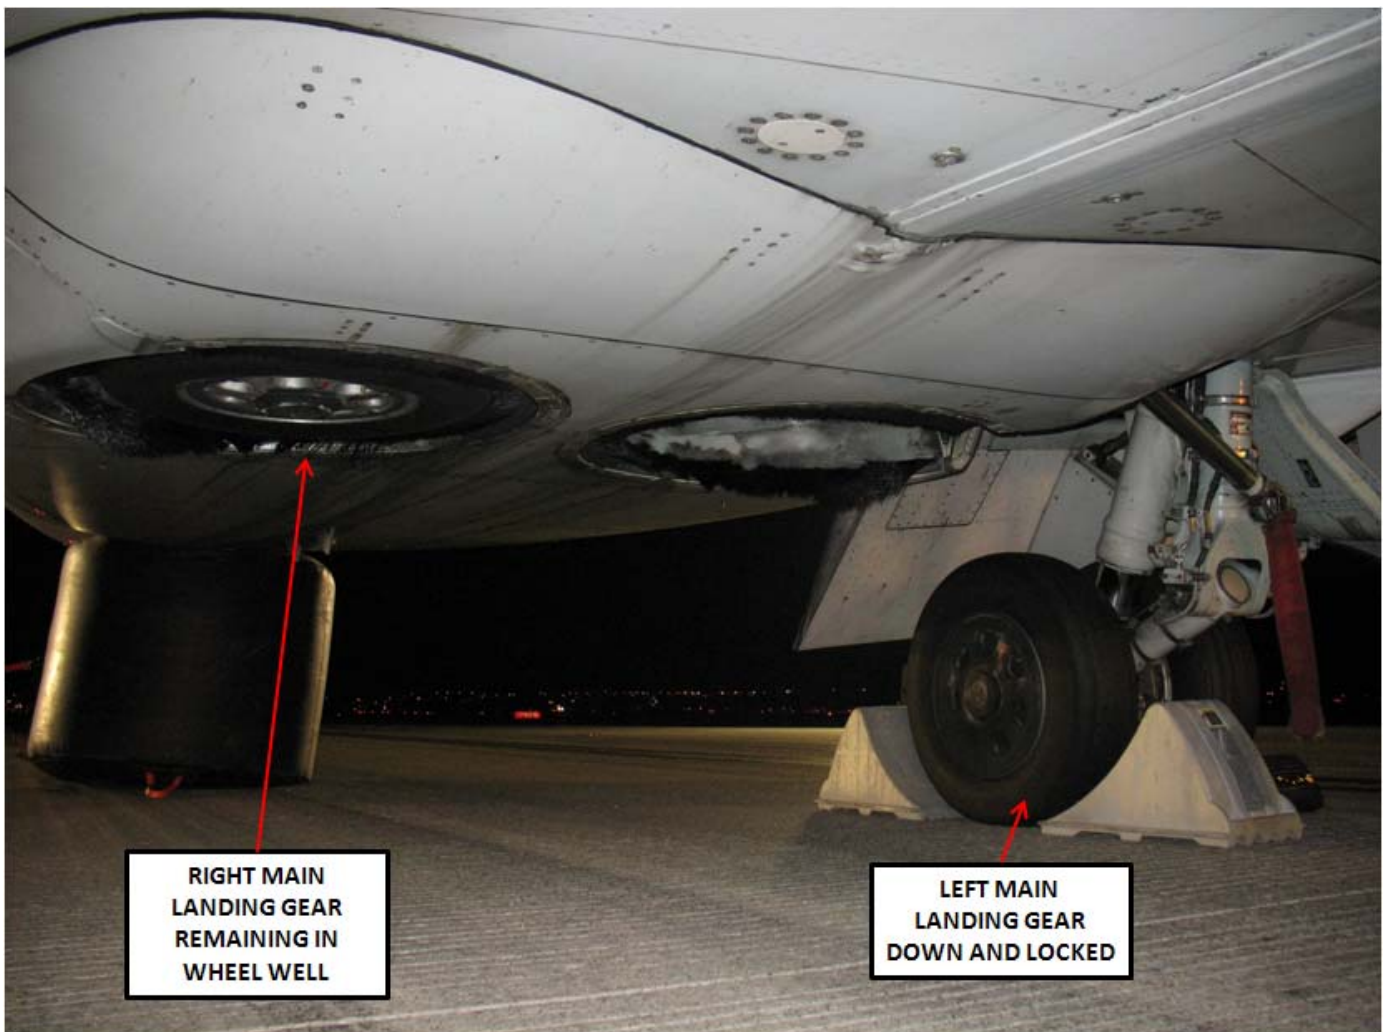
The aircraft was lifted using airbags that were positioned beneath the right wing and the tail. Once the proper height was achieved, a jack was placed under the right wing to support the aircraft. A visual inspection of the landing gear revealed that the right MLG remained within its respective wheel well and its door was flush with the aircraft fairing (figure 2).

Figure 2 View showing the position of the main landing gear

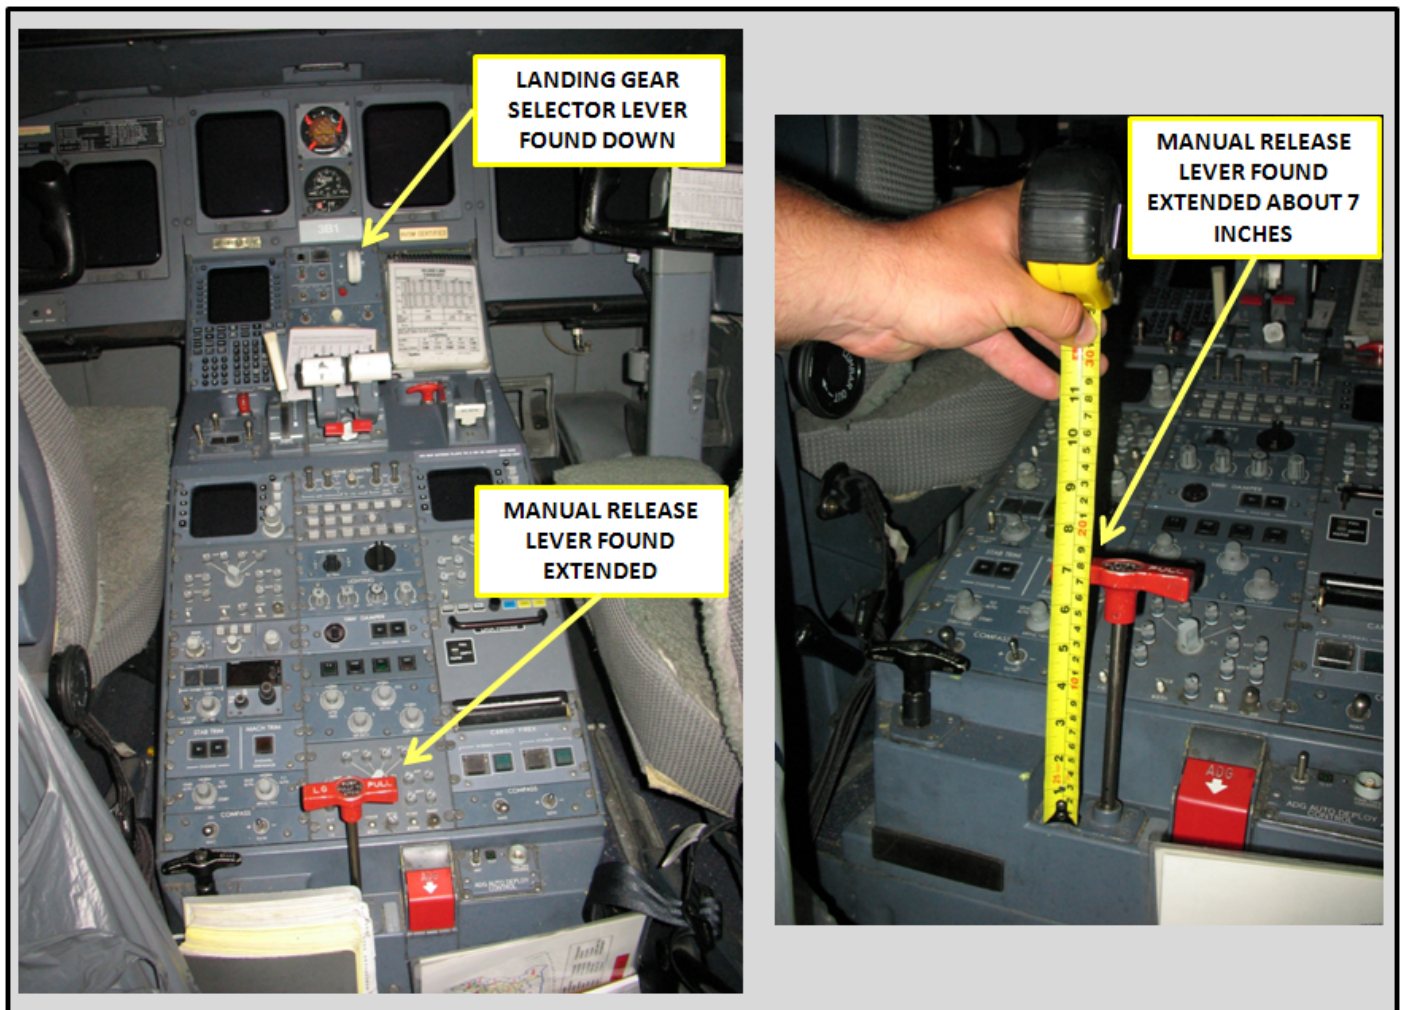
An inspection of the cockpit revealed that the landing gear manual release handle remained extended approximately 7 inches (figure 3). A SkyWest Airlines maintenance technician pulled up on the handle¹ resulting in the handle moving approximately 3 additional inches to its fully extended position of 10 inches. The additional handle displacement resulted in the right MLG extending out of its wheel well. When the maintenance technician released the handle from its fully extended position, the handle automatically began to slowly retract causing the right MLG to stop extending. The handle had to be re-pulled and manually held in its fully extended position for the right MLG to extend to its down and locked position. A slight push on the right MLG was required to bring the gear down to the down and locked position.

Figure 3 View of the cockpit showing the position of the manual release handle

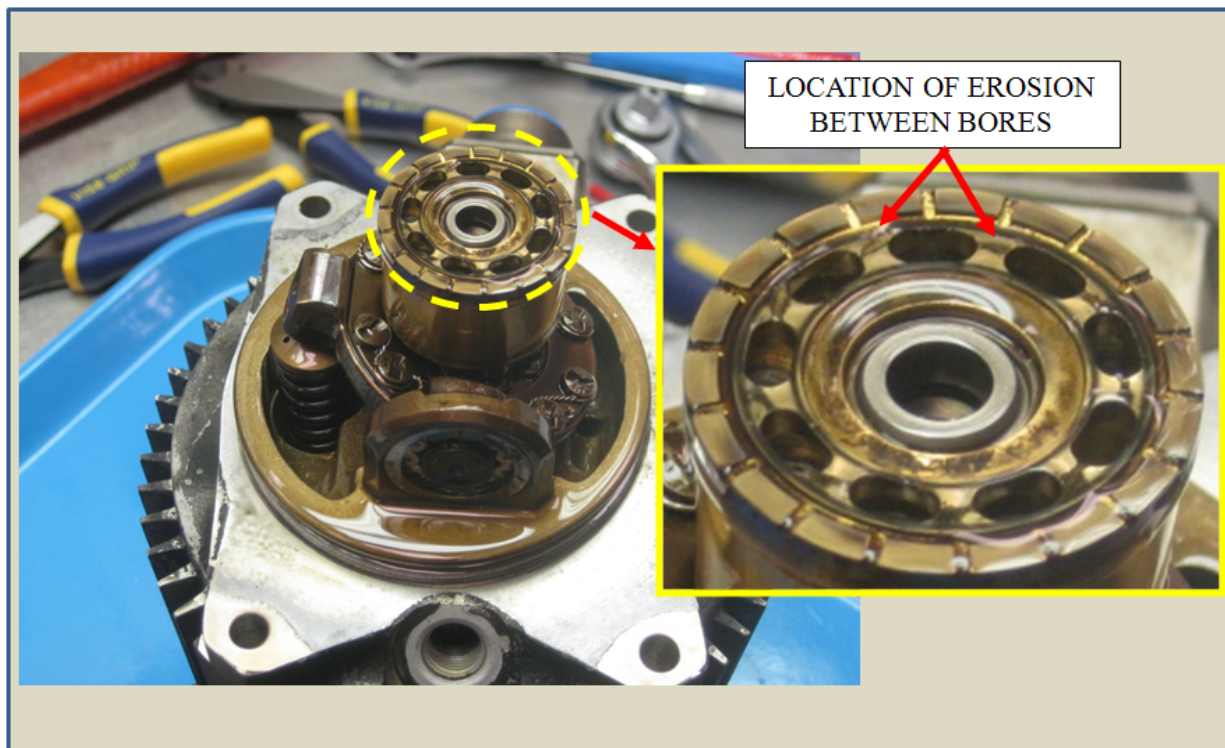
installed onto the test bench, the pumps output pressure was checked and found to be 2,933 psi which was less than the CMM pressure requirement of $3,000 \pm 25$ psi. In order to proceed with the functional testing, the pump's compensator was adjusted to increase the pump's output pressure to 3,014 psi. After this adjustment, the pump passed all test requirements (refer to table 2).

Following the functional testing, the motor pump was disassembled and inspected. The inspection found that, other than the cylinder block and the compensator, all components were in good condition. When the compensator was removed from the pump, its respective spool assembly was difficult to remove; it felt as if it was sticking within its sleeve. Inspection of the sleeve identified that “coking” was present within the sleeve. According to Eaton, the fact that the compensator could be adjusted during the testing indicates that the “sticking” did not affect the operation of the pump. Visual examination of the surface of the cylinder block revealed circumferential erosion between the bores (figure 5).

Figure 5 View of the cylinder block from pump ACMP-3B MX637374

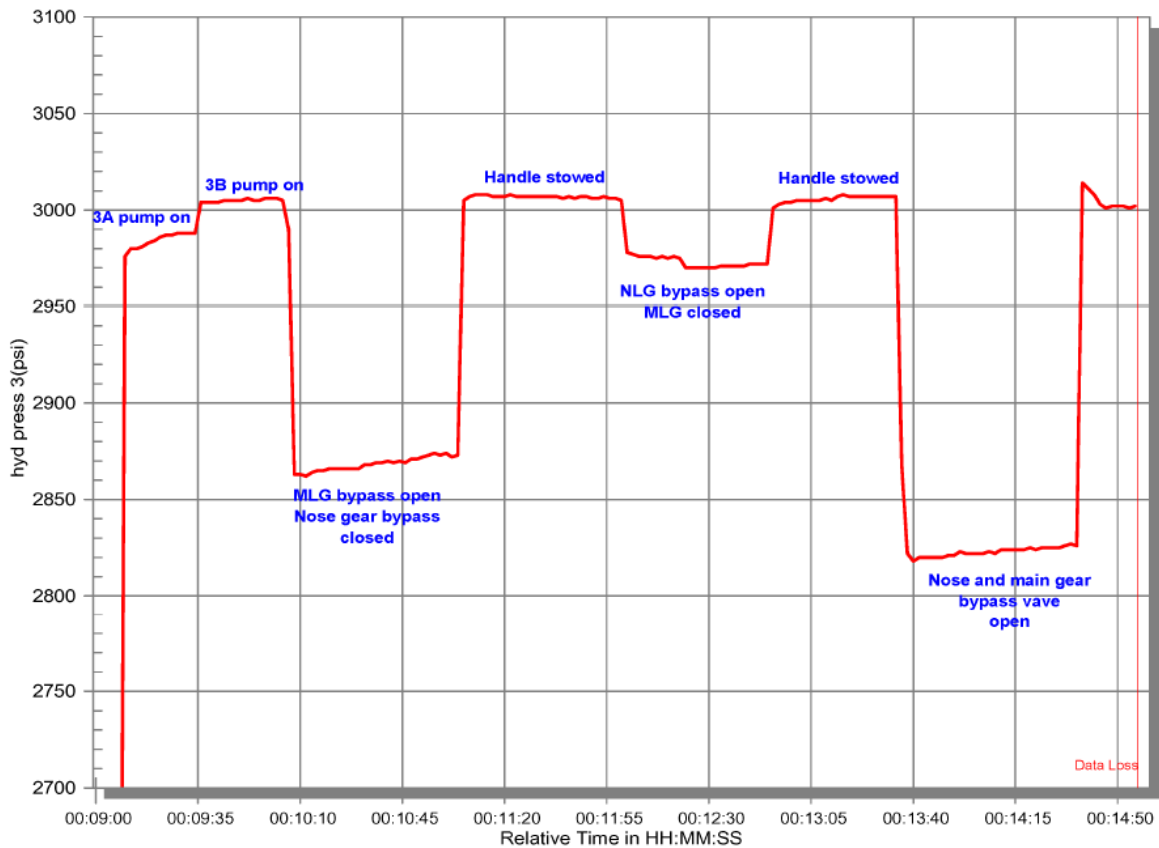
On August 4, 2011, SkyWest Airlines conducted a test on the landing gear system to determine the pressure drop in system 3 when the MLG and NLG bypass valves are commanded to bypass mode. They also performed this test for each valve separately (figure 10).

Figure 10 Plot showing the pressure drops due to the landing gear system bypass valves

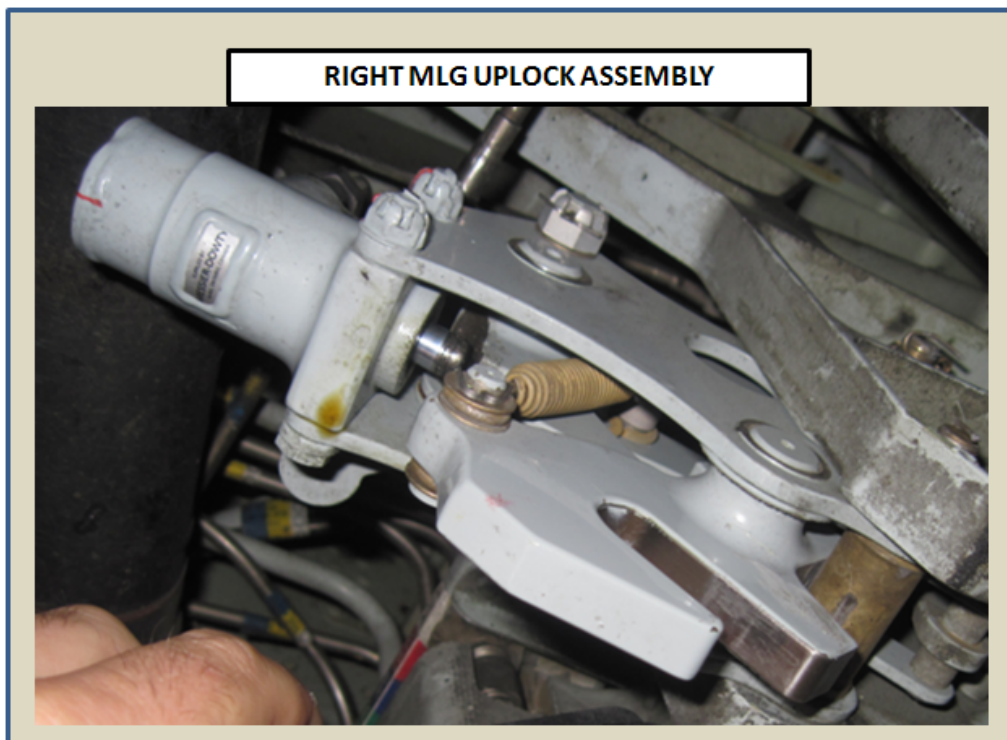
Visual inspection of the right uplock assembly at the working area of the latch (i.e. the hook where it is contacted by the uplock pin) revealed wear marks on its upper surface and wear marks and a dent on the lower surface. Visual inspection of the hook on left uplock assembly revealed contact marks on its upper surface. According to Messier Dowty, these marks are minor and consistent with normal in-service wear patterns

The airplane assembly instructions specify that the rigging gap between the root of an uplock hook and the edge of the MLG uplock pin should be a distance between 0.730 to 0.910 inches. To take this measurement, modeling clay was placed in the right uplock mechanism's hook while it was in the unlocked position. The MLG was then retracted allowing the uplock roller to displace a portion of the clay in the uplock hook. The MLG was then extended and the length of the remaining clay in the hook was measured. The remaining clay is equivalent to the gap between the uplock pin and the root of the uplock hook. The measured gap for the right uplock assembly hook was found to be 0.750 inches.

Figure 13 Right Main Landing Gear Uplock Assembly

The right uplock assembly was manually closed and a measurement of the gap between the proximity sensor and its target was found to be 0.031 inches (requirement between 0.035 and 0.045 inch). The gap between the left uplock mechanism's proximity sensor and target was not measured.

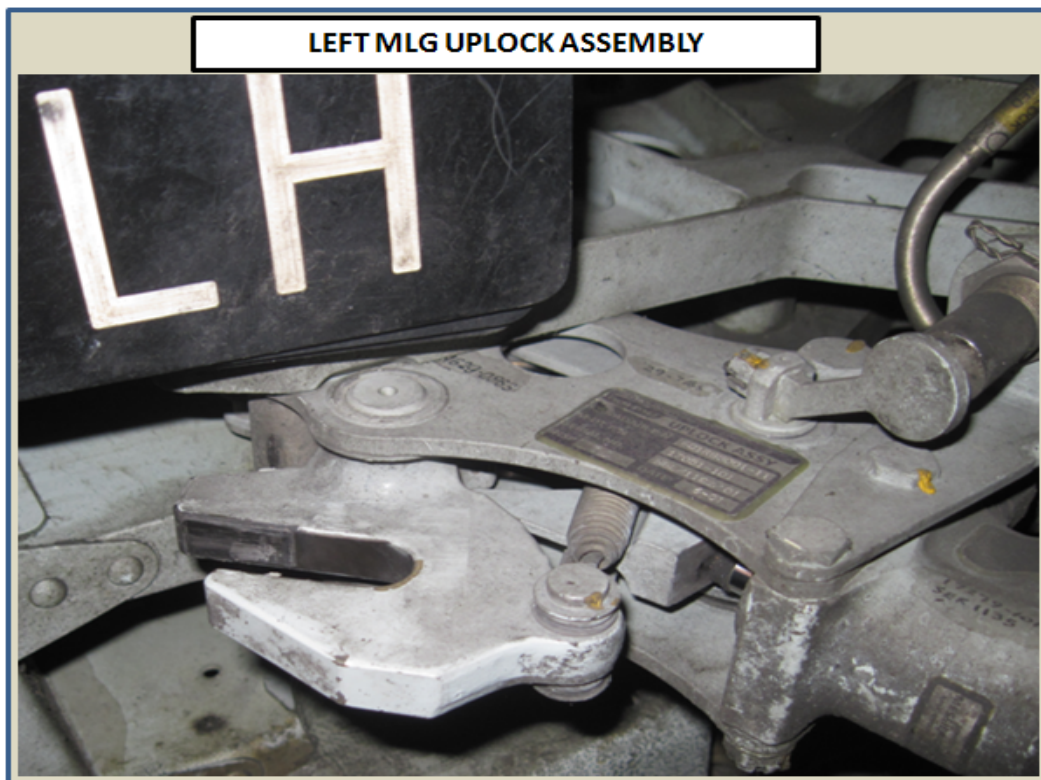
Figure 14 Left Main Landing Gear Uplock Assembly

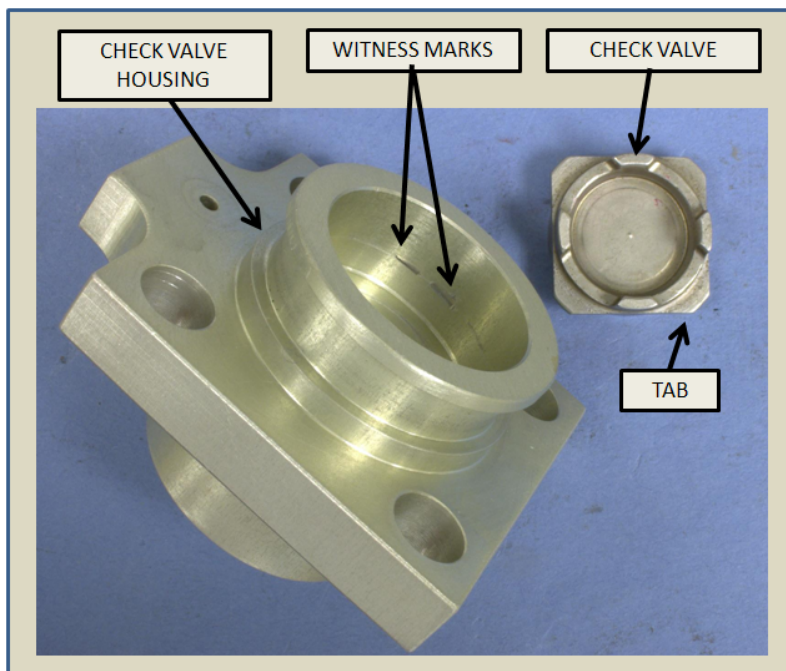
- a) Erosion was visually observed inside the valve body at the passages.
- b) A piece of seal strand was present on the spool.
- c) Witness marks were observed on the inside surface wall of the check valve housing (figure 16)⁷. The NTSB requested that Tactair ship the R&BP valve to the NTSB in Washington D.C.

Figure 16 Check Valve and Housing Assembly

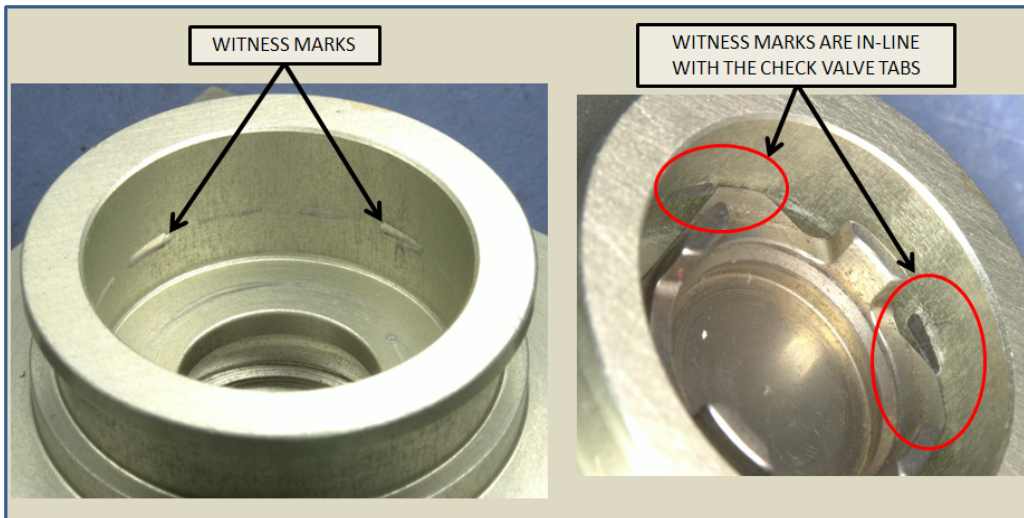
Upon receiving the R&BP valve, the NTSB examined the check valve and its respective housing under a microscope to evaluate the witness marks. Examination found that there were two sets of marks on the housing wall and they appeared to be slight indentations (removed material) having the approximate length and width as the tabs on the check valve (figure 17). The check valve was inserted into its housing which showed that the witness marks were in-line with the tab. The check valve was moved in and out and it was determined that the witness marks did not restrict the valve from moving.

Figure 17 Witness Marks on Housing Wall

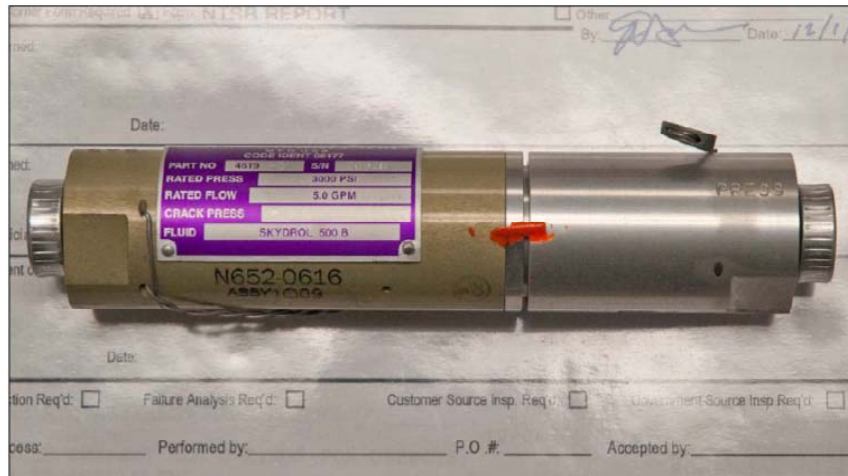
Visual inspection of the unit revealed that both of its hydraulic ports were capped (figure 18). There were no anomalies other than insignificant tool marks on the wrench flat areas consistent with installation upon the aircraft. The safety wire was taut, normally oriented, and terminated with what appeared to be the original lead seal as installed during manufacture by PneuDraulics. The torque stripe was unbroken and appeared normal.

Figure 18 Priority Valve
