**NATIONAL TRANSPORTATION SAFETY BOARD  
OFFICE OF AVIATION SAFETY  
WASHINGTON, D.C. 20594**

**Systems Group Chairman's Factual Report of Investigation**

Operator: UPS  
Aircraft: A300-600F, MSN 841  
Location: Birmingham, AL  
Date: August 14, 2013  
Time: 4:47 AM Local Time

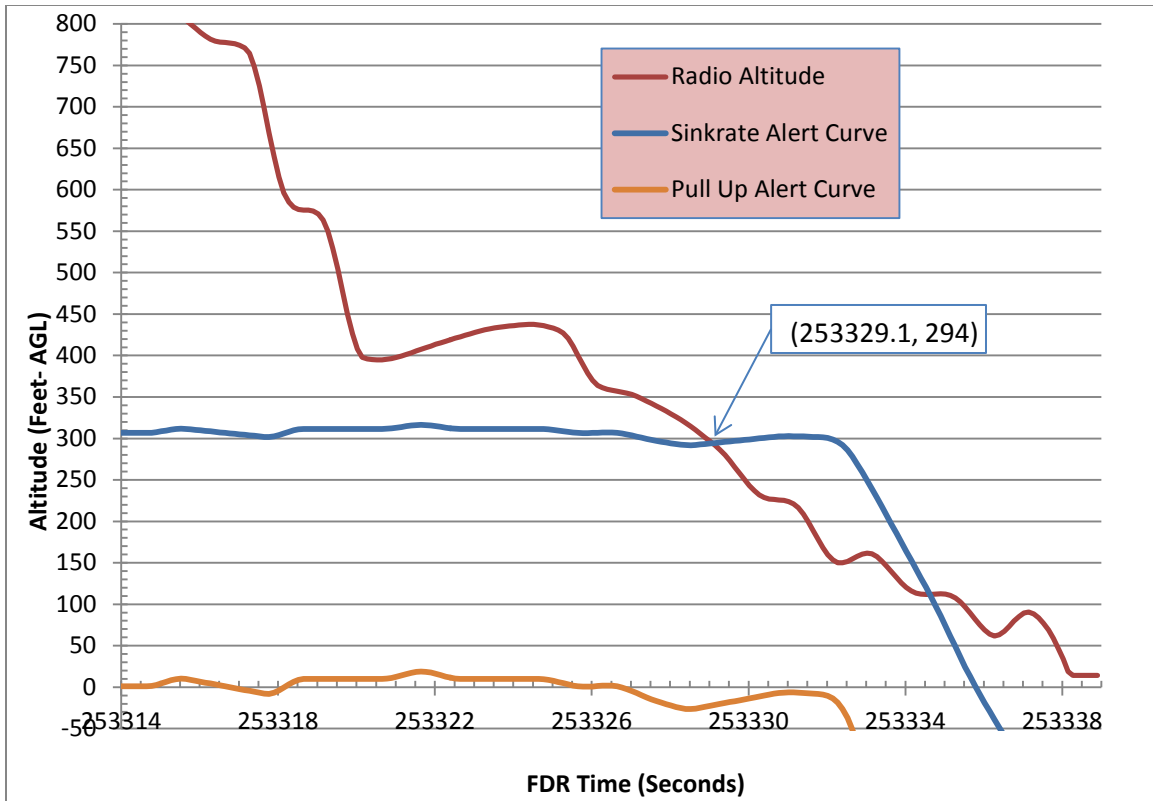
Figure 4 Mode 1 Alert Curves Using Accident Data

The Mode 1 “Sinkrate” and “Pull Up” alert envelopes and the radio altitude of the airplane were plotted as a function of FDR time (Figure 4). The airplane entered the “Sinkrate” envelope at FDR time 253329.1, at approximately 294 feet AGL. After the 0.8 second persistence time is added, the expected alert time was 253329.9, at approximately 250 feet AGL. This FDR time corresponded to 4:47:24.4 local time. The Mode 1 “Pull Up” envelope was not penetrated.

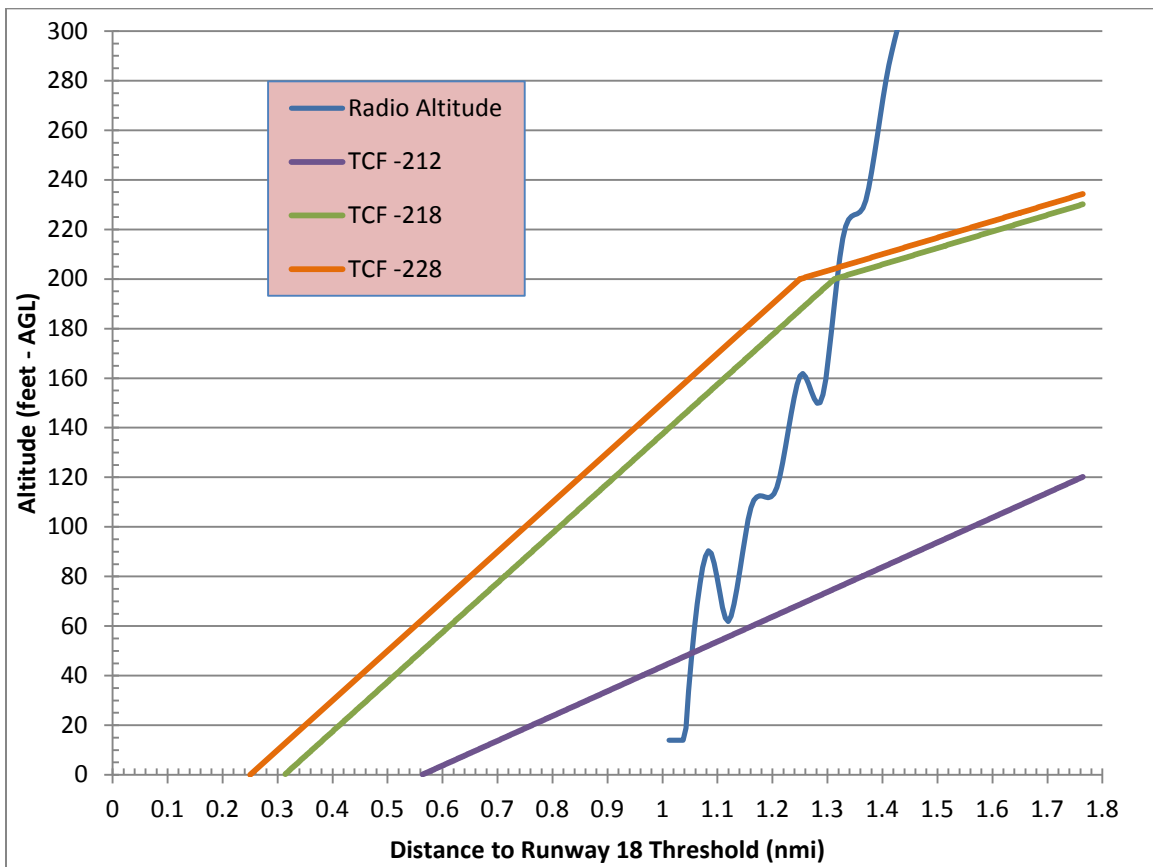
Figure 5 TCF Alert Curves Using Accident Data

Taking these numbers into account, the value of K for the accident flight was 0.5625 nmi. The value of K for a -218 through -226 unit would have been 0.3125 nmi. The value for K for -228 and higher units would be 0.25 nmi.

The -212, -218, and -228 TCF alert curves were plotted along with the actual radio altitude, shown in Figure 5. The airplane entered the -212 TCF envelope at approximately 49 feet, which correlated to approximately 4:47:32.4 local time. After the 1 second persistence time was added, the expected alert (“Too Low Terrain”) time was 4:47:33.4. At that time, there was no further FDR values for radio altitude, the last recorded value was 14 feet approximately 0.6 seconds prior. The airplane would have entered the -218 TCF envelope at approximately 200 feet, and the actual alert would have occurred at approximately 150 feet, 4:47:27 local time. The airplane would have entered the -228 TCF envelope at approximately 204 feet, with the alert time being approximately the same time as the -218 (less than 0.1 s difference).

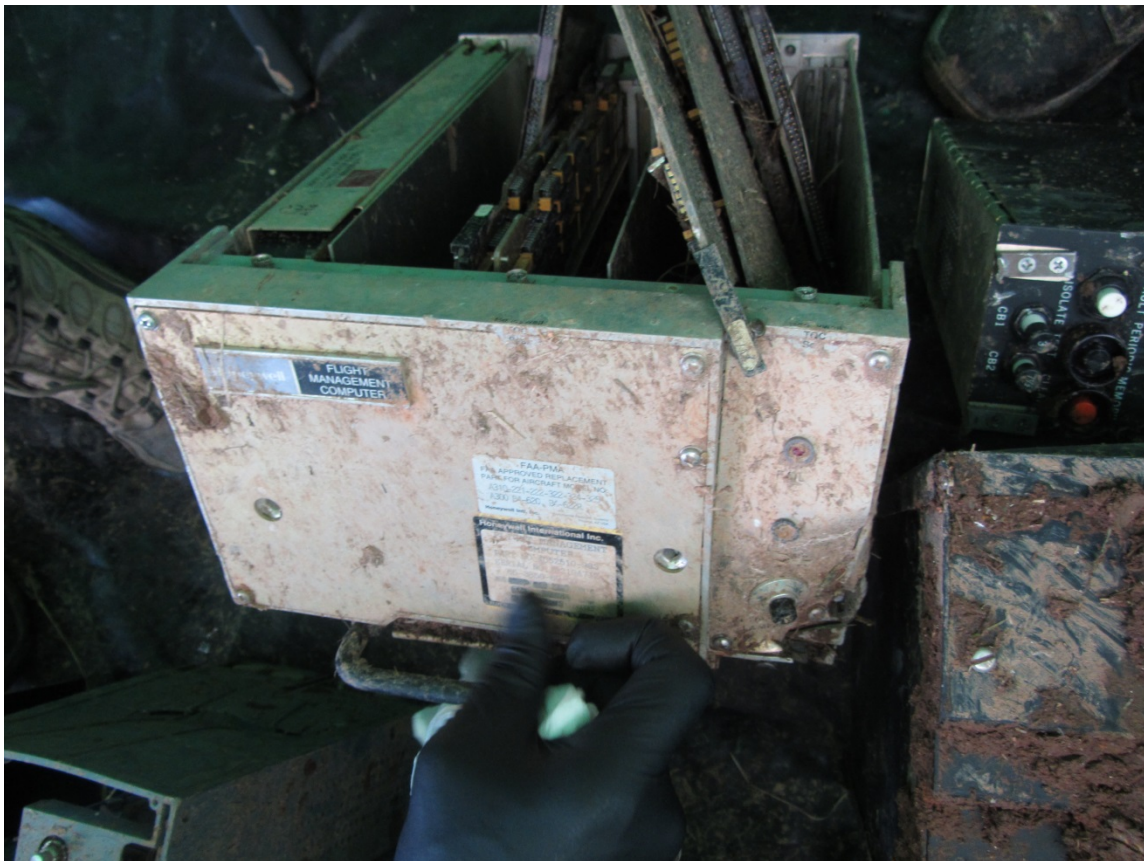
**Figure 6 Recovered Flight Management Computer**

The Flight Management Computers (FMCs) were identified at the accident site; Part Numbers 4052510-983, Serial Numbers 0203A660, and 0219A712. Both FMCs were found in the debris field, separated from the electronic rack and considerably damaged. Most of the circuit cards were separated from the FMC housings (Figure 6) with mud and water on them. The parts were then shipped by UPS to the NTSB. Honeywell provided a description of the Mass Memory Card (MMC) which contained the data stored in Static Random-Access Memory (SRAM). The MMCs, serial numbers 61697077, and 1789290 for both FMCs were identified in the recovered parts

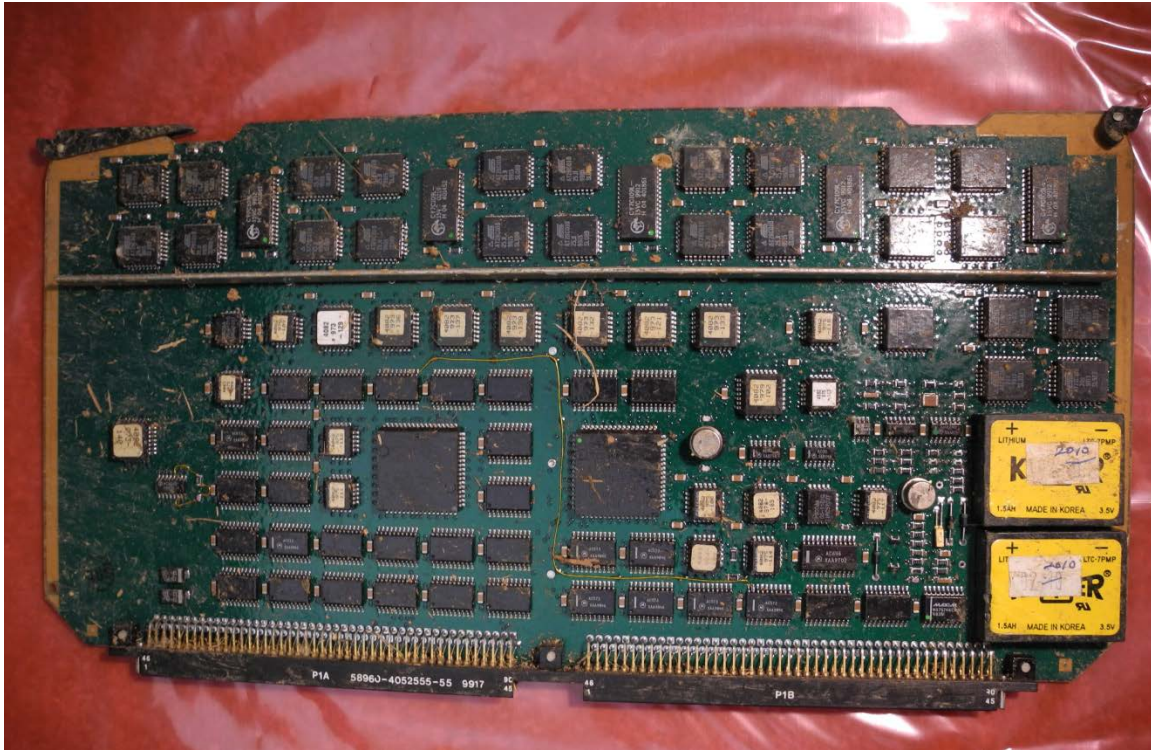
Figure 7 FMC MMC Card SN 1789290

(Figure 7). The parts were shipped to the Honeywell Sky Harbor facility (1944 E. Sky Harbor Circle, Phoenix, AZ) where they remained locked in a bonded, secure area.
