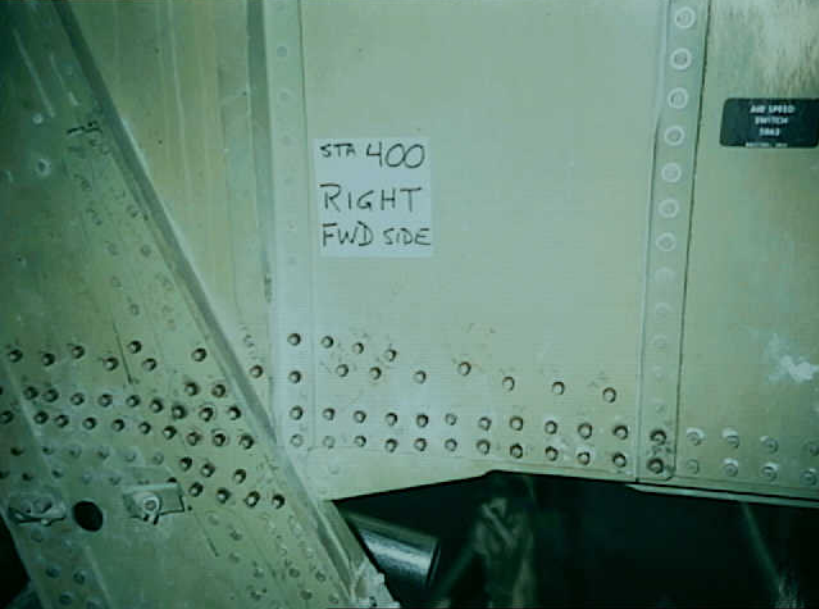
Systems 9 - Fuel Quantity Indication System - Photo 17. Repair found in frame at station 400 (right), beneath route of W350 and W1360 wire bundles.
