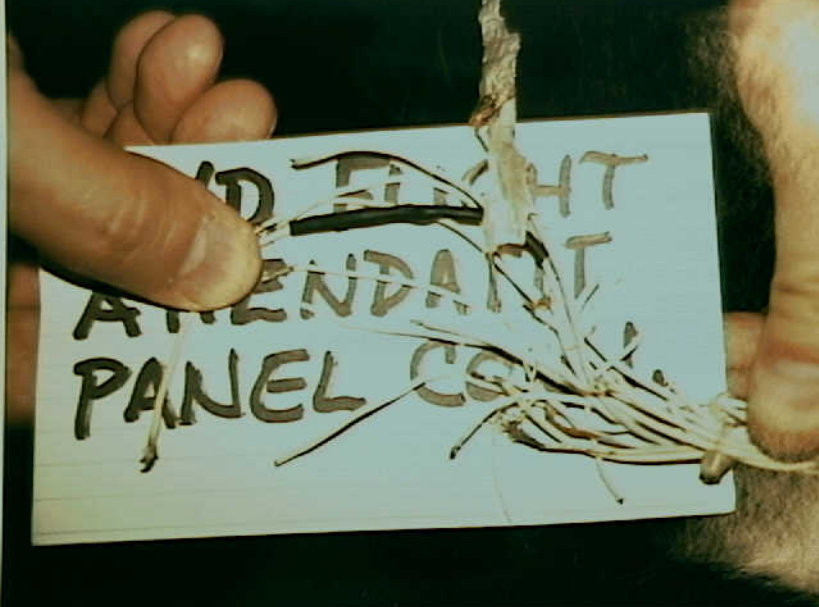
Systems 9 - Fuel Quantity Indication System - Photo 29.  
Repair found to wiring behind upper deck flight attendant control panel.
