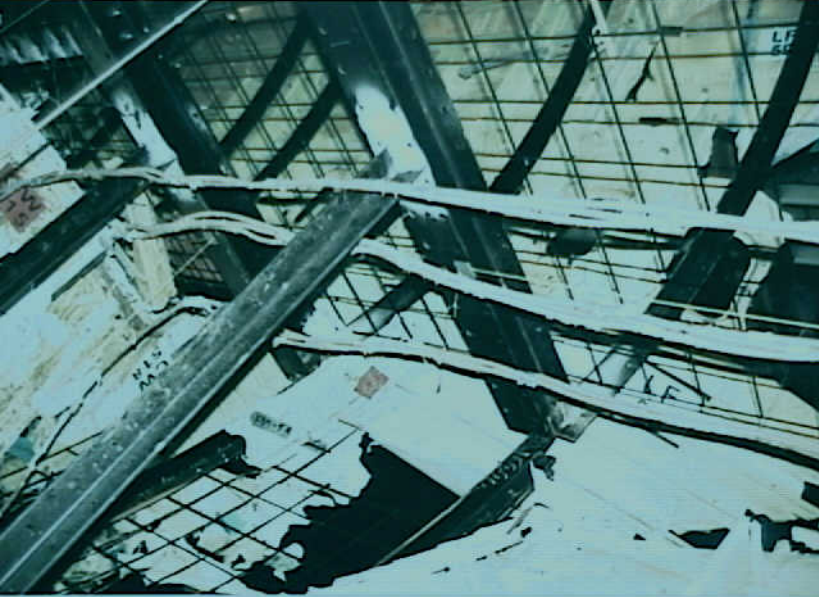
Systems 9 - Fuel Quantity Indication System - Photo 37. Forward spar, breach in left side of fuselage at about station 920 (along route of missing W480 wires), and generator cables for engines 1,2 and APU generator.
