**NATIONAL TRANSPORTATION SAFETY BOARD**  
Office of Aviation Safety  
Washington, D.C. 20594

**SYSTEMS GROUP CHAIRMAN FACTUAL REPORT ADDENDUM FOR  
ELECTRICAL WIRING INFORMATION**

**A. ACCIDENT: DCA96MA070**

**Airplane :** Boeing 747-131, N93119  
Operated as Trans World Airlines (TWA) Flight 800

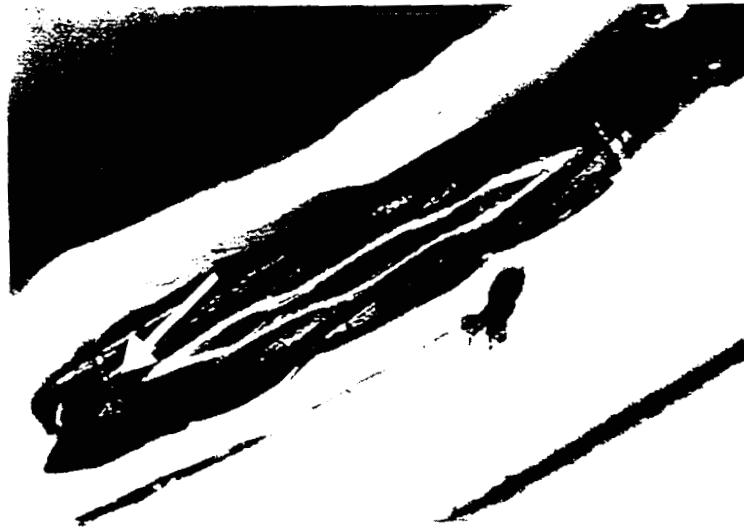
Figure 3 An aromatic polyimide tape substrate with micro cracks. The external fluorinated polymer coating has been removed for examination of the aged polyimide in order to show visually the concealed structure failure.

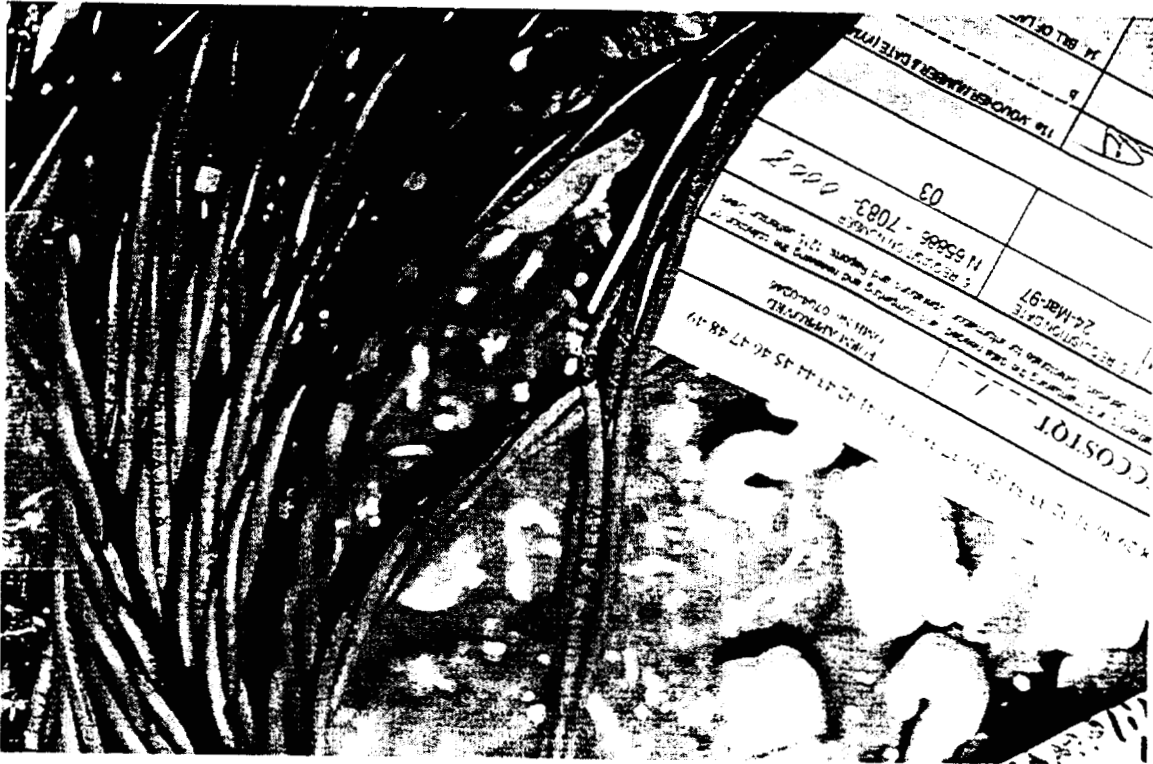
Figure 10 Typical severe trauma damage to insulation structure commonly found on many types of aircraft.

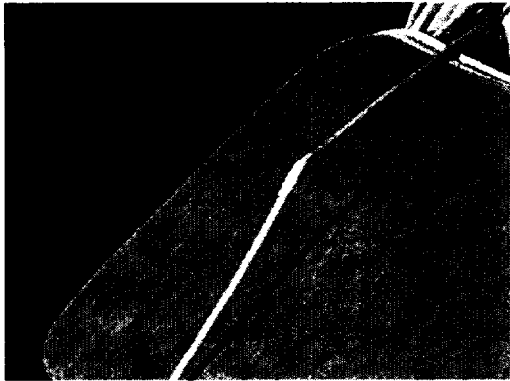
Mil-W-22759/34  
(X-ETFE)  
Flowing

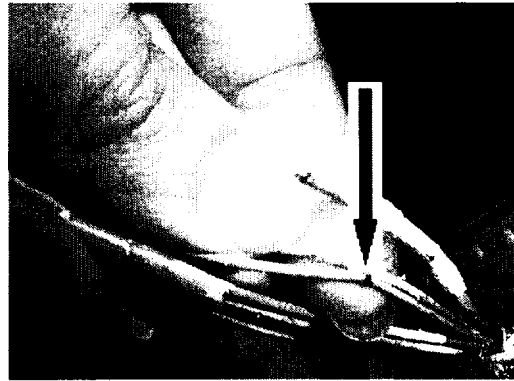
Mil-W-81381 (Aromatic  
Polyimide) Fracturing  
from age

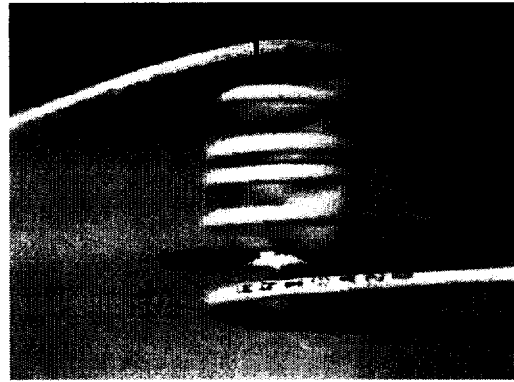
Mil-W-81044/16 (Aliphatic  
Polyimide) Spalling
