**NATIONAL TRANSPORTATION SAFETY BOARD
OFFICE OF AVIATION SAFETY
WASHINGTON, D.C. 20594**

**SYSTEMS GROUP CHAIRMAN'S
FACTUAL REPORT OF INVESTIGATION**

DCA01MA034

Operator: Avjet Corporation
Aircraft: Gulfstream III (N303GA)
Location: Aspen, Colorado
Date: March 29, 2001
Time: 19:02 Mountain Standard Time

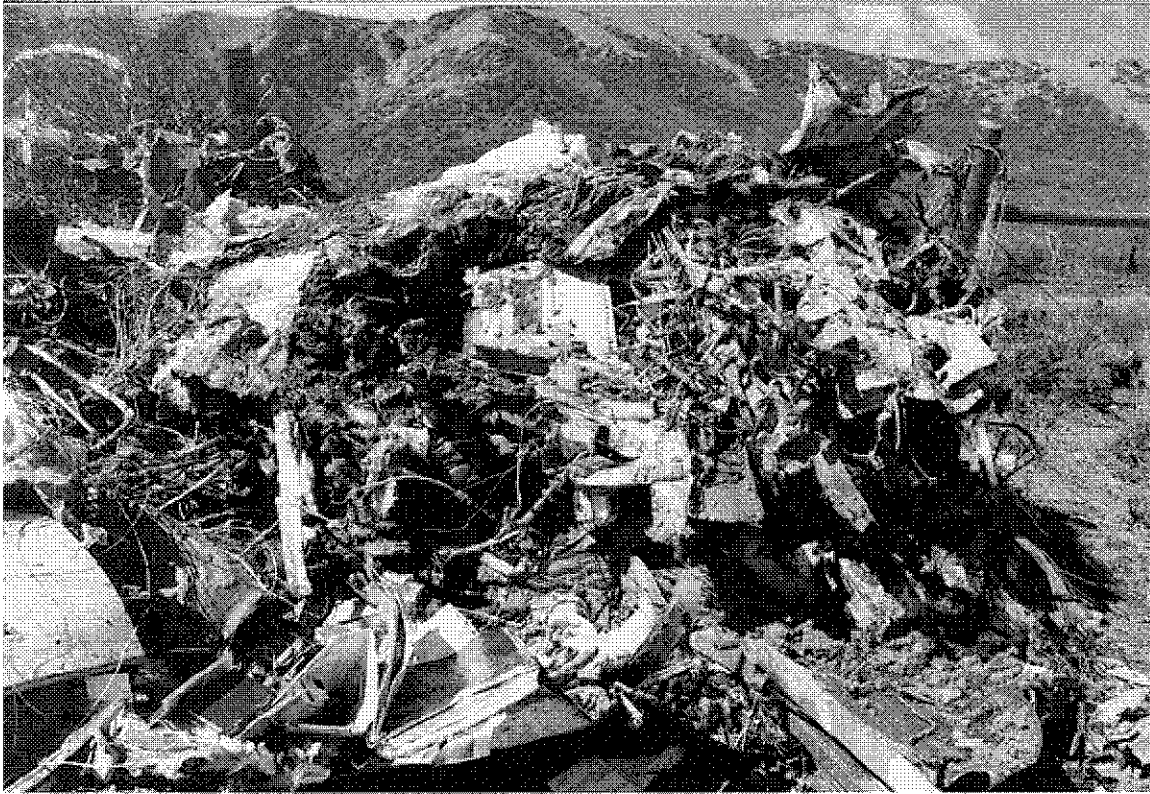
Most of the flight instruments and panels were recovered in the vicinity of cockpit wreckage. Figure 1 shows the cockpit wreckage, which included parts from the electrical equipment center to the nose of the airplane. All of the instruments were separated from the panels, so we were not able to determine which instruments were the captain's versus which were the first officer's. Though the instruments experienced varying degrees of damaged, the indications of the instrument were recorded and are provided in Appendix A.

Figure 1. Cockpit wreckage.

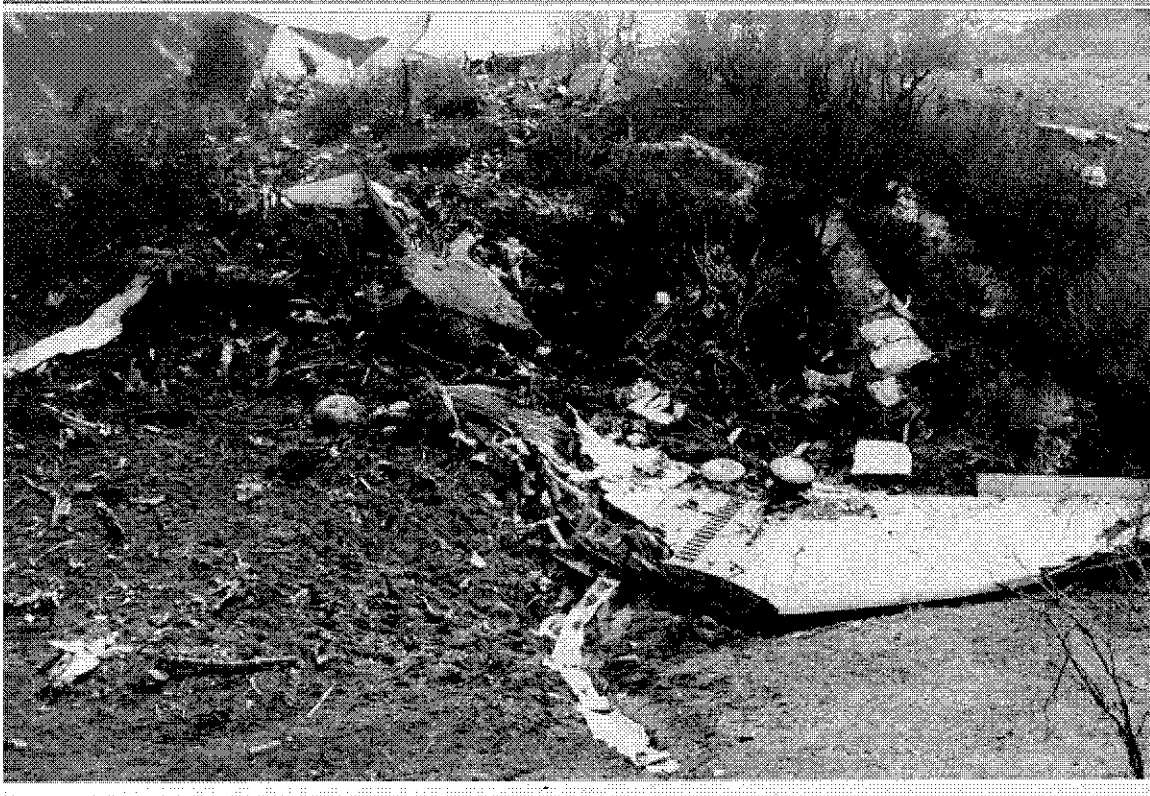
Both flaps were found separated from the wing, near the wing structure. Figure 2 shows the wreckage. The view is of the top of the wings with the left wing on the right side of the photo. A large portion of the left flap can be seen above the left wing. All four jackscrews were found with the traveling nut still attached to the jackscrew and portions of flap structure. The position of the traveling nut on all four jackscrews was within approximately $\frac{1}{2}$ inch from the jackscrew down mechanical stop. According to Gulfstream this position corresponds to flaps in the Full Down or 39 degree position.

Figure 2. Wings, Flaps, Ailerons and Main Landing Gear.

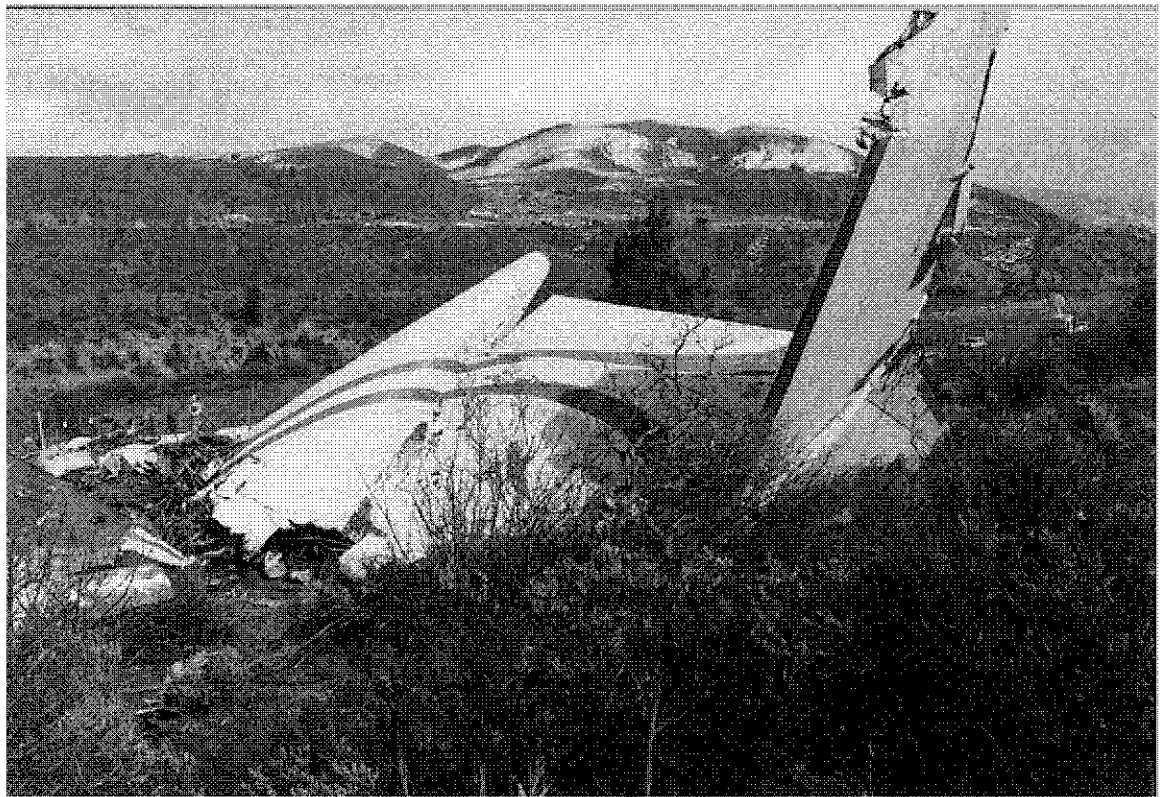
The horizontal stabilizer was found still attached to the vertical stabilizer. Figure 3 shows the empennage wreckage. The horizontal stabilizer was determined to be in approximately the 6 degree LED position, as determined by the position of the leading edge relative to index marks on the vertical stabilizer.

Figure 3. Empennage.

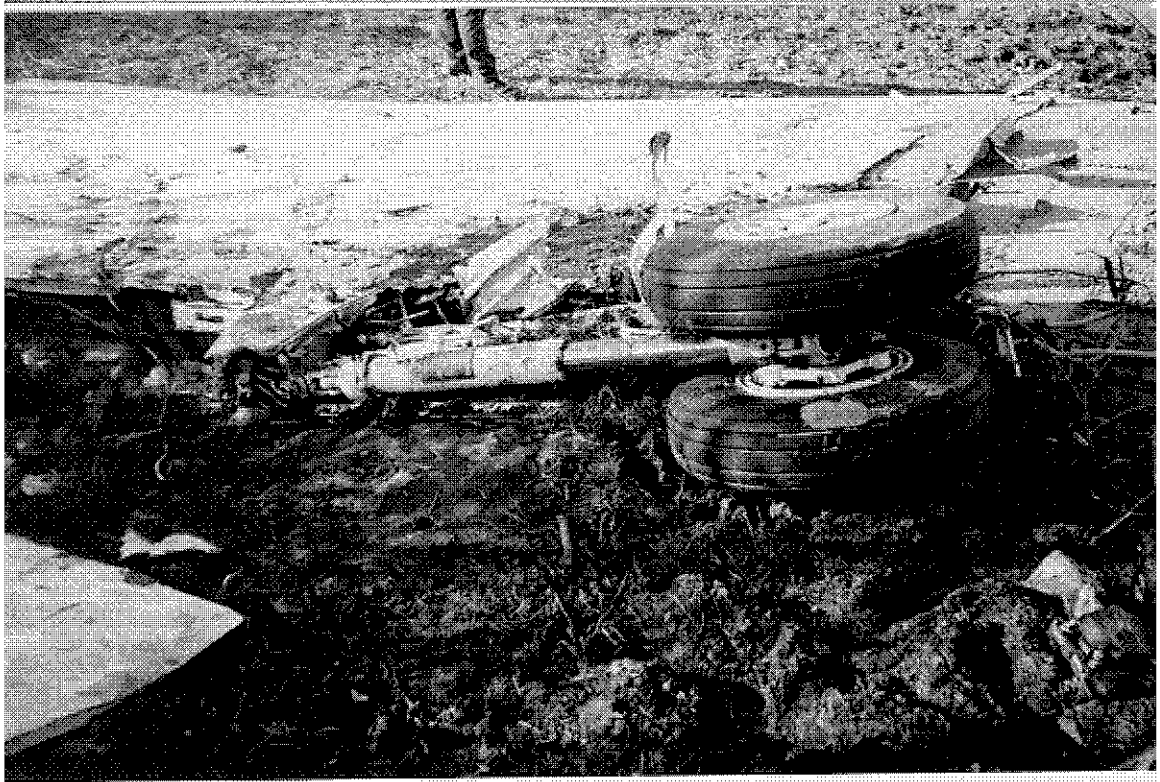
The Left Main Landing Gear was found still attached and mostly undamaged; tires inflated with little mud on inboard tires, wheels or brakes (Figure 4). The struts and tires were pressurized. The side brace actuator was attached at the both ends. The gear was in the up position, but up past the normal full up position. No damage to the strut attachment points at the wing structure (sponson rib) was observed.

Figure 4. Left Main Landing Gear

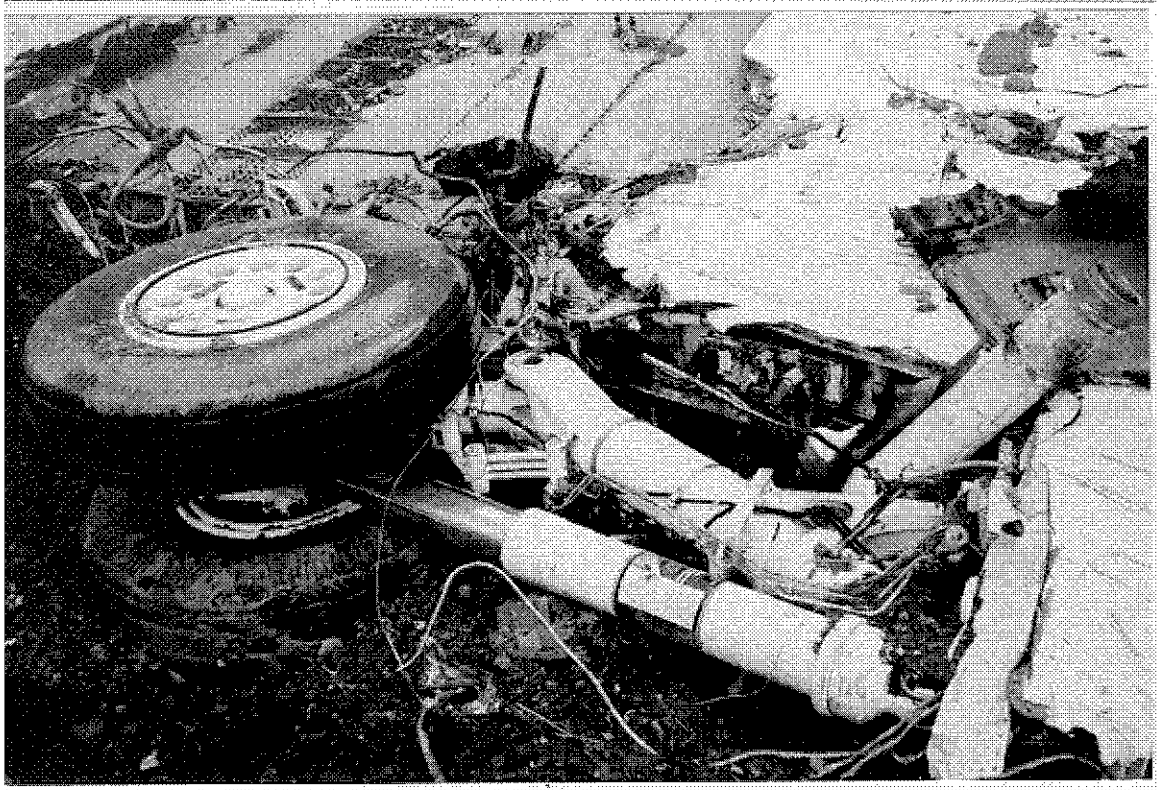
The Right Main Landing Gear was found still attached and mostly undamaged; tires inflated with little mud on inboard tires wheels or brakes. The struts and tires were pressurized (Figure 5). The side brace actuator was attached to the gear on one side, but was separated from the endcap at the wing rear beam attach fitting. The gear was past the full up position. No damage to the attachment points (sponson rib) was observed.

Figure 5. Right Main Landing Gear.

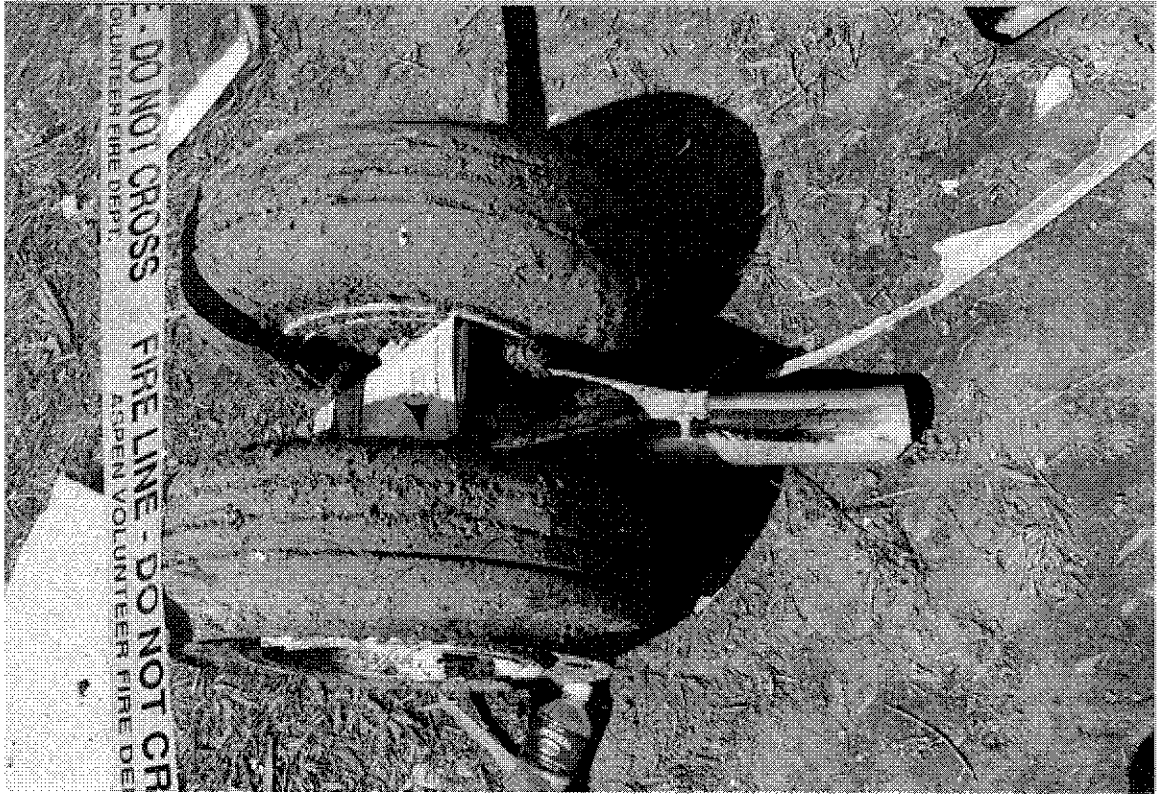
The Nose Landing Gear fractured at two places. The tires were on the wheels and attached to the shock strut piston, which was fractured below the steering unit (Figure 6). The wheels and tires were coated with a heavy layer of mud. The nose gear steering shock strut cylinder fractured near the upper trunnion attachment point (Figure 7). The segment which included the steering shock strut cylinder was located closest to the initial impact point, in the bottom of the ravine. The upper trunnion attachment point was approximately 40 yards southeast of the cylinder in the wreckage, which included the flight compartment. The segment which included the wheels was approximately 25 yards southeast of the upper trunnion attachment point.

Figure 6. Nose Gear Wheels and Portion of Strut Piston.

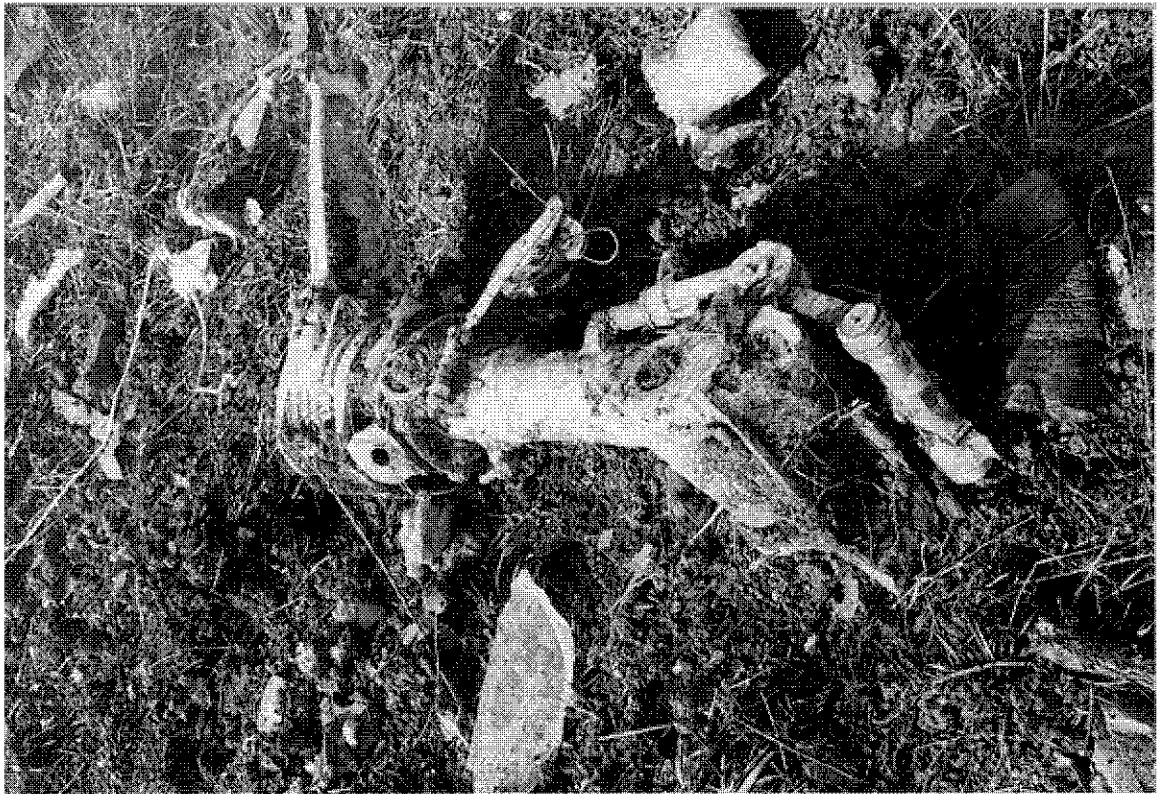
Figure 7. Nose Gear Steering Shock Strut Cylinder.
