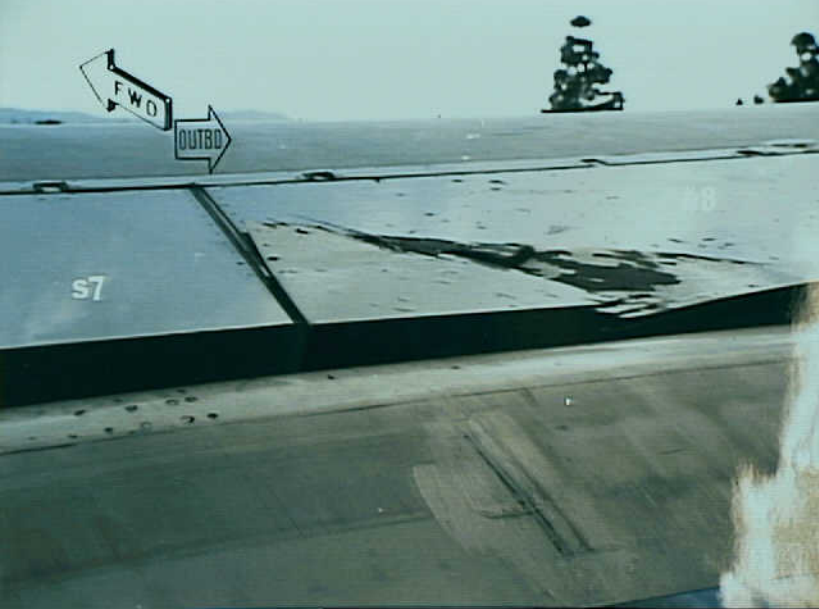
Systems 9 - Photo 10. View looking inboard of spoiler 8. Note damage to inboard trailing edge. There was no damage to the leading edge of the flap panel.
