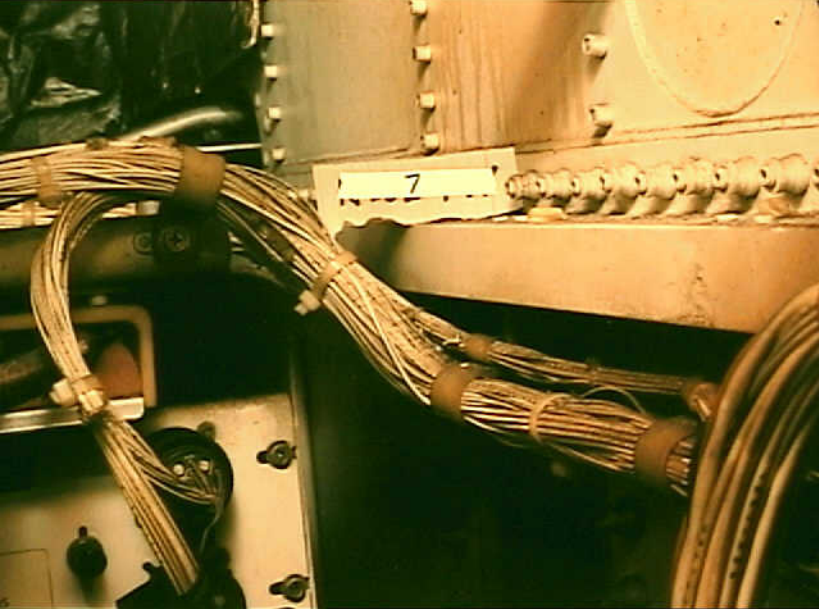
Systems 9 - Photo 12. Airplane 7. B-747 Drill shavings on wire bundles immediately beneath floor structure repair shown in photo 11. Fluid stain visible on structure.
