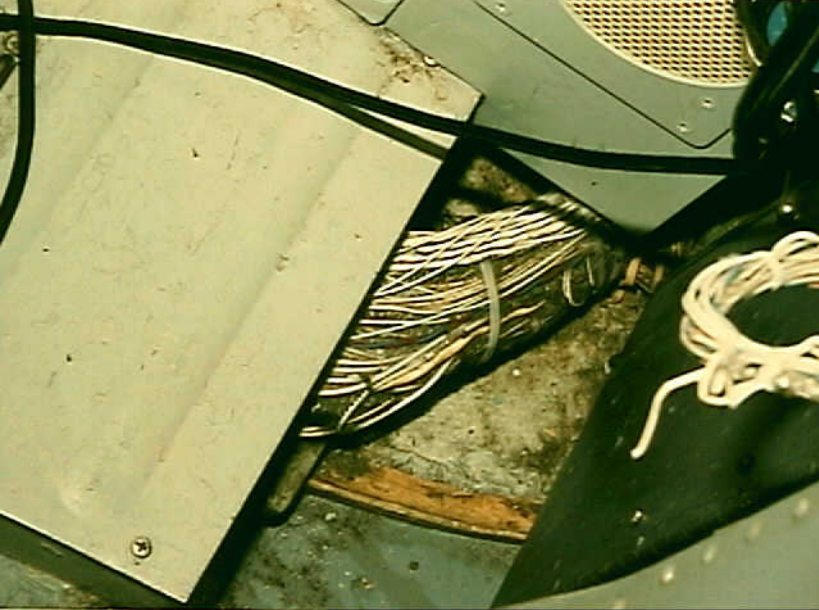
Systems 9 - Photo 32. Airplane 14. B-747 cockpit floor aft and outboard of First Officer seat. Wire bundle was stiff and not flexible, containing bared wire fragments, metal shavings, dirt, and a mixture of wire types. New wires laid on existing bundle.
