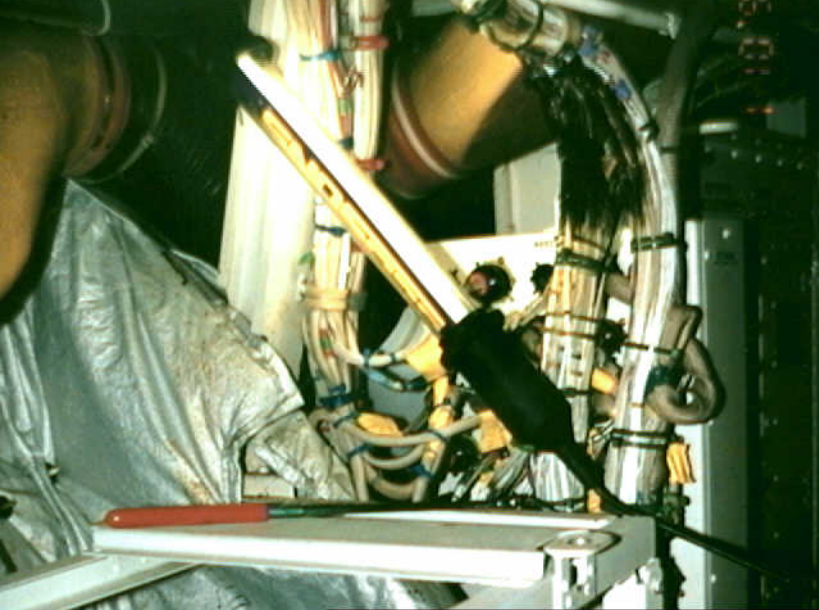
Systems 9 - Photo 41. Airplane 19. B767 burned wires seen after chiller removed from the rack over the oxygen tank. The edge of the chiller was near the burned area, damaged wire insulation was found on unburned wires, and foam on chiller burned.
