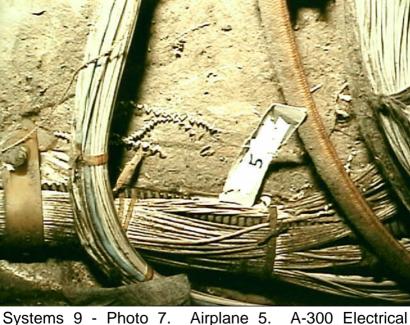
compartment beneath cockpit. Drill shavings shown on wires and shaving are between cable and wires. Loose string, wire chafe, and lint are visible. (Left edge of photo
