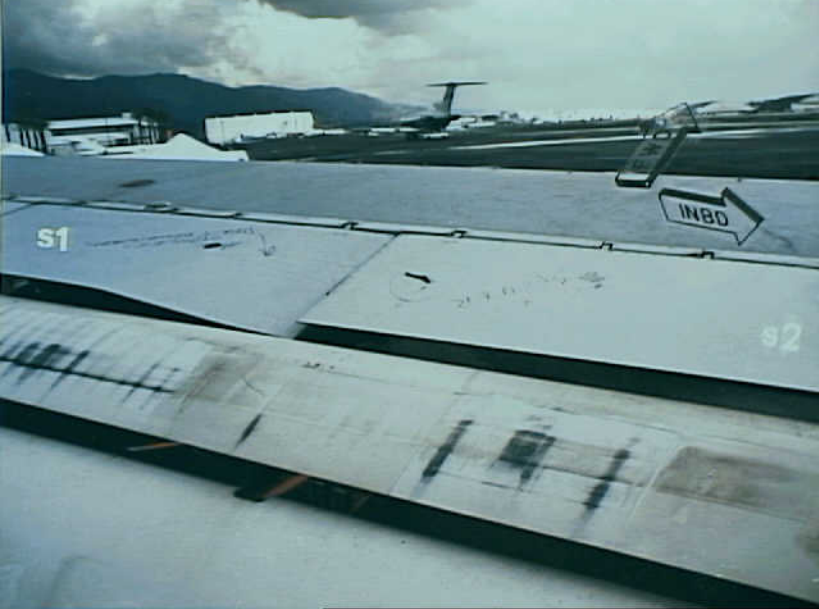
Systems 9 - Photo 9. View looking forward of spoiler 1. Note damage to inboard trailing edge. There was no damage to the leading edge of the flap panel.
