NATIONAL TRANSPORTATION SAFETY BOARD

Systems Group Chairman's Factual Report

DCA06MA064

Location: Blue Grass Airport, Lexington, Kentucky
Date: August 27, 2006
Time: 0607 Local Time (EDT)
Aircraft: Comair Flight 5191, a Bombardier Canadair
CL-600-2B19-7472, N431CA

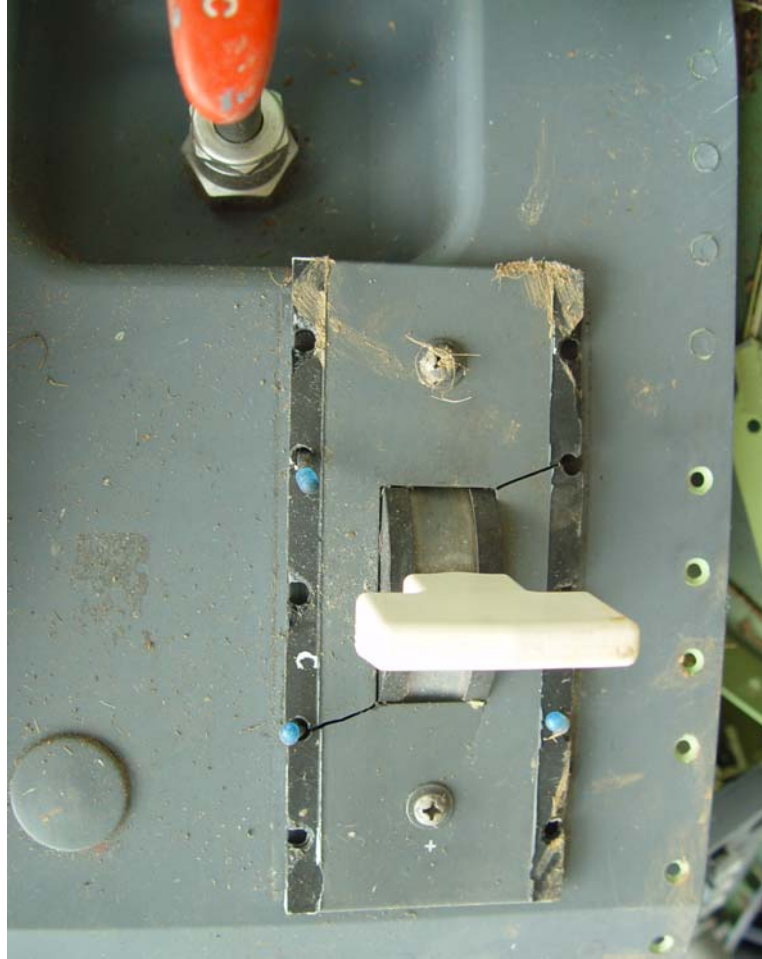
Figure 1 - Flap Selector

The flaps selector lever in the flight deck was found in the 20° detent (see Figure 1). The flap position indicator was missing, but comparison to an exemplar unit indicated the selector was in the 20° position.

The flap actuator measurements were provided to Bombardier Aerospace Engineering for conversion to flap setting. According to Bombardier Aerospace Engineering, in each case, the converted flap measurements were consistent with a 20°-flap setting.

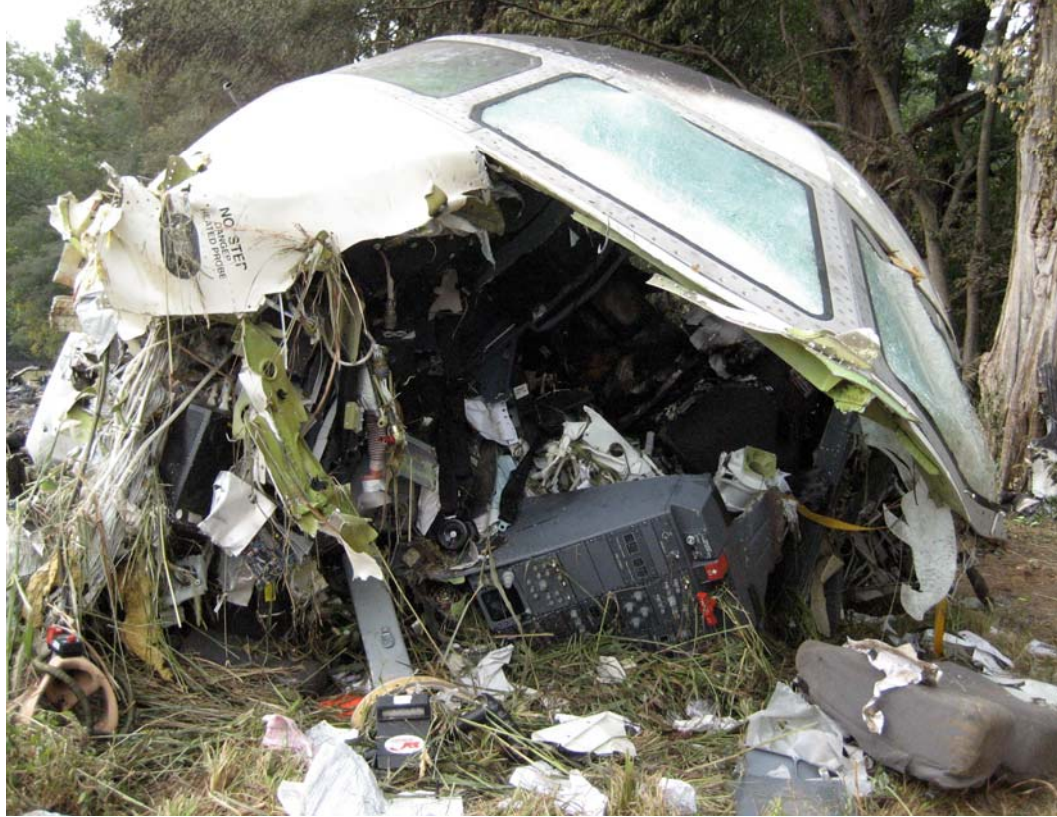
Figure 2 - Damage to Flight Deck

The forward portion of the flight deck was substantially damaged by impact damage (see Figure 2). The aft portion of the flight deck was subjected to post-crash fire.

Both forward windshields were damaged and shattered (see Figure 2). No assessment of pre-existing condition of the windshields was possible.
