**NATIONAL TRANSPORTATION SAFETY BOARD**

**Systems Group Chairman's Factual Report**

DCA-09-MA-026

Operator: US Airways  
Location: Hudson River  
Date: January 15, 2009  
Time: 1530 Eastern Standard Time  
Airplane: Airbus Industrie A320-214, N106US

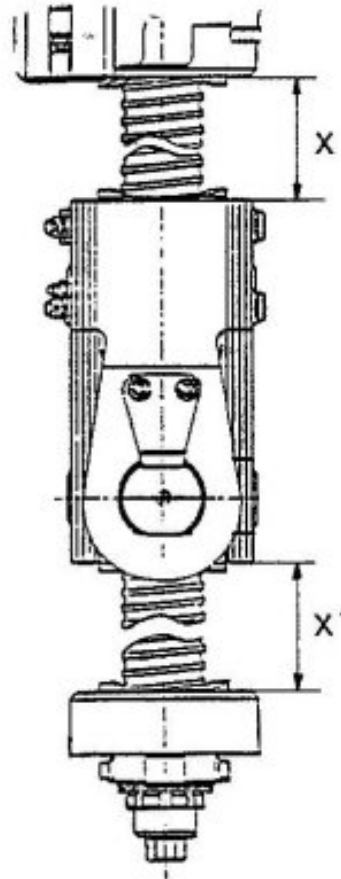
Figure 1  
Trimmable Horizontal Stabilizer Actuator Measurement Locations

The pitch trim system was examined, and the trim indications were noted from the indicating wheel in the cockpit, the index marks on the tail, and by measuring the trimmable horizontal stabilizer actuator (THSA). The pitch trim wheel in the cockpit indicated approximately 4.7 units aircraft nose up. The index marks on the tail indicated a position of 4.7 units aircraft nose up. The measurements of the THSA were 270 mm measured from the bottom of the ball screwjack to the top of the lower ballscrew stop (measurement X' on figure 1). The length of the upper screw section of the THSA (measurement X on figure 1) could not be measured accurately, but was determined to be approximately 270 +/- 40 mm. According to Airbus documentation, these measurements correlated to a pitch trim position between 4.5 and 5 units aircraft nose up.

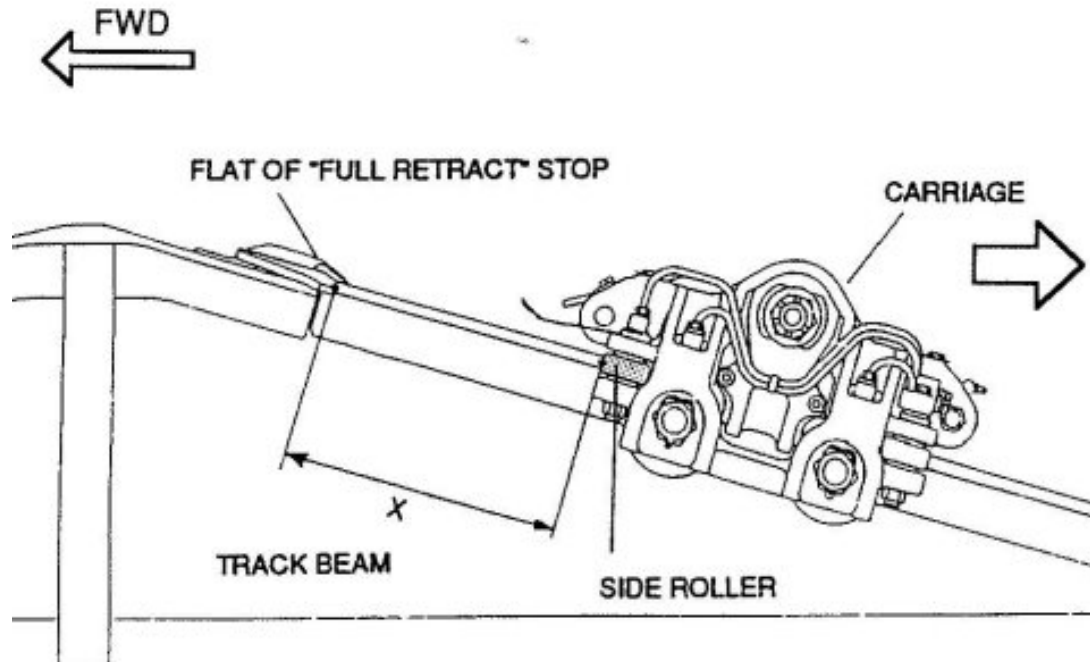
Figure 2  
Flap Carriage Measurement Location

The flap positions were determined by taking measurements as specified in figure 2. The measurements are taken along the flap track beam between the flat of the “full retract” stop and the edge of the side roller of the flap carriage (measurement X on figure 2). These measurements were taken on tracks 2 and 3 of the right wing and were determined to be 358 and 361 mm respectively. According to Airbus documentation, these measurements correspond with flap position 2. Examination of the flap lever in the cockpit determined that the lever was in position 2. These measurements could not be taken on the left wing because these measurement points were not accessible. Qualitative examination determined that the flap positions on each side of the aircraft appeared to be the same.

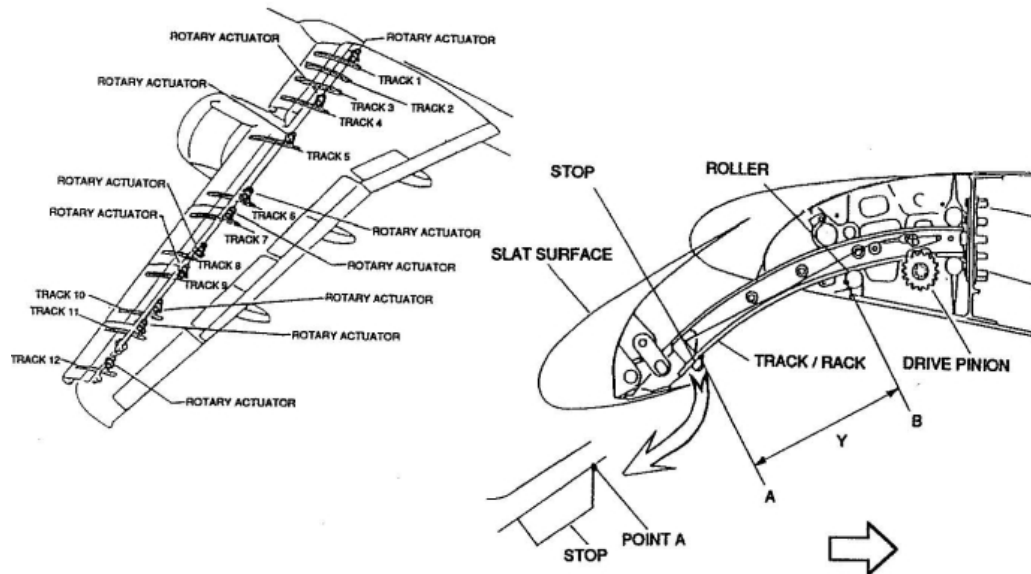
Figure 3  
Slat Position Measurement Locations

The slat positions were determined by taking measurements as called out in figure 3. The measurements are taken along the slat track beam between the stop and the roller of the slat (measurement Y in figure 3). These measurements were taken on tracks 5 and 6 of the left wing and were determined to be 234 and 236 mm respectively. According to Airbus documentation, these measurements correspond with slat configuration 2 or 3 (the slat positions do not change when the flap lever is moved from position 2 to position 3). These measurements were also taken on tracks 5, 6, and 7 of the right wing and were all determined to be 235 mm. According to Airbus documentation, this measurement also corresponds to slat configuration 2 or 3.
