NATIONAL TRANSPORTATION SAFETY BOARD

SYSTEMS GROUP CHAIRMAN'S FACTUAL REPORT OF INVESTIGATION

A. ACCIDENT DCA-94-MA-076

Location: Aliquippa, Pennsylvania
Date: September 8, 1994
Time: 1904 Eastern Daylight Time
Aircraft: Boeing 737-300, N513AU

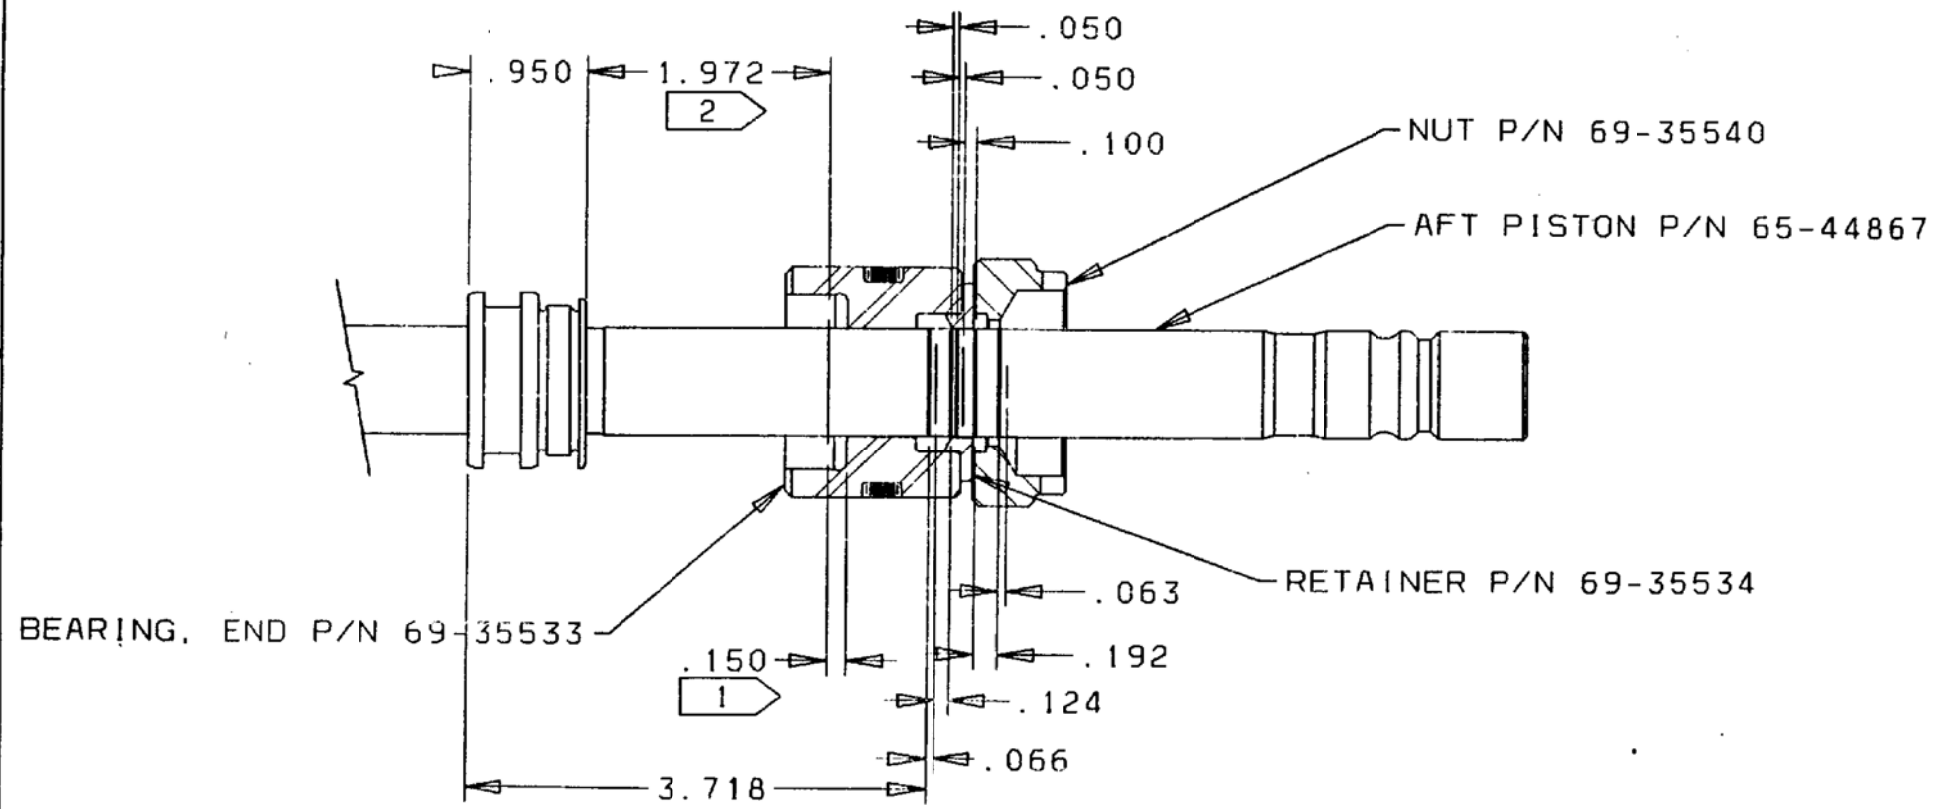
BOEING CORPORATE OFFICES SEATTLE, WA 98124	SIZE	DWG NO		
	B	FSCM NO	USAIR FLT 427	
		91205	RUDDER PISTON ANALYSIS	
BOEING PROPRIETARY		P CLINE	10/13/94	SCALE 1

1 $\sin^{-1} \left(\frac{.150}{4.5} \right) = 1.9$ DEGREES RETRACT (RIGHT RUDDER)

2 NEUTRAL POSITION OF PCU (0 DEGREES SURFACE)

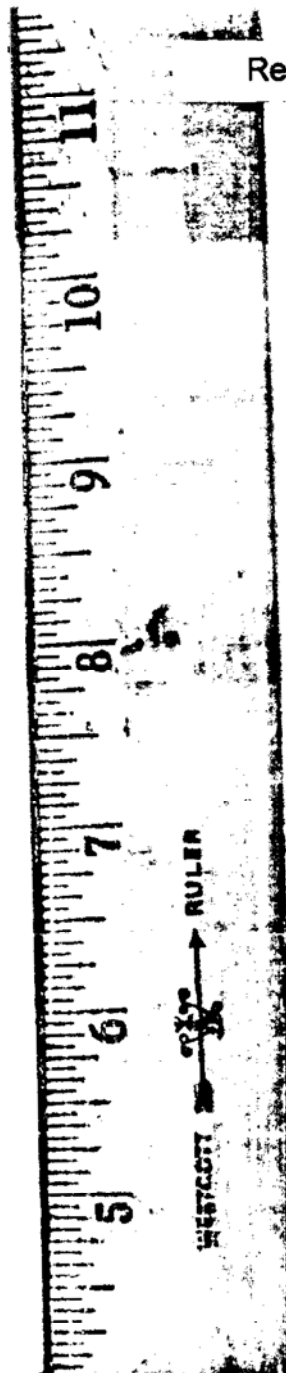
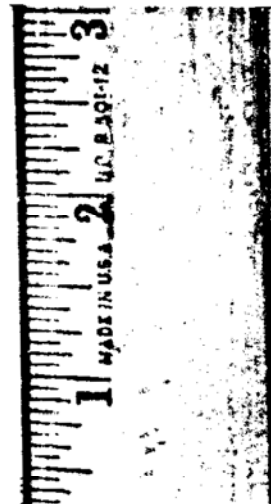
A fracture was identified on the 65-54206-5 shaft assembly below the upper spline. This fracture was analyzed by NTSB metallurgists. See Appendix 2 for a report of the findings.

Figure 1: Overall view of the shaft with arrows "1" indicating the fracture and arrow "2" an impact mark.

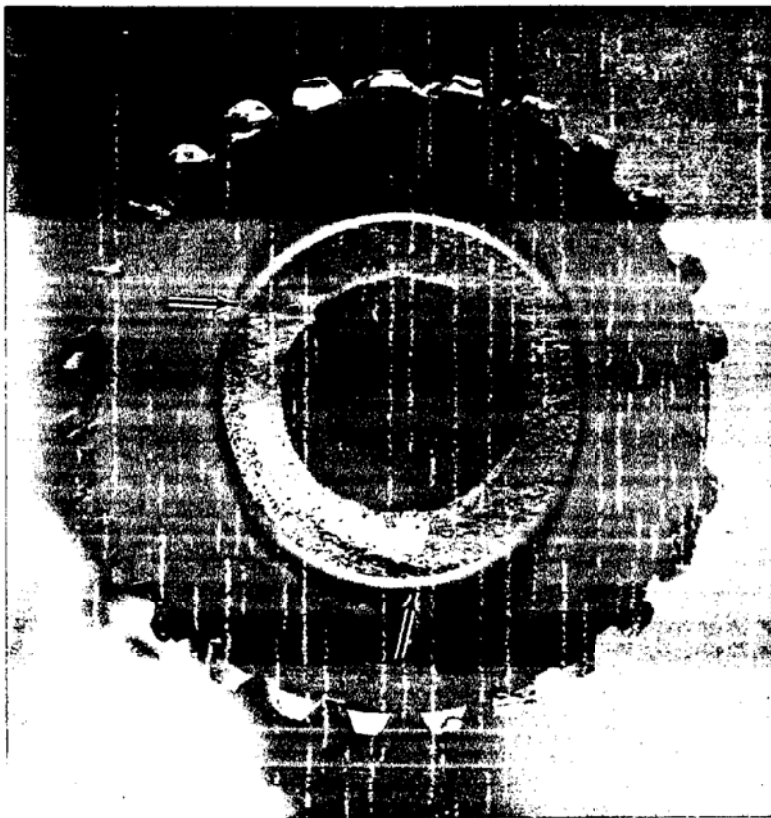
Figure 2: Fracture surface on the larger piece of the shaft. Smeared portion of the fracture is between the arrows. Magnification, 2X
